**PUNTA GORDA
AIRPORT (PGD)**

JUNE 2015

STATEWIDE
**Airfield
Pavement
Management**
PROGRAM

In March 2015, a PCI survey inspection was performed at Punta Gorda Airport. The results of the inspection indicate that, based on ASTM D 5340-12, the airport's airfield pavement facilities had an overall area-weighted average PCI of 71, representing a Satisfactory overall network condition. Table I summarizes the overall condition summary by network level branch in comparison to the FDOT recommended minimum service level and action recommendations for either major rehabilitation or maintenance level activities.

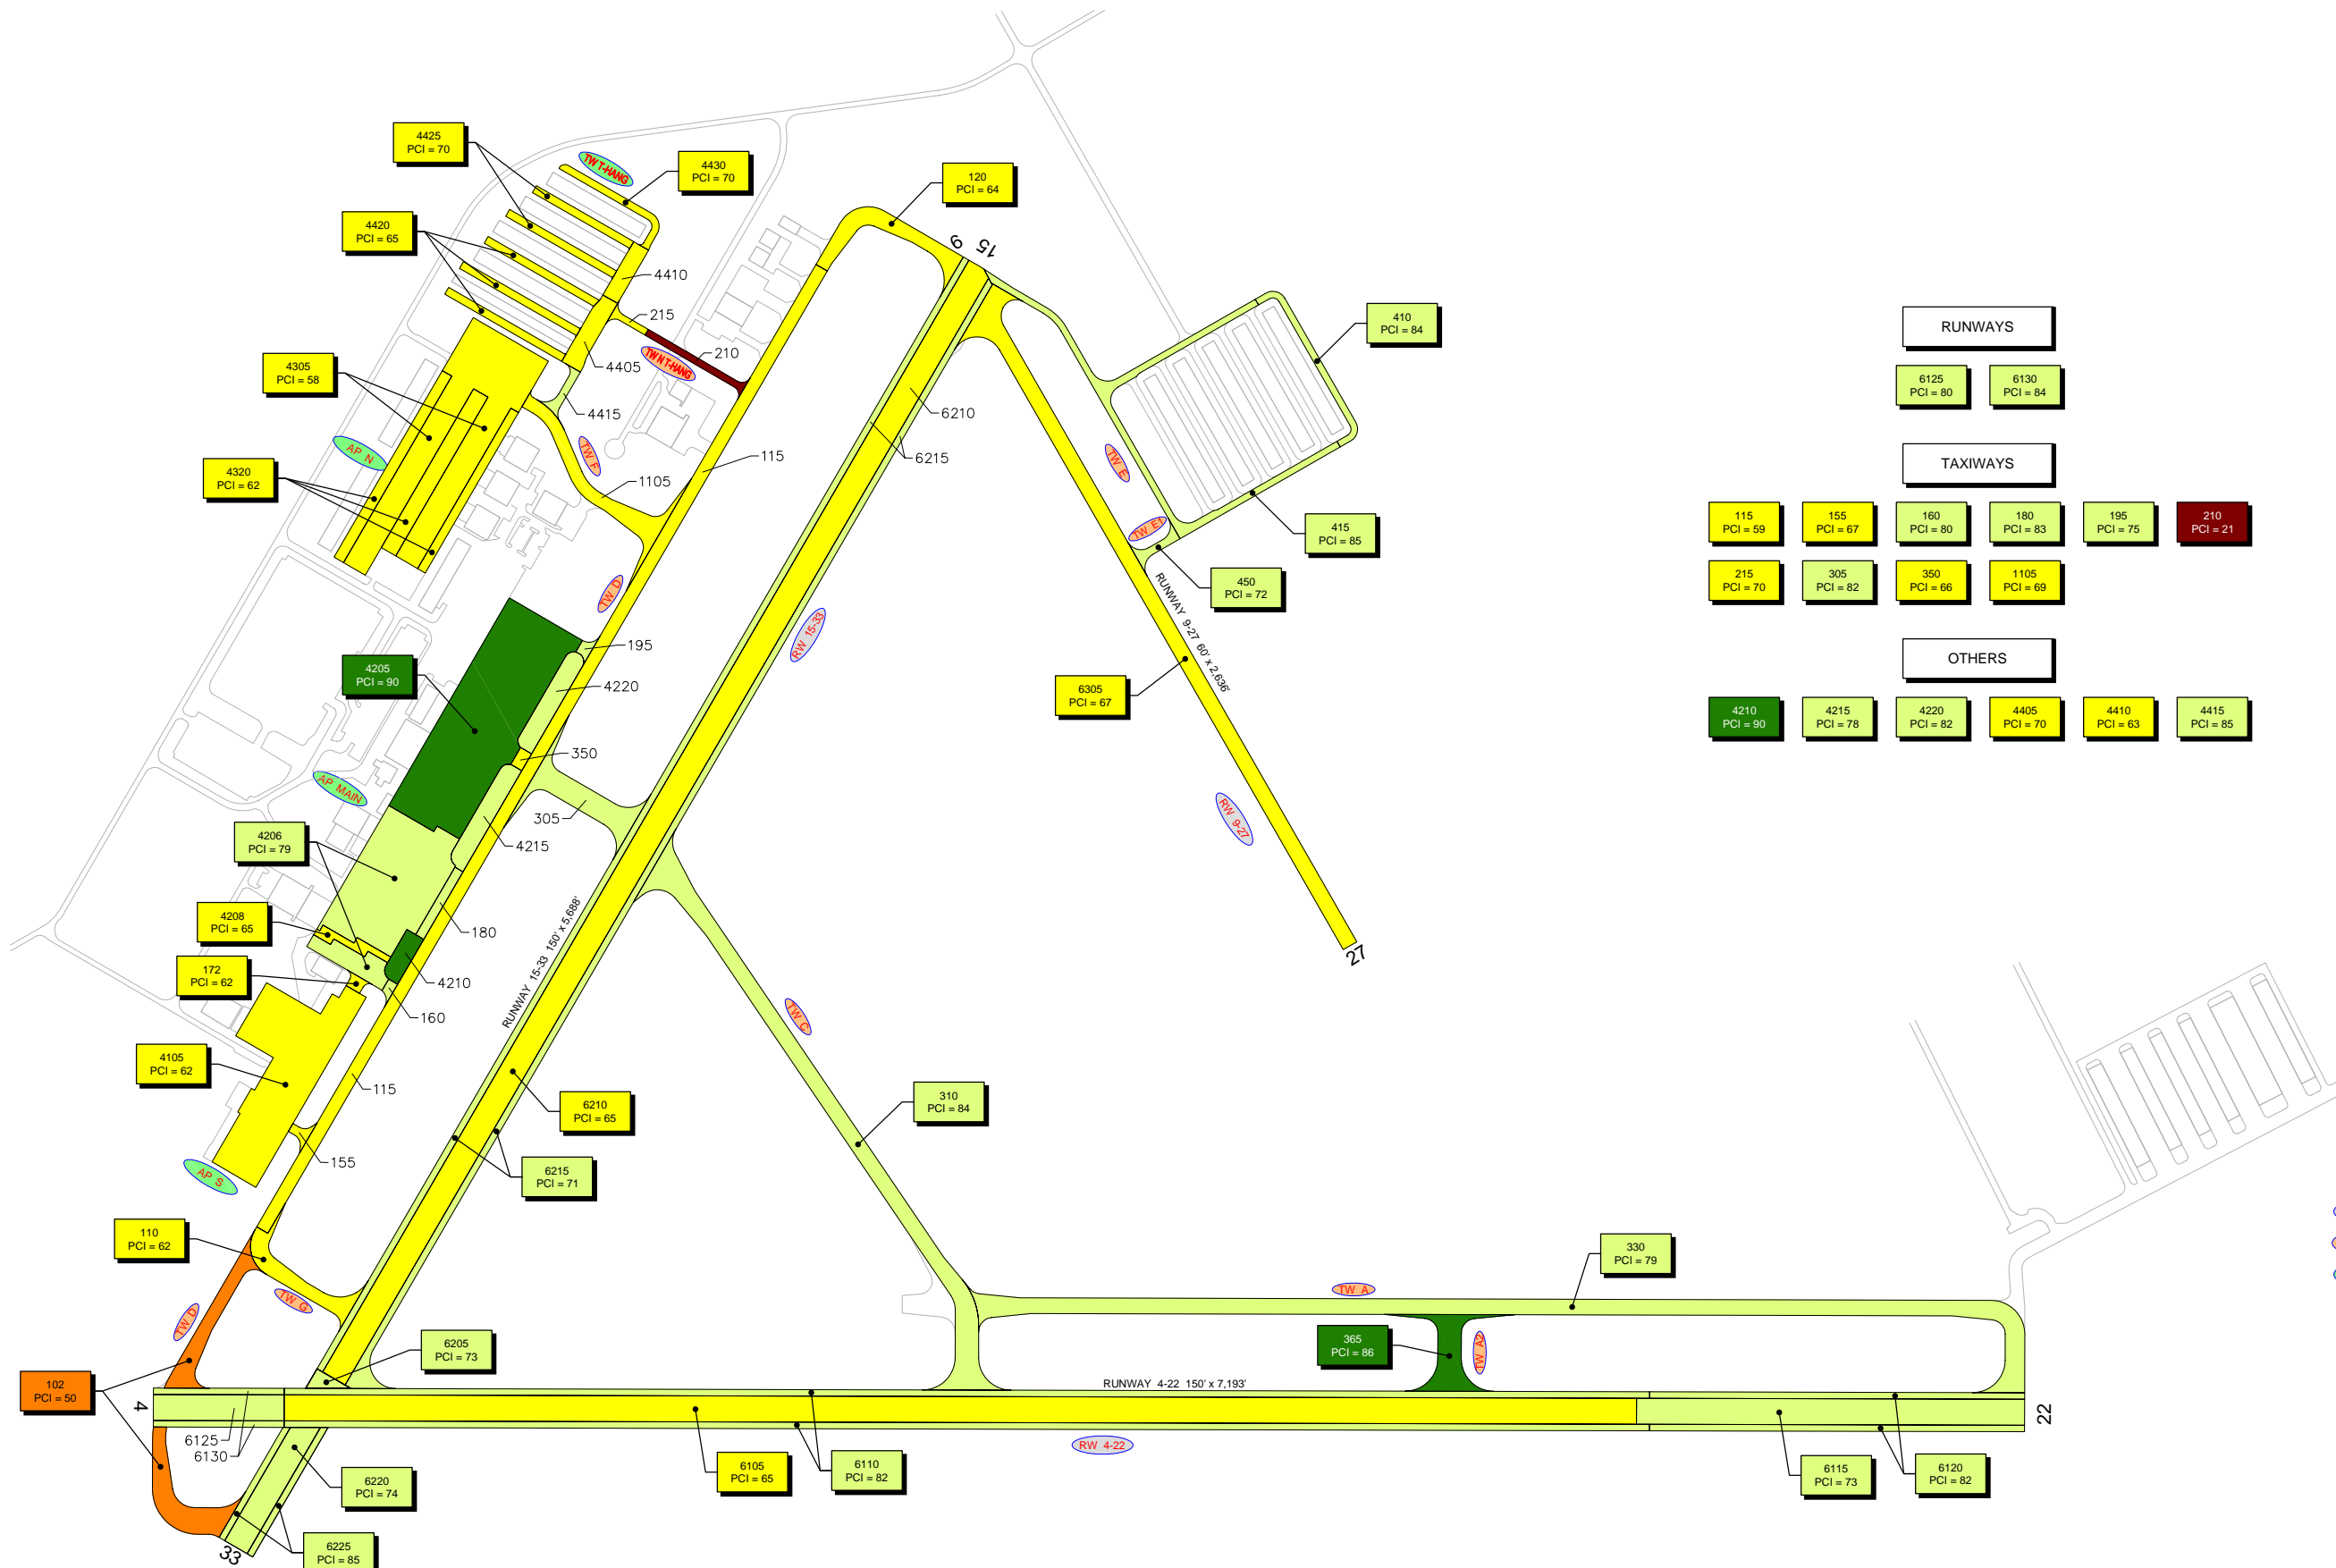
RUNWAYS	
6125 PCI = 80	6130 PCI = 84
TAXIWAYS	
115 PCI = 59	155 PCI = 67
215 PCI = 70	305 PCI = 82
350 PCI = 66	1105 PCI = 69
OTHERS	
4210 PCI = 90	4215 PCI = 78
4220 PCI = 82	4405 PCI = 70
4410 PCI = 63	4415 PCI = 85
