FLORIDA DEPARTMENT OF TRANSPORTATION
AVIATION AND SPACEPORT OFFICE

**ORLANDO
SANFORD
INTERNATIONAL
AIRPORT (SFB)**

JUNE 2015

STATEWIDE
**Airfield
Pavement
Management**
PROGRAM

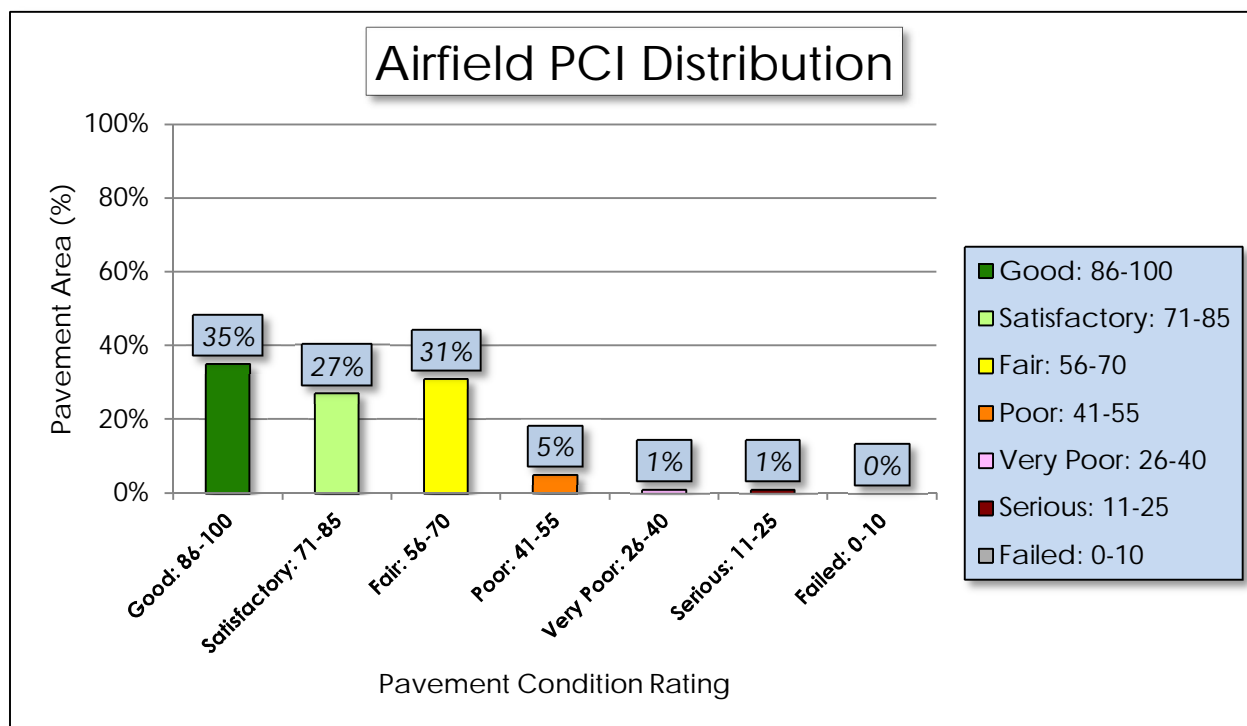
Figure 3-1: Airfield Pavement Condition Index Rating Summary

The pavement condition at Orlando Sanford International Airport is represented in Figure 3-1 in accordance with the condition categories and PCI scale referenced in ASTM D 5340. Further detail is provided in Table 3-3 which describes the breakdown of the airport's airfield conditions according to area and use.

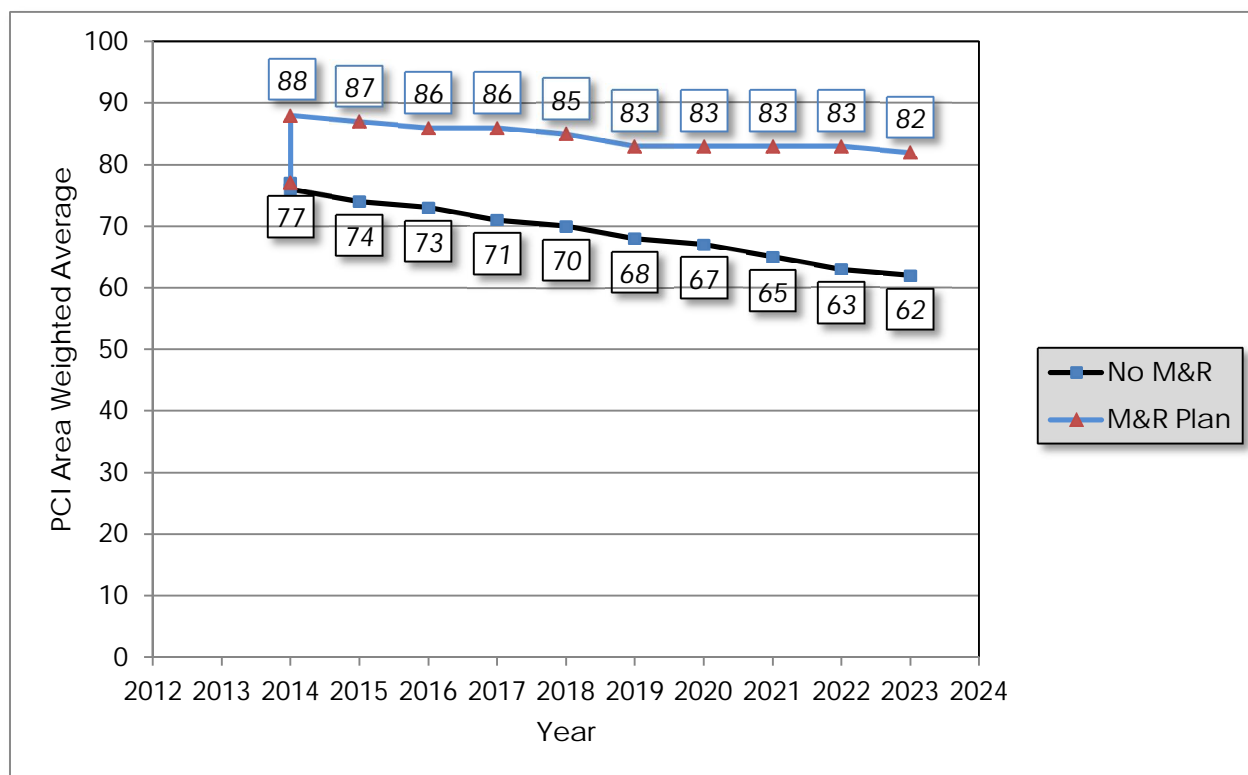
Figure 6-1: 10-Year Major Rehabilitation Budget Scenario Analysis

The 10-year major rehabilitation program addresses those pavement sections that have a current or project PCI that is below the Critical PCI of 65 during the 10-year analysis period. The unconstrained or “unlimited budget” Major Rehabilitation Program is compared to a “No Major Rehabilitation Program” scenario in Figure 6-1. As shown, if no major rehabilitation work is completed in the next 10 years at your airport, the average PCI may be 20 points less than a plan that provides timely repairs to the airfield pavements.
