**SPACE COAST
REGIONAL AIRPORT
(TIX)**

JUNE 2015

STATEWIDE
**Airfield
Pavement
Management**
PROGRAM

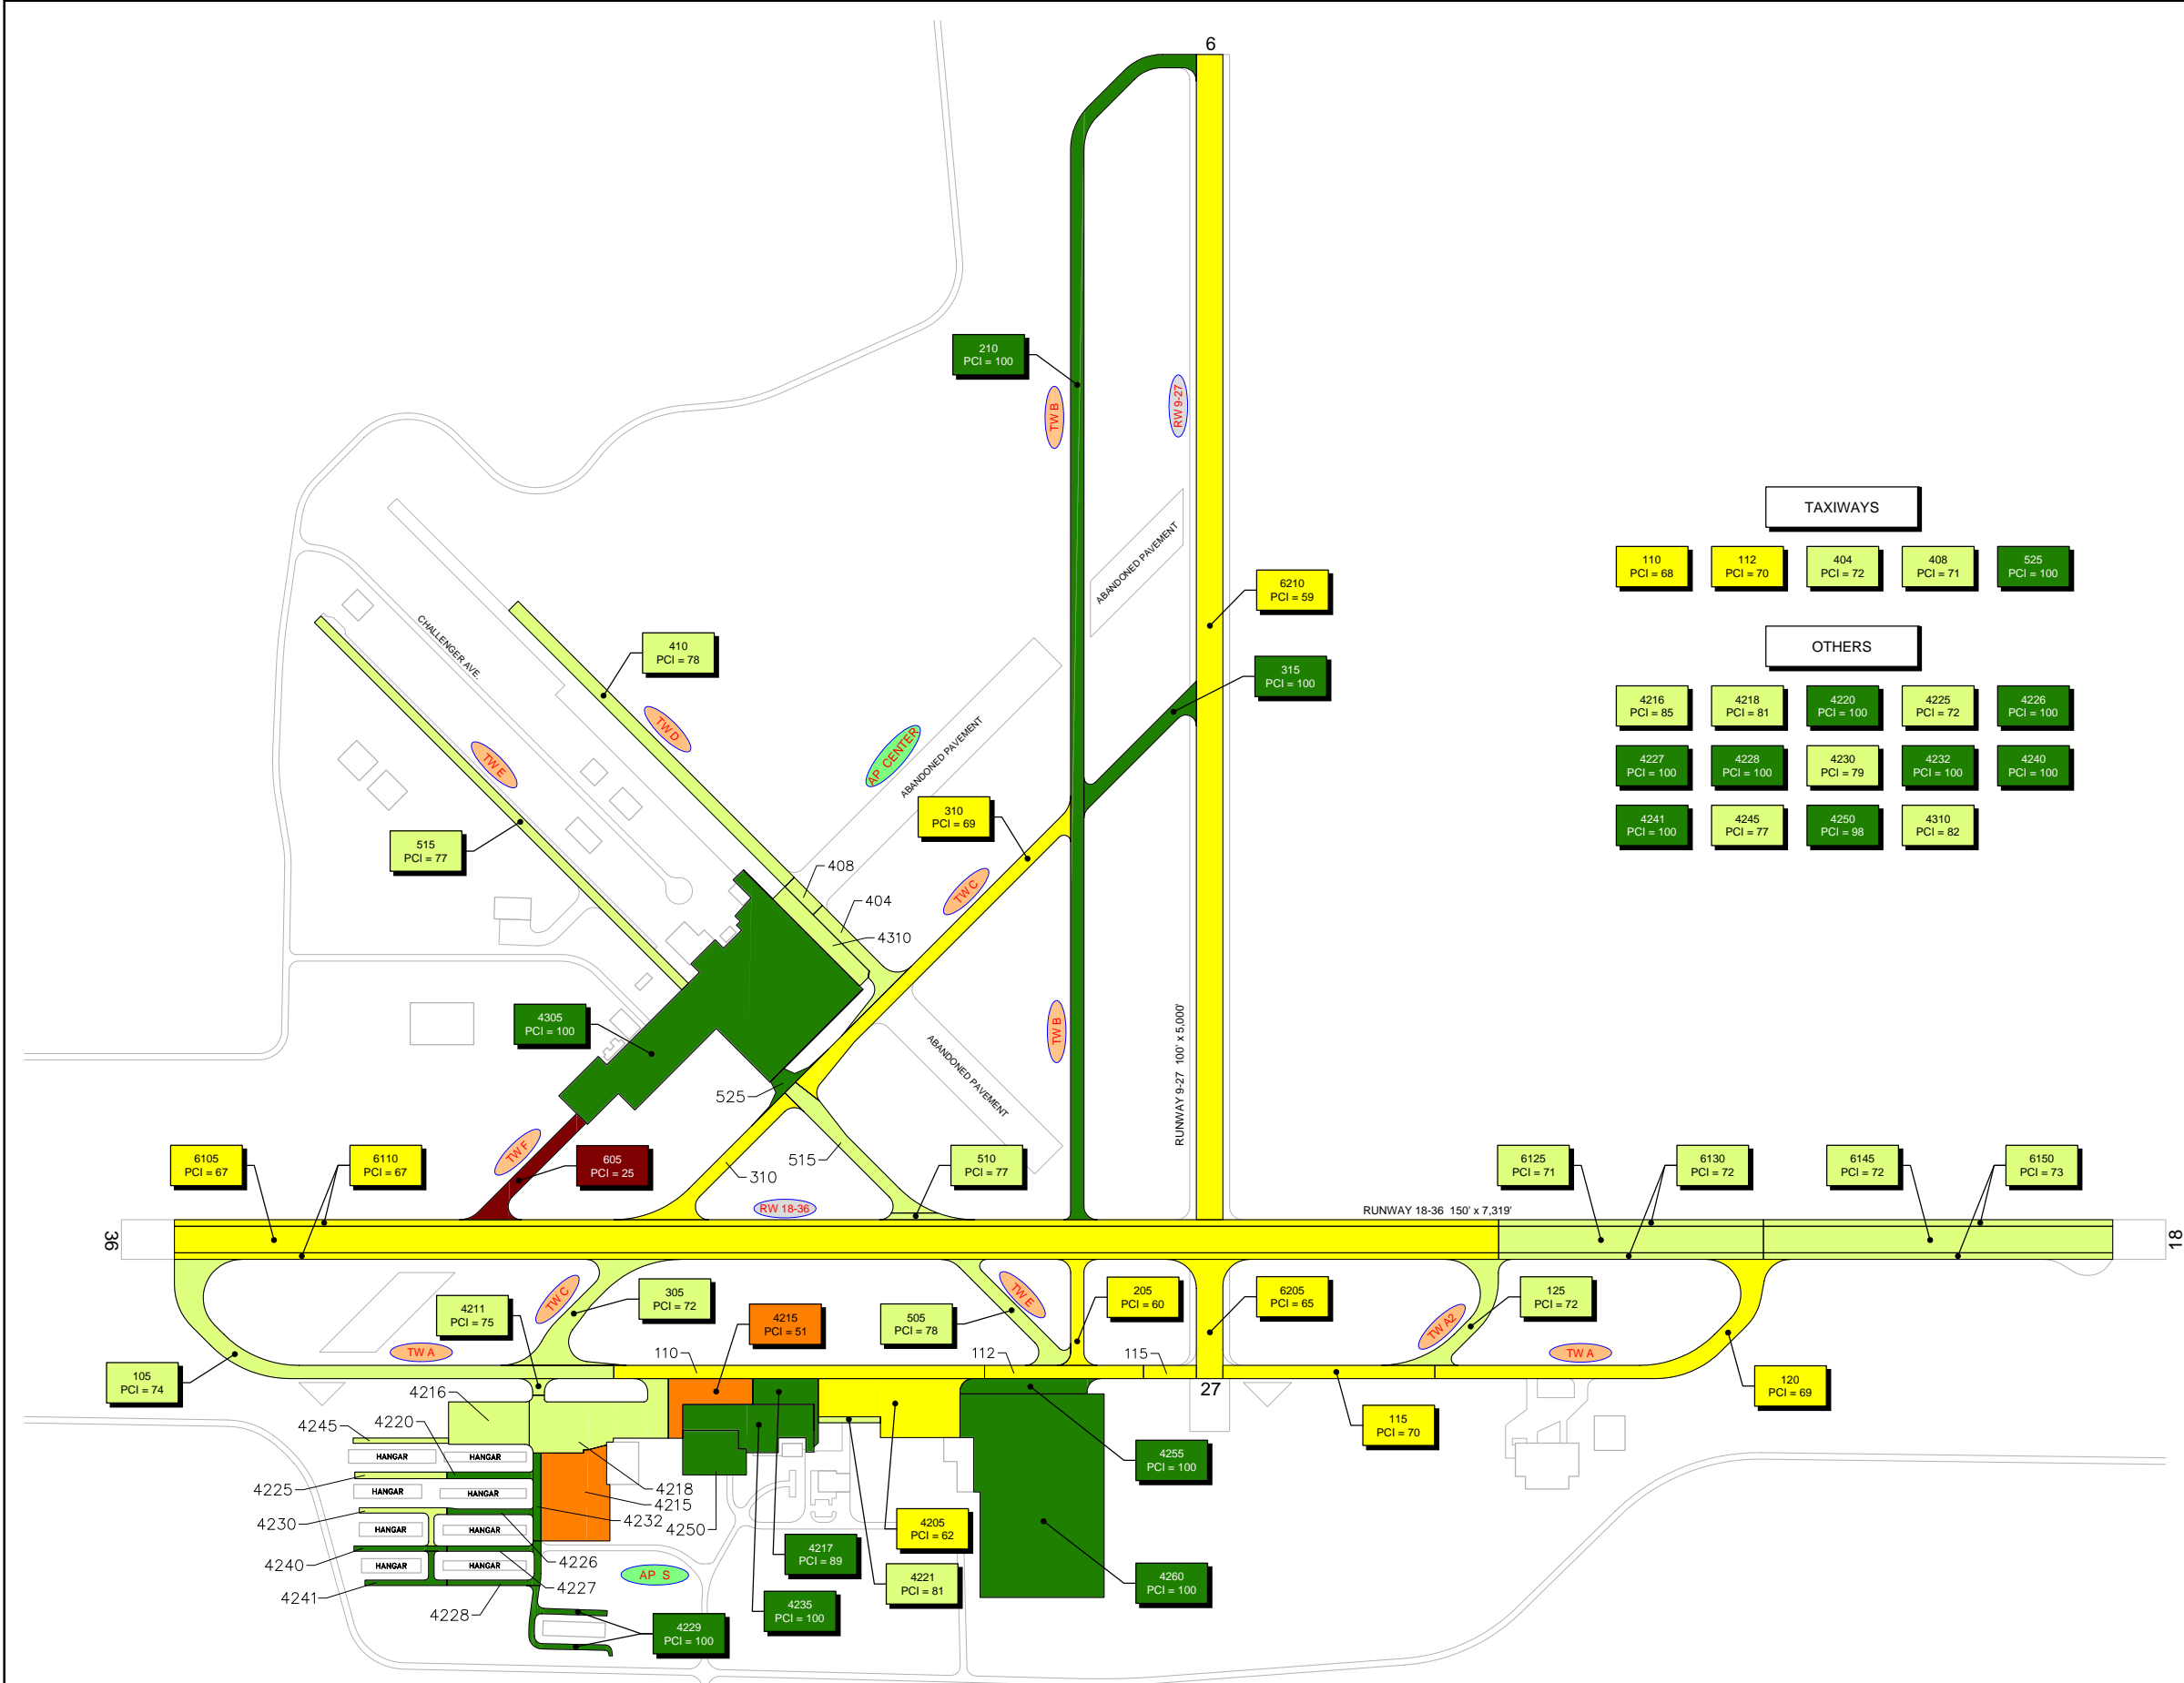
- AIRFIELD PAVEMENT CONDITION INDEX RATING EXHIBIT
- PAVEMENT CONDITION INDEX INVENTORY

TAXIWAYS				
110 PCI = 68	112 PCI = 70	404 PCI = 72	408 PCI = 71	525 PCI = 100
OTHERS				
4216 PCI = 85	4218 PCI = 81	4220 PCI = 100	4225 PCI = 72	4226 PCI = 100
4227 PCI = 100	4228 PCI = 100	4230 PCI = 79	4232 PCI = 100	4240 PCI = 100
4241 PCI = 100	4245 PCI = 77	4250 PCI = 98	4310 PCI = 82
