Statewide Airfield Pavement Management Program

Airport Pavement Evaluation Report September 2017

Plant City Airport (PCM) General Aviation Airport District 7

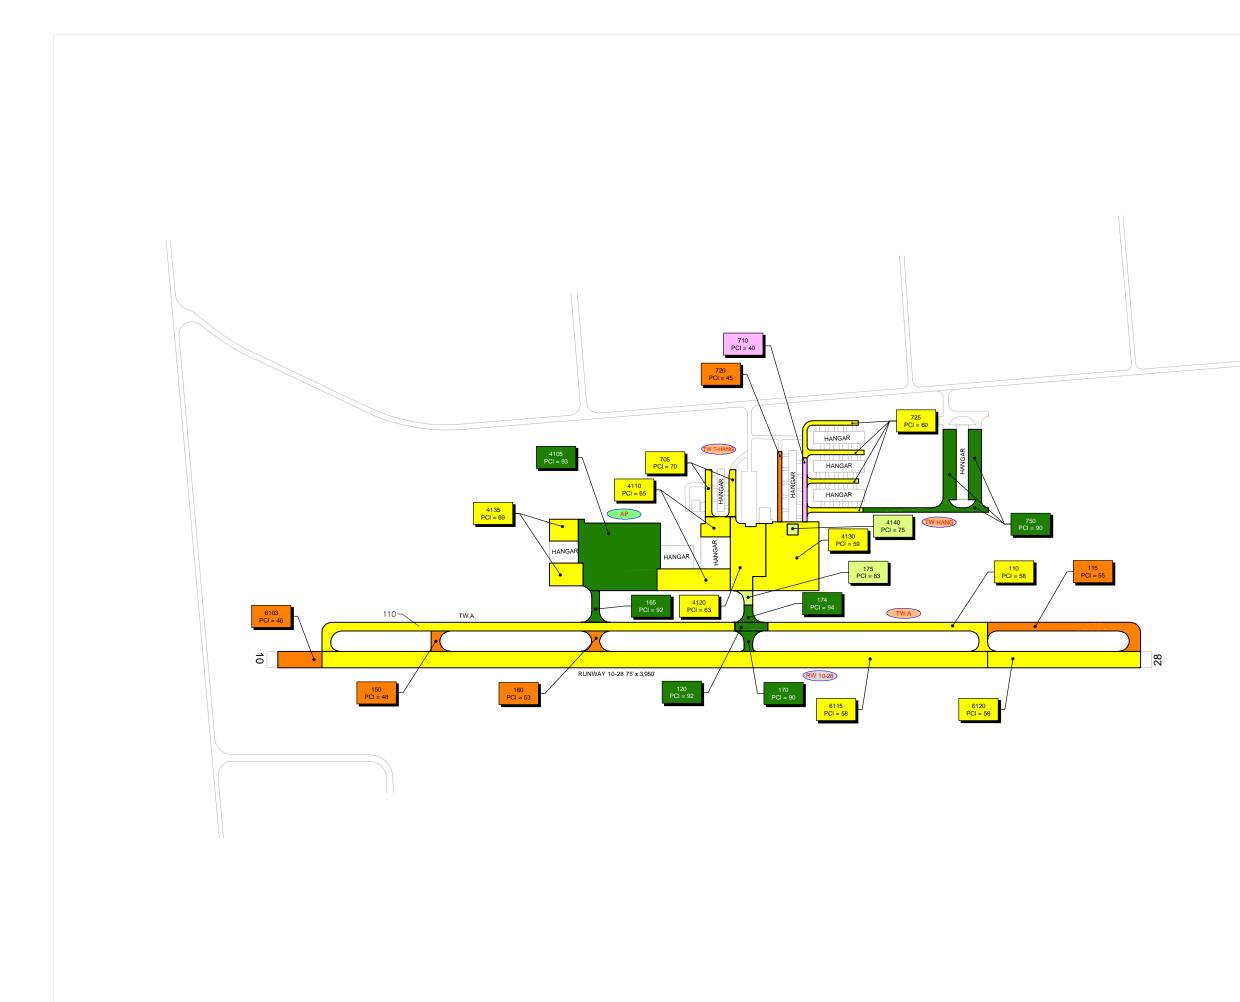
003 - AIRFIELD PAVEMENT CONDITION INDEX EXHIBIT

Figure 4.1.3 is an inset view of the 2017 Airfield Pavement Condition Index Exhibit that visually represents the results of the latest PCI Survey inspection. A large format exhibit is located in **Appendix C Technical Exhibits.**
