FLORIDA DEPARTMENT OF TRANSPORTATION AVIATION AND SPACEPORTS OFFICE

Statewide Airfield Pavement Management Program

Airport Pavement Evaluation Report September 2017

Quincy Municipal Airport (2J9) General Aviation Airport District 3

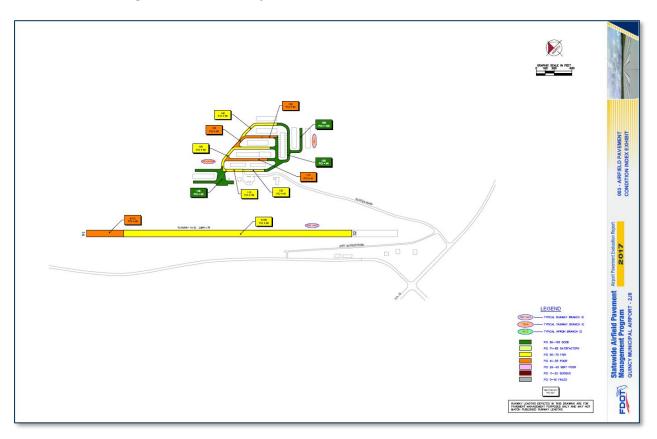
Figure 4.1.3 is an inset view of the 2017 Airfield Pavement Condition Index Exhibit that visually represents the results of the latest PCI Survey inspection. A large format exhibit is located in **Appendix C Technical Exhibits.**
