FLORIDA DEPARTMENT OF TRANSPORTATION
AVIATION AND SPACEPORTS OFFICE

Statewide Airfield Pavement Management Program

Airport Pavement Evaluation Report September 2017

**Palatka Municipal-
Lt. Kay Larkin Field (28J)**
General Aviation Airport
District 2

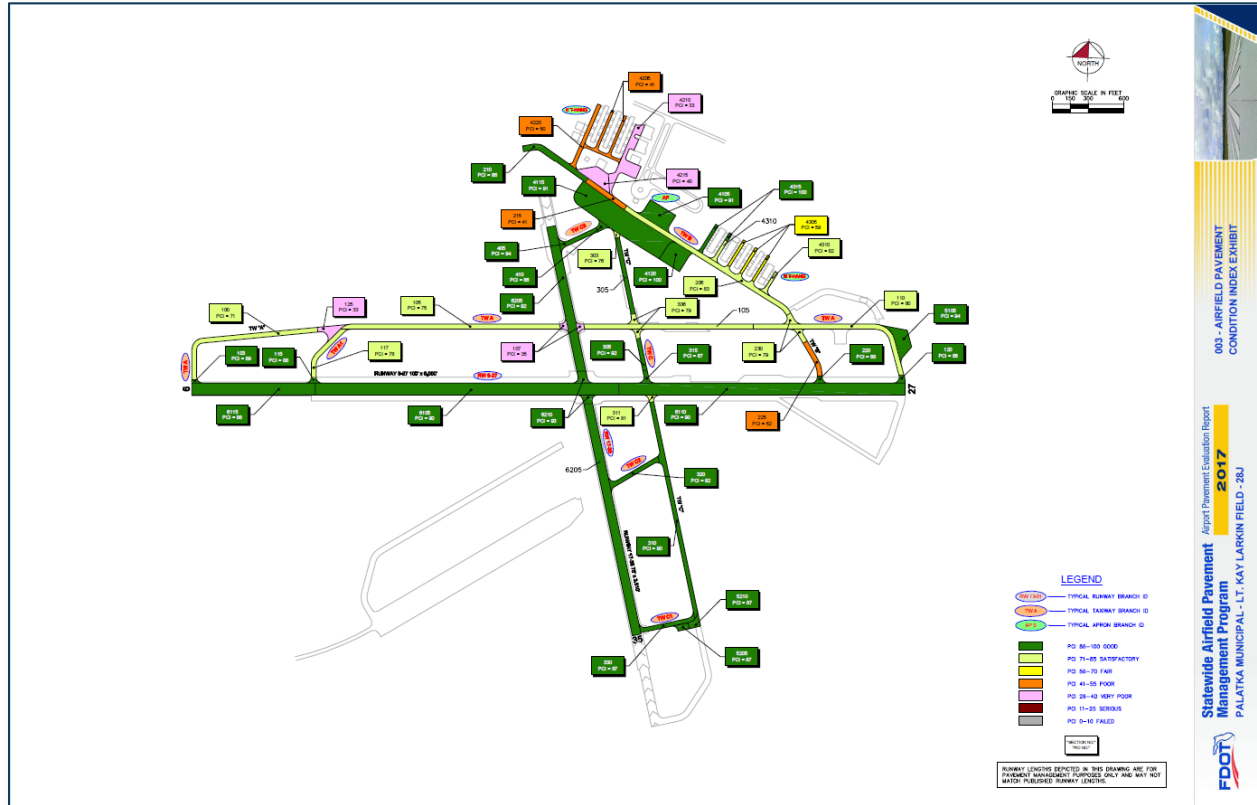
Figure 4.1.3 2017 Airfield Pavement Condition Index Exhibit

Figure 4.1.3 is an inset view of the 2017 Airfield Pavement Condition Index Exhibit that visually represents the results of the latest PCI Survey inspection. A large format exhibit is located in **Appendix C Technical Exhibits**.
