Statewide Airfield Pavement Management Program

**Airport Pavement
Evaluation Report
September 2017**

**Avon Park Executive
Airport (AVO)**
General Aviation Airport
District 1

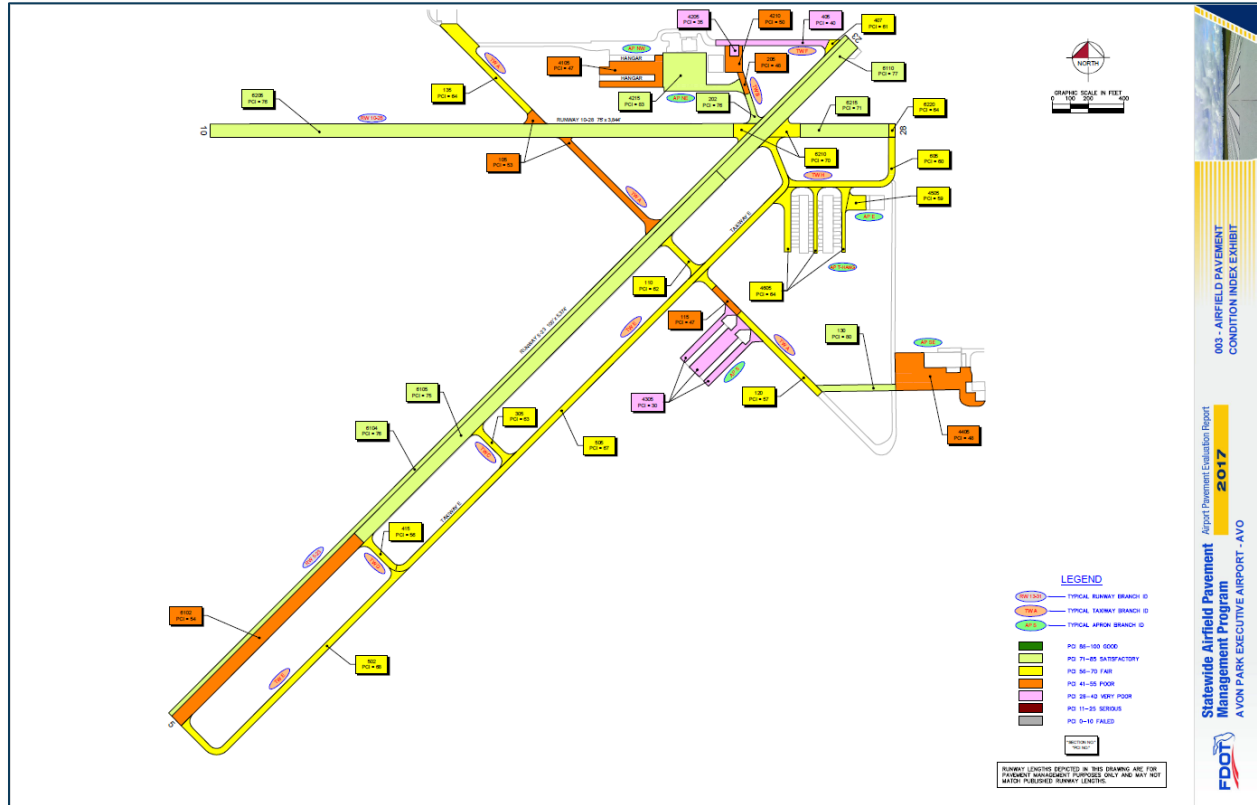
Figure 4.1.3 2017 Airfield Pavement Condition Index Exhibit

Figure 4.1.3 is an inset view of the 2017 Airfield Pavement Condition Index Exhibit that visually represents the results of the latest PCI Survey inspection. A large format exhibit is located in **Appendix C Technical Exhibits**.

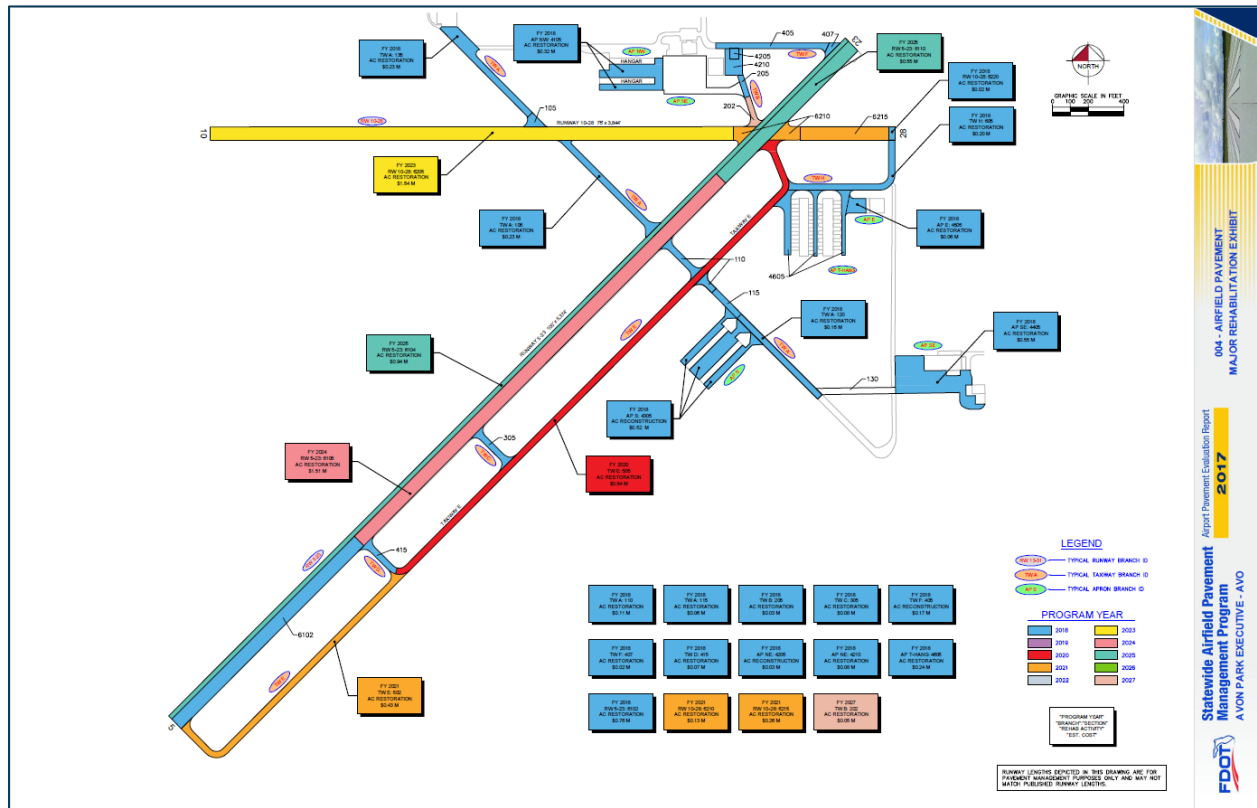
Figure 6.3.1-2 10-Year Major Rehabilitation Needs by Program Year Exhibit

The following **Figure 6.3.1-1** summarizes the section-level major rehabilitation needs for a 10-year period between 2018 and 2027. **Figure 6.3.1-2** provides an inset view of Airfield Pavement Major Rehabilitation Exhibit, a large format exhibit is located in **Appendix C Technical Exhibits**. The exhibit graphically depicts the Major Rehabilitation Needs with rounded costs.
