# **Statewide Airfield Pavement Management Program**

**Airport Pavement  
Evaluation Report  
September 2017**

**Brooksville -  
Tampa Bay Regional  
Airport (BKV)**  
General Aviation Airport  
District 7

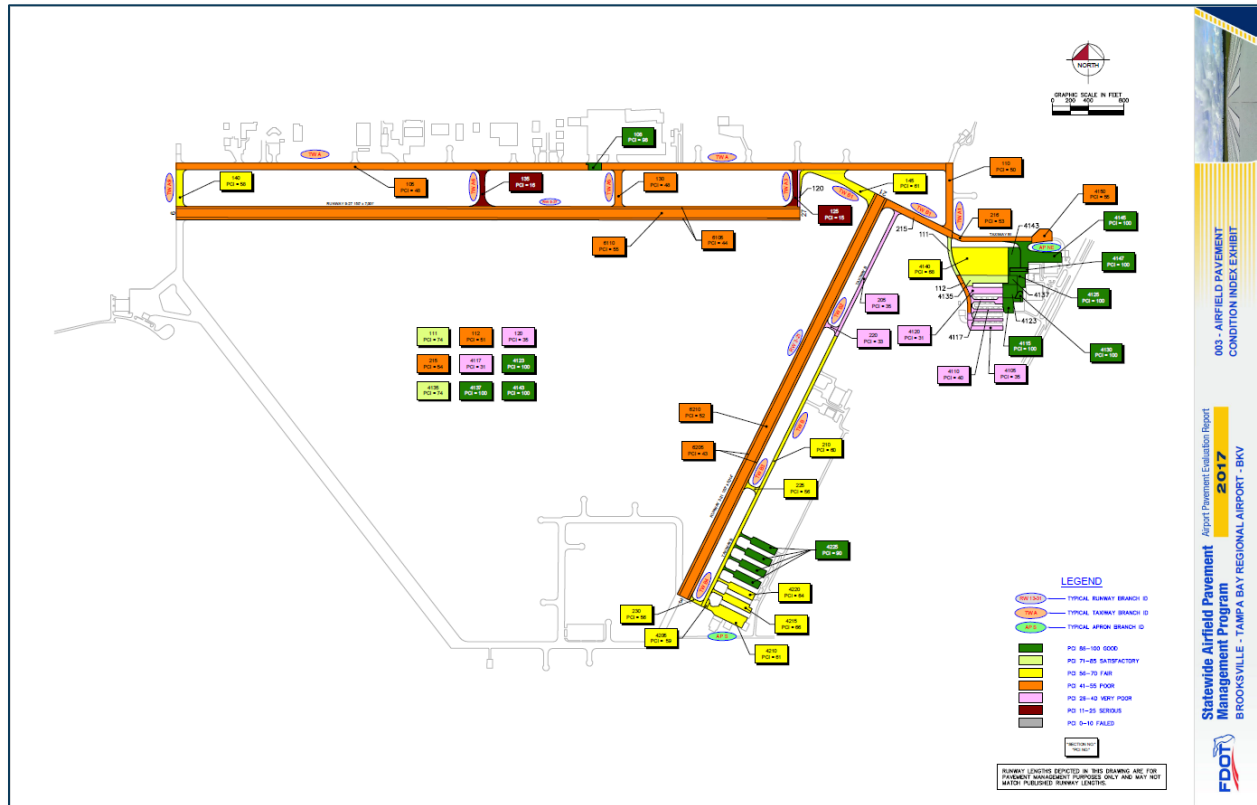
*Figure 4.1.3 2017 Airfield Pavement Condition Index Exhibit*

**Figure 4.1.3** is an inset view of the 2017 Airfield Pavement Condition Index Exhibit that visually represents the results of the latest PCI Survey inspection. A large format exhibit is located in **Appendix C Technical Exhibits**.

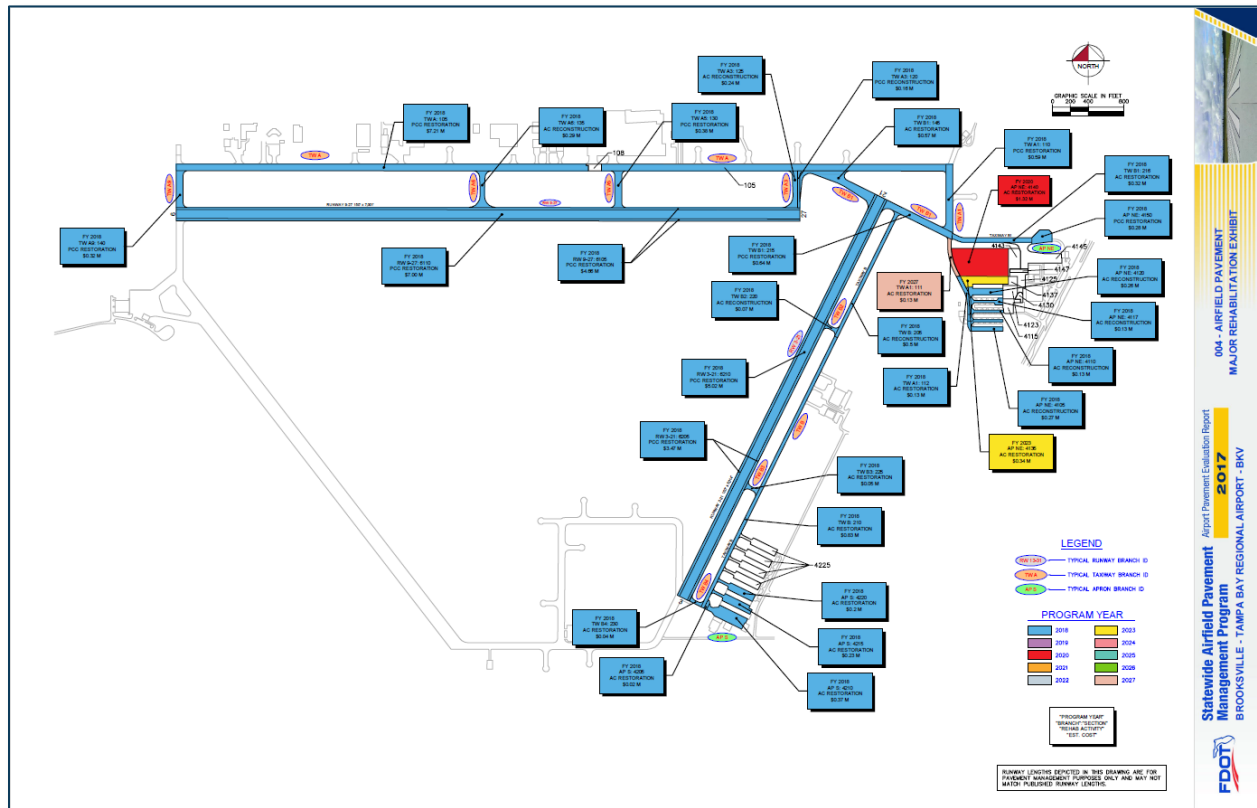
Figure 6.3.1-2 10-Year Major Rehabilitation Needs by Program Year Exhibit

The following **Figure 6.3.1-1** summarizes the section-level major rehabilitation needs for a 10-year period between 2018 and 2027. **Figure 6.3.1-2** provides an inset view of Airfield Pavement Major Rehabilitation Exhibit, a large format exhibit is located in **Appendix C Technical Exhibits**. The exhibit graphically depicts the Major Rehabilitation Needs with rounded costs.
