Statewide Airfield Pavement Management Program

**Airport Pavement
Evaluation Report
September 2017**

**Crystal River-
Captain Tom Davis
Field (CGC)**

General Aviation Airport
District 7

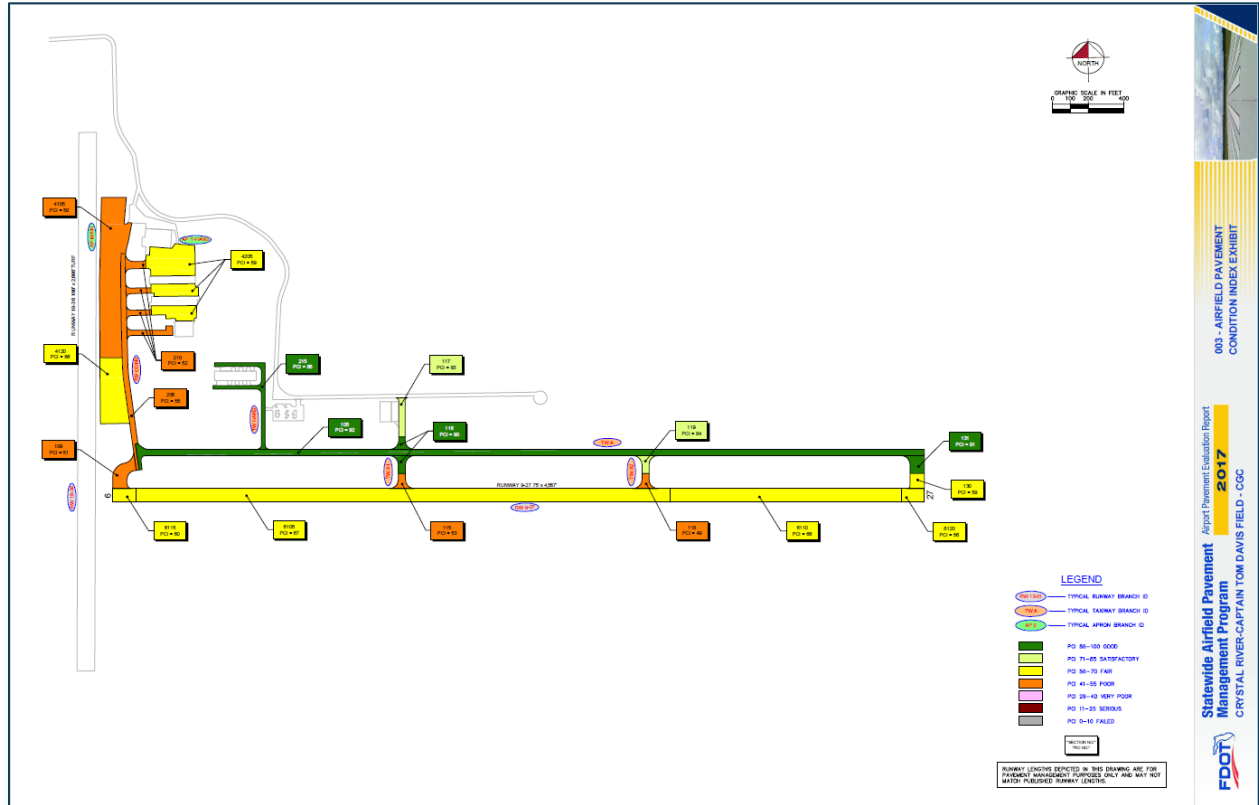
Figure 4.1.3 2017 Airfield Pavement Condition Index Exhibit

Figure 4.1.3 is an inset view of the 2017 Airfield Pavement Condition Index Exhibit that visually represents the results of the latest PCI Survey inspection. A large format exhibit is located in **Appendix C Technical Exhibits**.

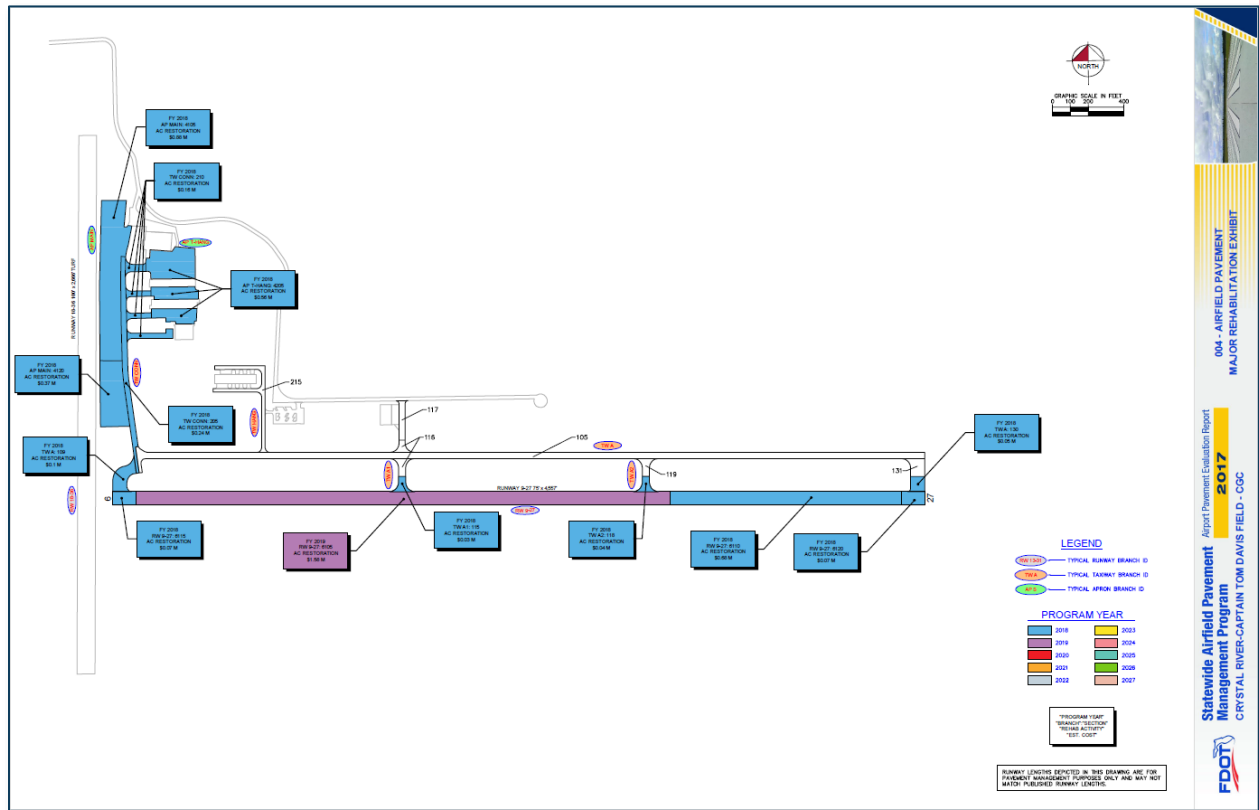
Figure 6.3.1-2 10-Year Major Rehabilitation Needs by Program Year Exhibit

The following **Figure 6.3.1-1** summarizes the section-level major rehabilitation needs for a 10-year period between 2018 and 2027. **Figure 6.3.1-2** provides an inset view of Airfield Pavement Major Rehabilitation Exhibit, a large format exhibit is located in **Appendix C Technical Exhibits**. The exhibit graphically depicts the Major Rehabilitation Needs with rounded costs.
