Statewide Airfield Pavement Management Program

Airport Pavement
Evaluation Report
September 2017

**Merritt Island
Airport (COI)**
General Aviation Airport
District 5

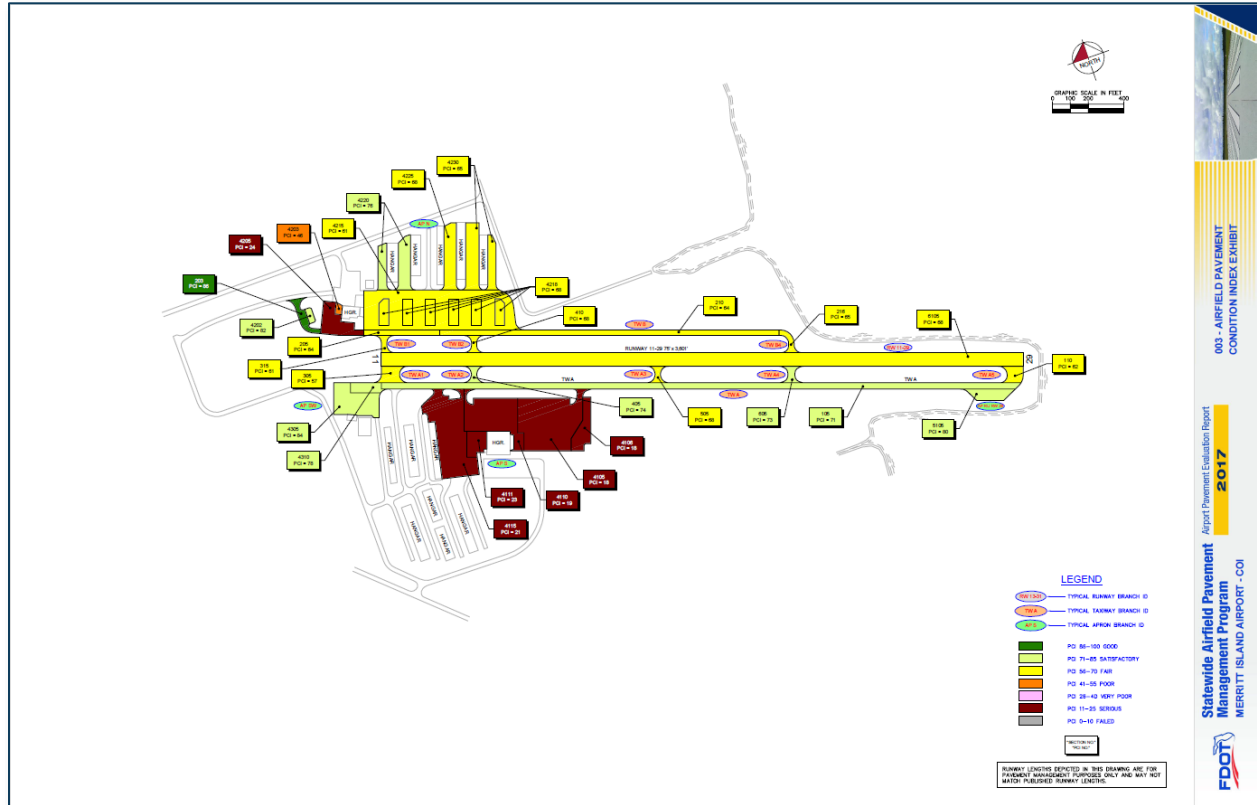
Figure 4.1.3 2017 Airfield Pavement Condition Index Exhibit

Figure 4.1.3 is an inset view of the 2017 Airfield Pavement Condition Index Exhibit that visually represents the results of the latest PCI Survey inspection. A large format exhibit is located in **Appendix C Technical Exhibits**.
