Statewide Airfield Pavement Management Program

**Airport Pavement
Evaluation Report
September 2017**

**Cross City
Airport (CTY)**
General Aviation Airport
District 2

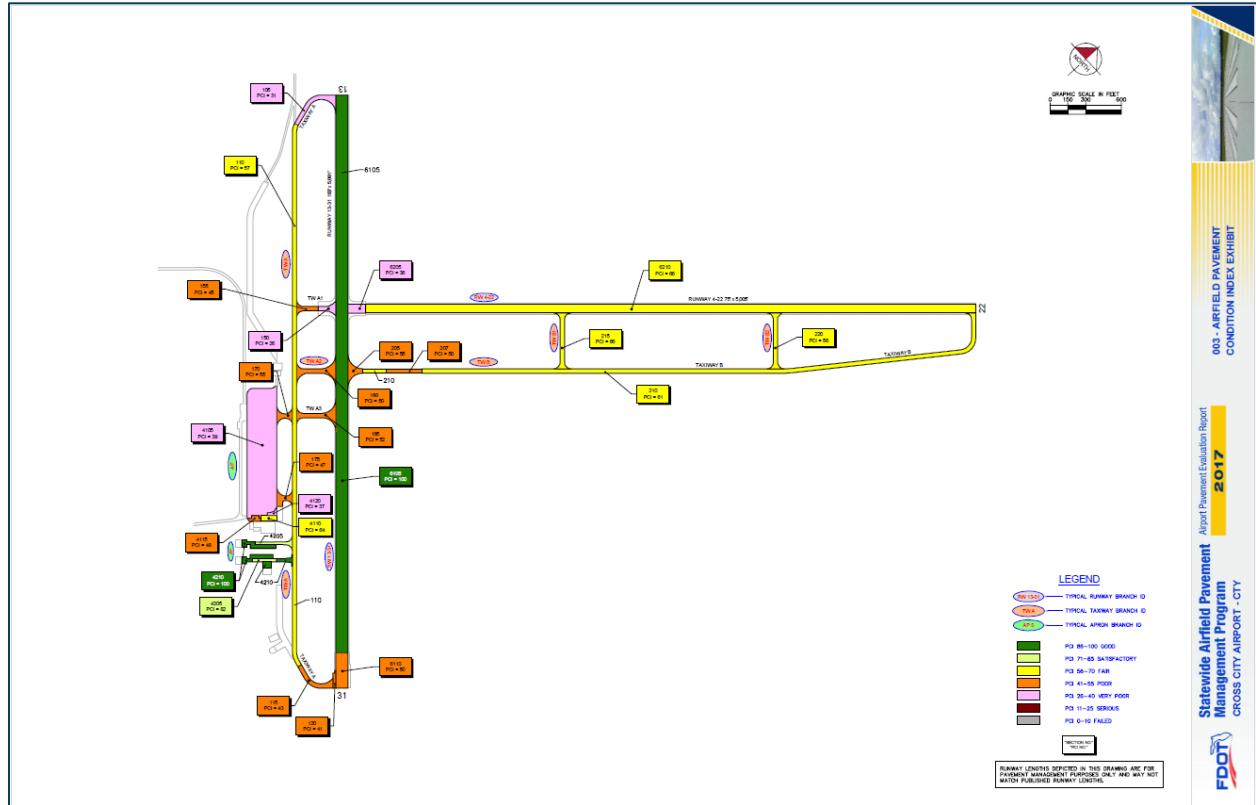
Figure 4.1.3 2017 Airfield Pavement Condition Index Exhibit

Figure 4.1.3 is an inset view of the 2017 Airfield Pavement Condition Index Exhibit that visually represents the results of the latest PCI Survey inspection. A large format exhibit is located in **Appendix C Technical Exhibits**.

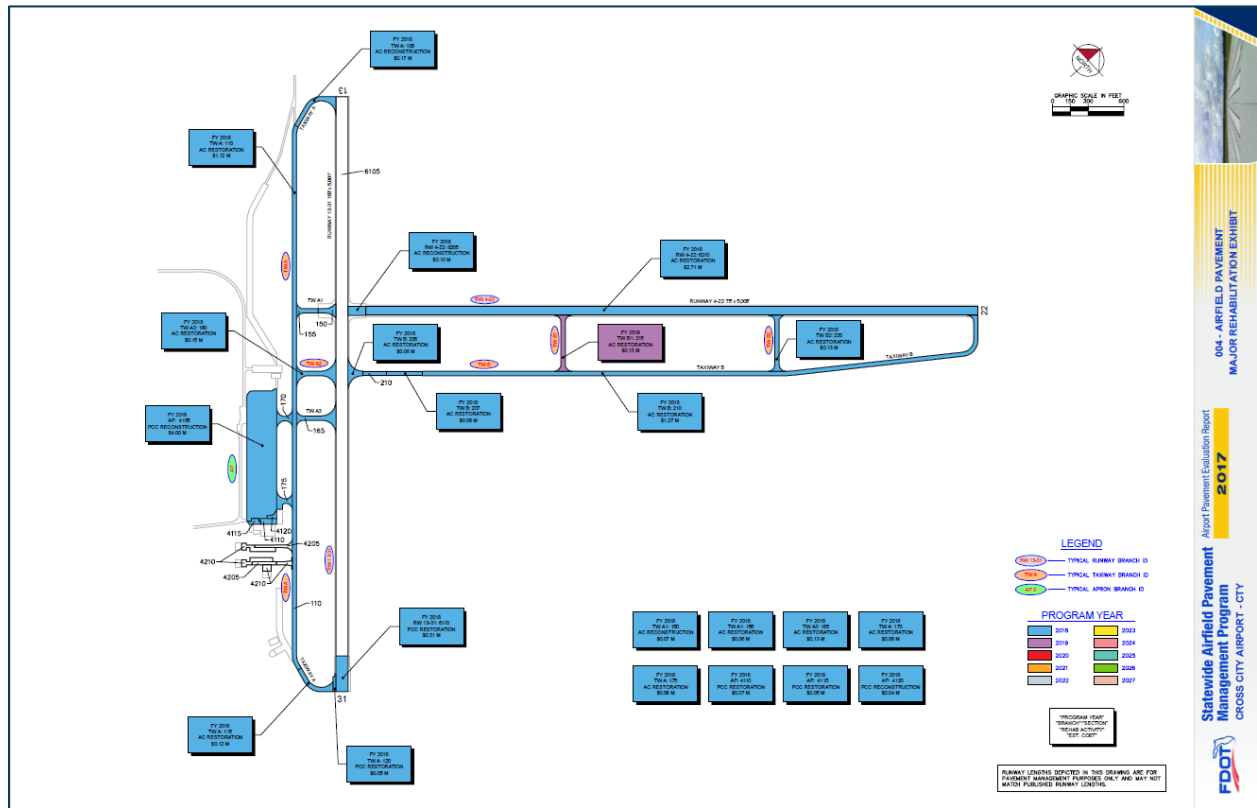
Figure 6.3.1-2 10-Year Major Rehabilitation Needs by Program Year Exhibit

The following **Figure 6.3.1-1** summarizes the section-level major rehabilitation needs for a 10-year period between 2018 and 2027. **Figure 6.3.1-2** provides an inset view of Airfield Pavement Major Rehabilitation Exhibit, a large format exhibit is located in **Appendix C Technical Exhibits**. The exhibit graphically depicts the Major Rehabilitation Needs with rounded costs.
