FLORIDA DEPARTMENT OF TRANSPORTATION
AVIATION AND SPACEPORTS OFFICE

Statewide Airfield Pavement Management Program

Airport Pavement Evaluation Report September 2017

**Flagler Executive
Airport (FIN)**
General Aviation Airport
District 5

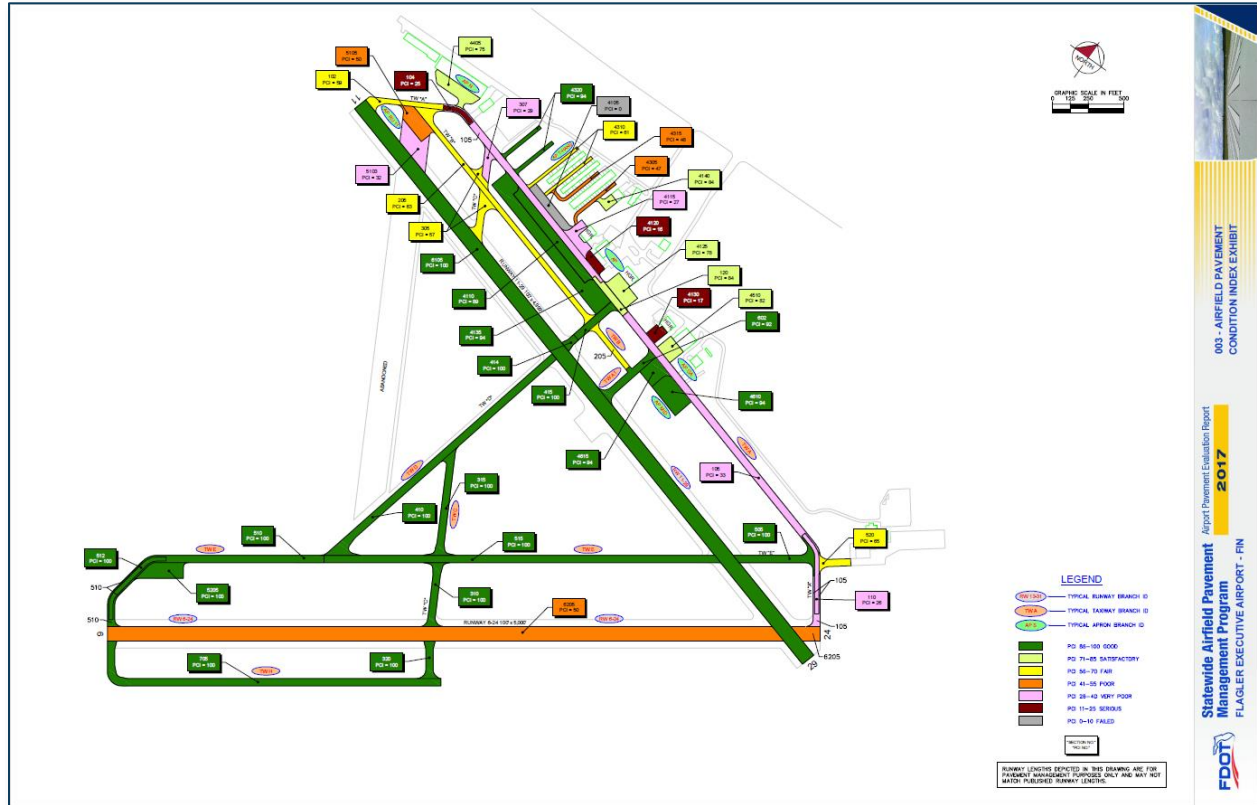
Figure 4.1.3 2017 Airfield Pavement Condition Index Exhibit

Figure 4.1.3 is an inset view of the 2017 Airfield Pavement Condition Index Exhibit that visually represents the results of the latest PCI Survey inspection. A large format exhibit is located in **Appendix C Technical Exhibits**.

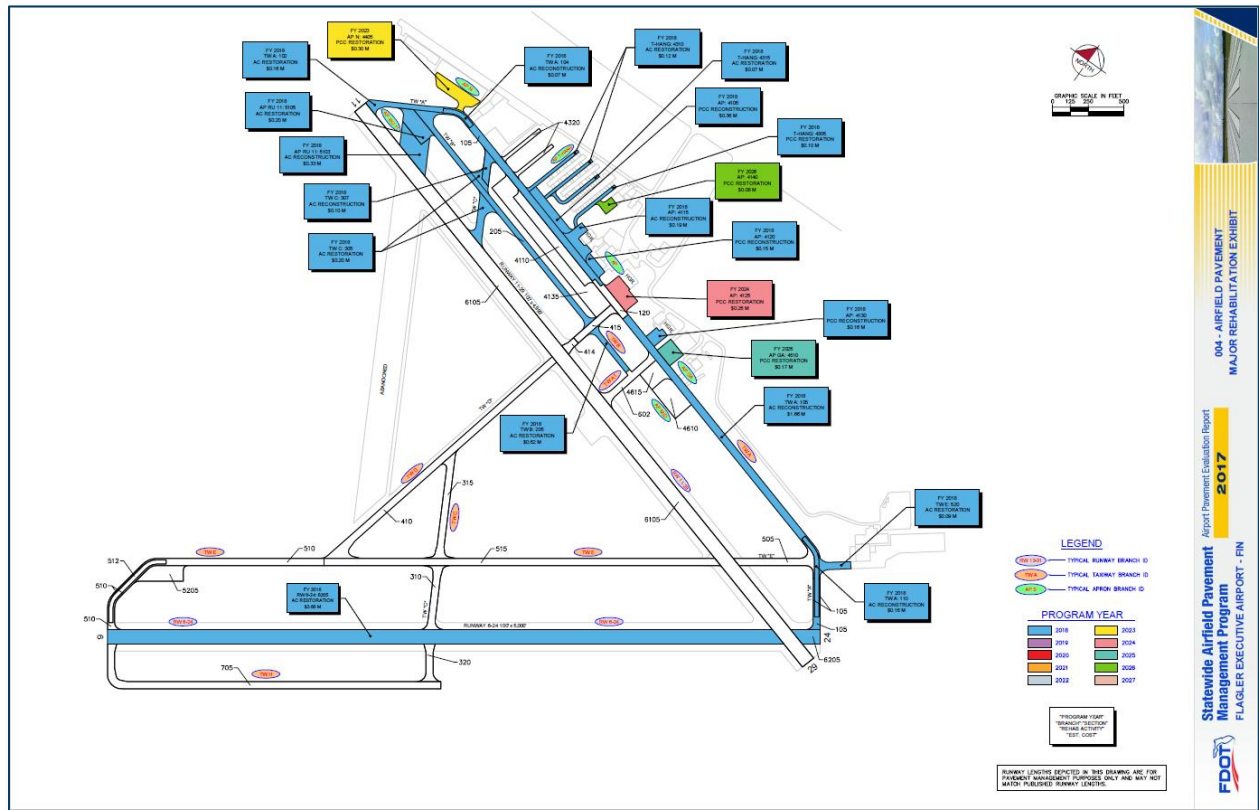
Figure 6.3.1-2 10-Year Major Rehabilitation Needs by Program Year Exhibit

The following **Figure 6.3.1-1** summarizes the section-level major rehabilitation needs for a 10-year period between 2018 and 2027. **Figure 6.3.1-2** provides an inset view of Airfield Pavement Major Rehabilitation Exhibit, a large format exhibit is located in **Appendix C Technical Exhibits**. The exhibit graphically depicts the Major Rehabilitation Needs with rounded costs.
