Statewide Airfield Pavement Management Program

**Airport Pavement
Evaluation Report
September 2017**

**Winter Haven's
Gilbert Airport (GIF)**
General Aviation Airport
District 1

Florida Department of Transportation

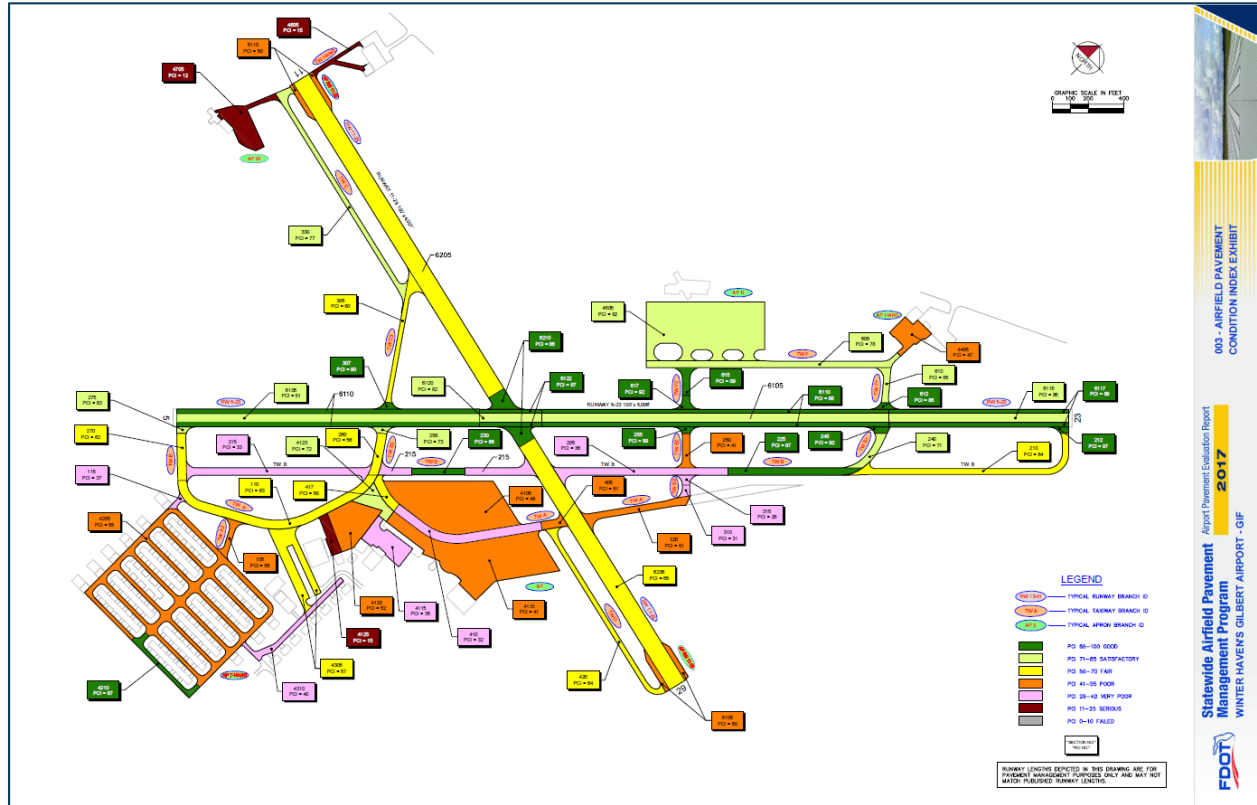
Figure 4.1.3 2017 Airfield Pavement Condition Index Exhibit

Figure 4.1.3 is an inset view of the 2017 Airfield Pavement Condition Index Exhibit that visually represents the results of the latest PCI Survey inspection. A large format exhibit is located in **Appendix C Technical Exhibits**.

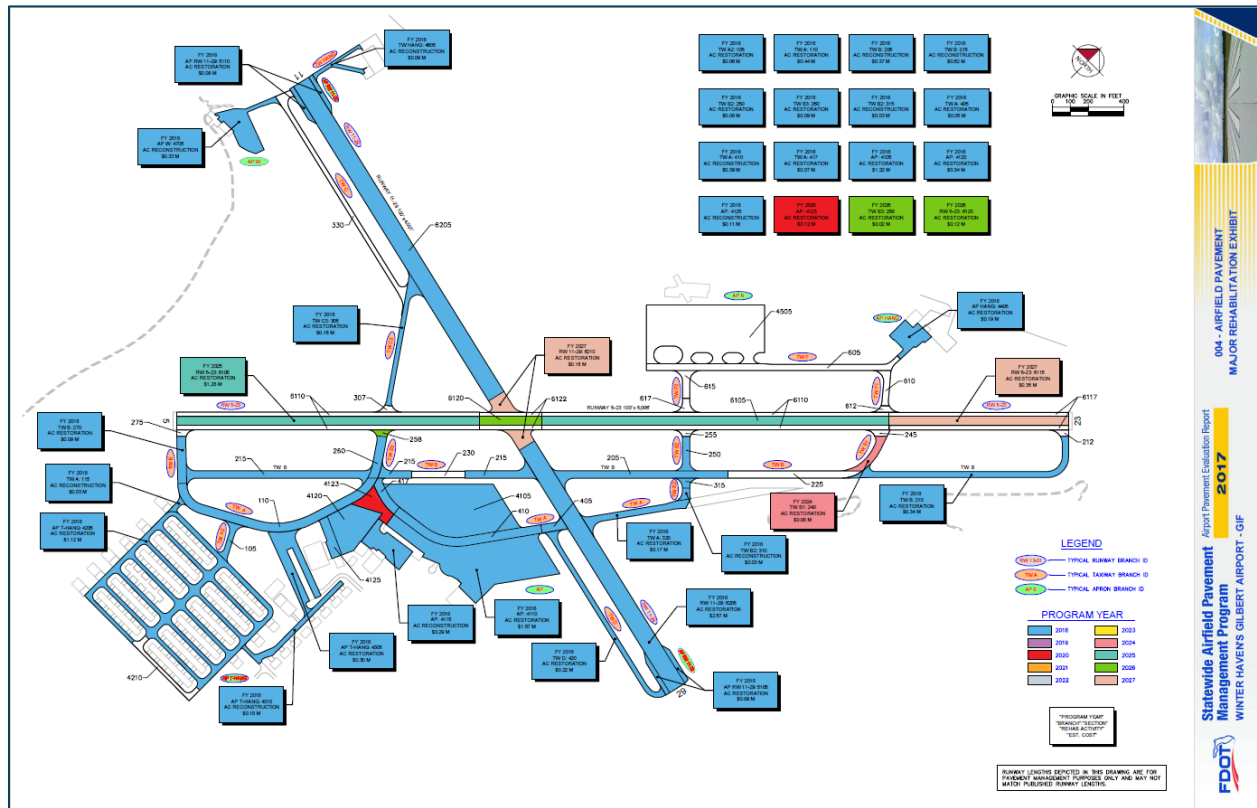
Figure 6.3.1-2 10-Year Major Rehabilitation Needs by Program Year Exhibit

The following **Figure 6.3.1-1** summarizes the section-level major rehabilitation needs for a 10-year period between 2018 and 2027. **Figure 6.3.1-2** provides an inset view of Airfield Pavement Major Rehabilitation Exhibit, a large format exhibit is located in **Appendix C Technical Exhibits**. The exhibit graphically depicts the Major Rehabilitation Needs with rounded costs.
