Statewide Airfield Pavement Management Program

Airport Pavement Evaluation Report September 2017

Inverness Airport (INF) General Aviation Airport District 7

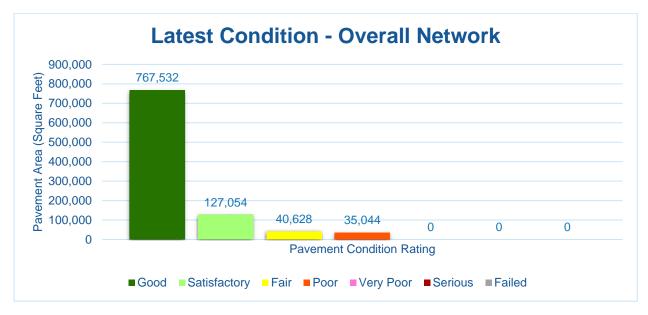
Figure 4.1.1 Latest Condition – Overall Network

The following **Figure 4.1.1** summarizes the network-level pavement condition analysis based on the most recent PCI Survey inspection results.

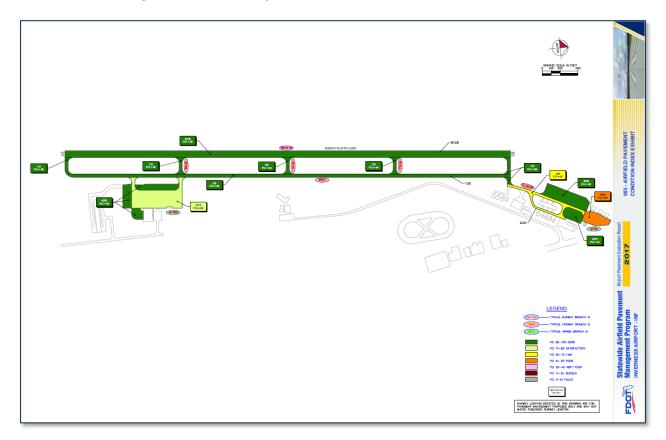
Figure 4.1.3 2017 Airfield Pavement Condition Index Exhibit

Figure 4.1.3 is an inset view of the 2017 Airfield Pavement Condition Index Exhibit that visually represents the results of the latest PCI Survey inspection. A large format exhibit is located in **Appendix C Technical Exhibits.**

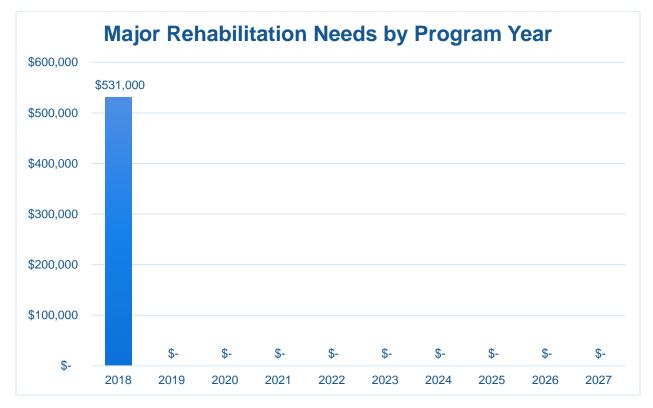
The following **Figure 6.3.1-1** summarizes the section-level major rehabilitation needs for a 10year period between 2018 and 2027. **Figure 6.3.1-2** provides an inset view of Airfield Pavement Major Rehabilitation Exhibit, a large format exhibit is located in **Appendix C Technical Exhibits**. The exhibit graphically depicts the Major Rehabilitation Needs with rounded costs.
