Florida Department of Transportation

Statewide Airfield Pavement Management Program

Summary of Lake City Gateway Airport

Lake City Gateway Airport was inspected in February 2017 – the overall weighted PCI value was 67, a condition rating of Fair. The results of the maintenance, repair, and major rehabilitation analysis identified \$1,445,970 in localized M&R needs based on current conditions and a 10-Year major rehabilitation need of \$20,389,000 based on forecasted conditions. The current major rehabilitation needs based on the latest inspection consist of \$17,527,000 for pavements below critical condition.

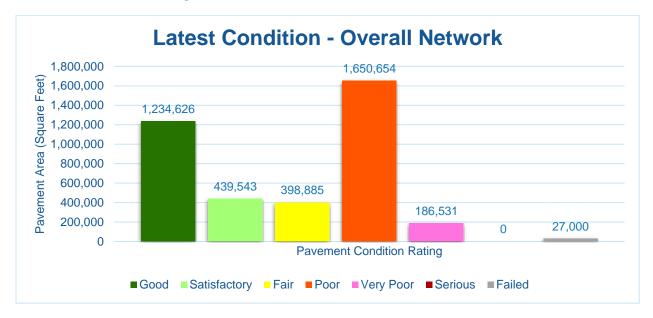
Figure 4.1.1 Latest Condition - Overall Network

The following Figure 4.1.1 summarizes the network-level pavement condition analysis based on the most recent PCI Survey inspection results.

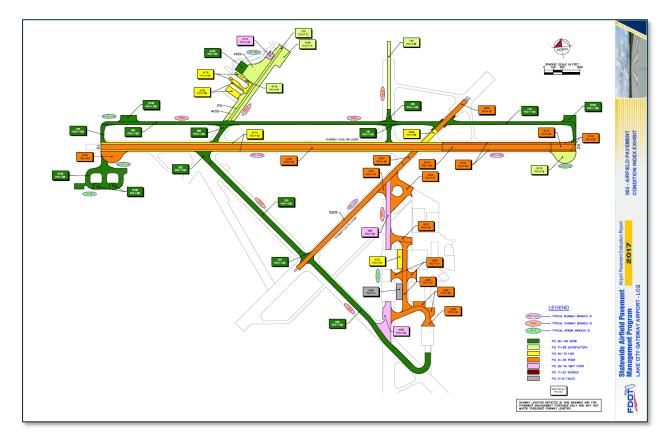
Figure 4.1.3 2017 Airfield Pavement Condition Index Exhibit

Figure 4.1.3 is an inset view of the 2017 Airfield Pavement Condition Index Exhibit that visually represents the results of the latest PCI Survey inspection. A large format exhibit is located in **Appendix C Technical Exhibits.**

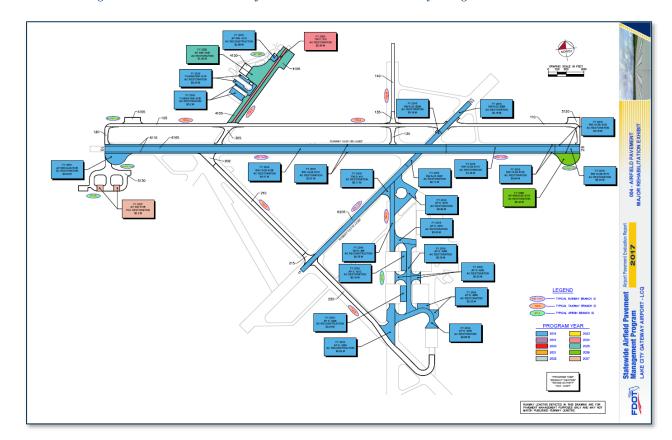
Figure 6.3.1-2 10-Year Major Rehabilitation Needs by Program Year Exhibit

The following Figure 6.3.1-1 summarizes the section-level major rehabilitation needs for a 10year period between 2018 and 2027. Figure 6.3.1-2 provides an inset view of Airfield Pavement Major Rehabilitation Exhibit, a large format exhibit is located in Appendix C Technical **Exhibits**. The exhibit graphically depicts the Major Rehabilitation Needs with rounded costs.
