# **Statewide Airfield Pavement Management Program**

## **Airport Pavement Evaluation Report September 2017**

**Marco Island  
Airport (MKY)**  
General Aviation Airport  
District 1

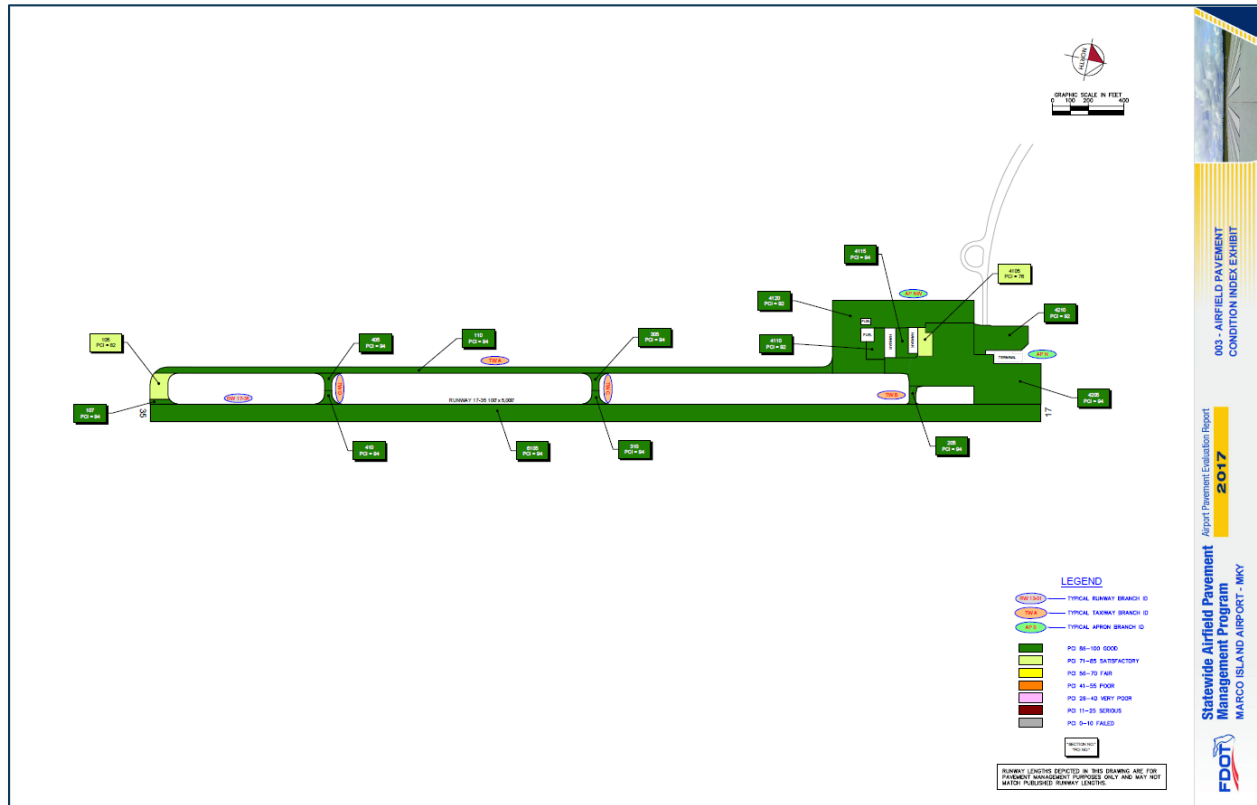
*Figure 4.1.3 2017 Airfield Pavement Condition Index Exhibit*

**Figure 4.1.3** is an inset view of the 2017 Airfield Pavement Condition Index Exhibit that visually represents the results of the latest PCI Survey inspection. A large format exhibit is located in **Appendix C Technical Exhibits**.
