Florida Department of Transportation

# Statewide Airfield Pavement Management Program

#### Summary of Pompano Beach Airpark

Pompano Beach Airpark was inspected in May 2017 - the overall weighted PCI value was 75, a condition rating of Satisfactory. The results of the maintenance, repair, and major rehabilitation analysis identified \$756.570 in localized M&R needs based on current conditions and a 10-Year major rehabilitation need of \$15,873,000 based on forecasted conditions. The current major rehabilitation needs based on the latest inspection consist of \$15,160,000 for pavements below critical condition.

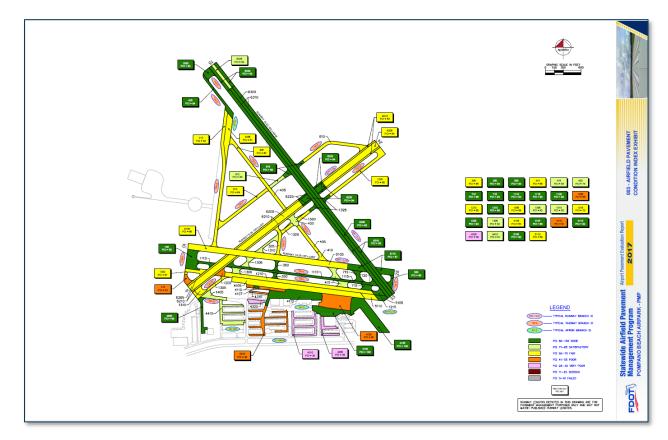
Figure 4.1.3 2017 Airfield Pavement Condition Index Exhibit

Figure 4.1.3 is an inset view of the 2017 Airfield Pavement Condition Index Exhibit that visually represents the results of the latest PCI Survey inspection. A large format exhibit is located in **Appendix C Technical Exhibits.**

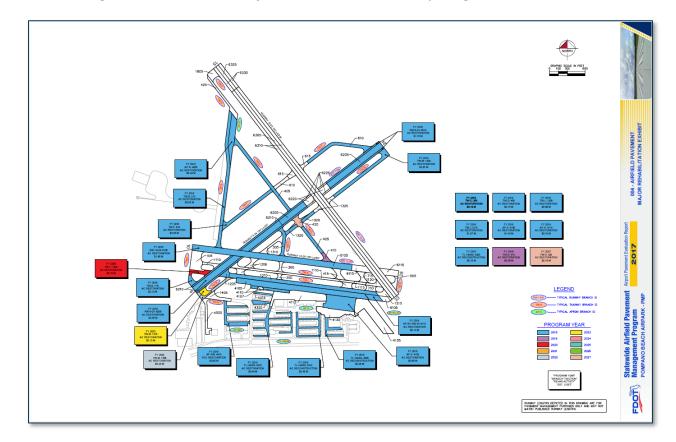
Figure 6.3.1-2 10-Year Major Rehabilitation Needs by Program Year Exhibit

The following Figure 6.3.1-1 summarizes the section-level major rehabilitation needs for a 10year period between 2018 and 2027. Figure 6.3.1-2 provides an inset view of Airfield Pavement Major Rehabilitation Exhibit, a large format exhibit is located in Appendix C Technical **Exhibits**. The exhibit graphically depicts the Major Rehabilitation Needs with rounded costs.
