Statewide Airfield Pavement Management Program

Airport Pavement
Evaluation Report
September 2017

**Dade-Collier
Training and Transition
Airport (TNT)**
General Aviation Airport
District 6

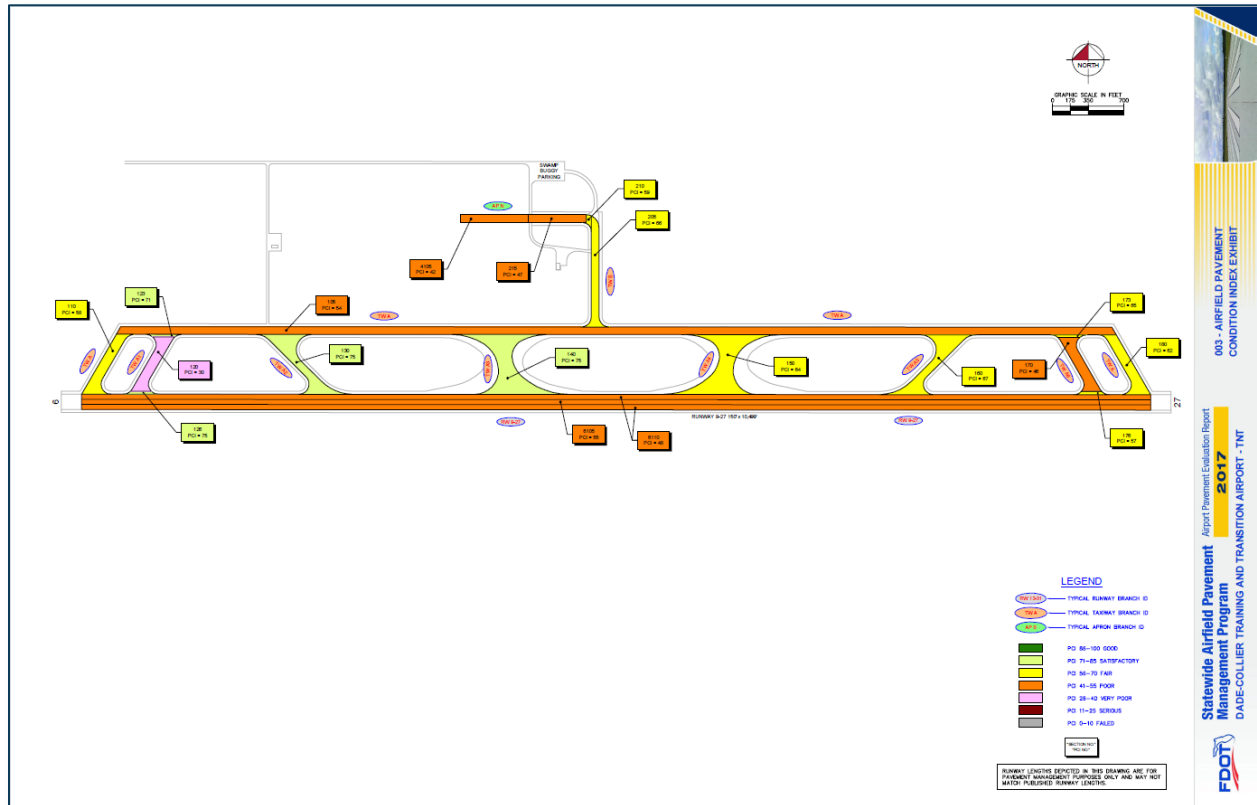
Figure 4.1.3 2017 Airfield Pavement Condition Index Exhibit

Figure 4.1.3 is an inset view of the 2017 Airfield Pavement Condition Index Exhibit that visually represents the results of the latest PCI Survey inspection. A large format exhibit is located in **Appendix C Technical Exhibits**.

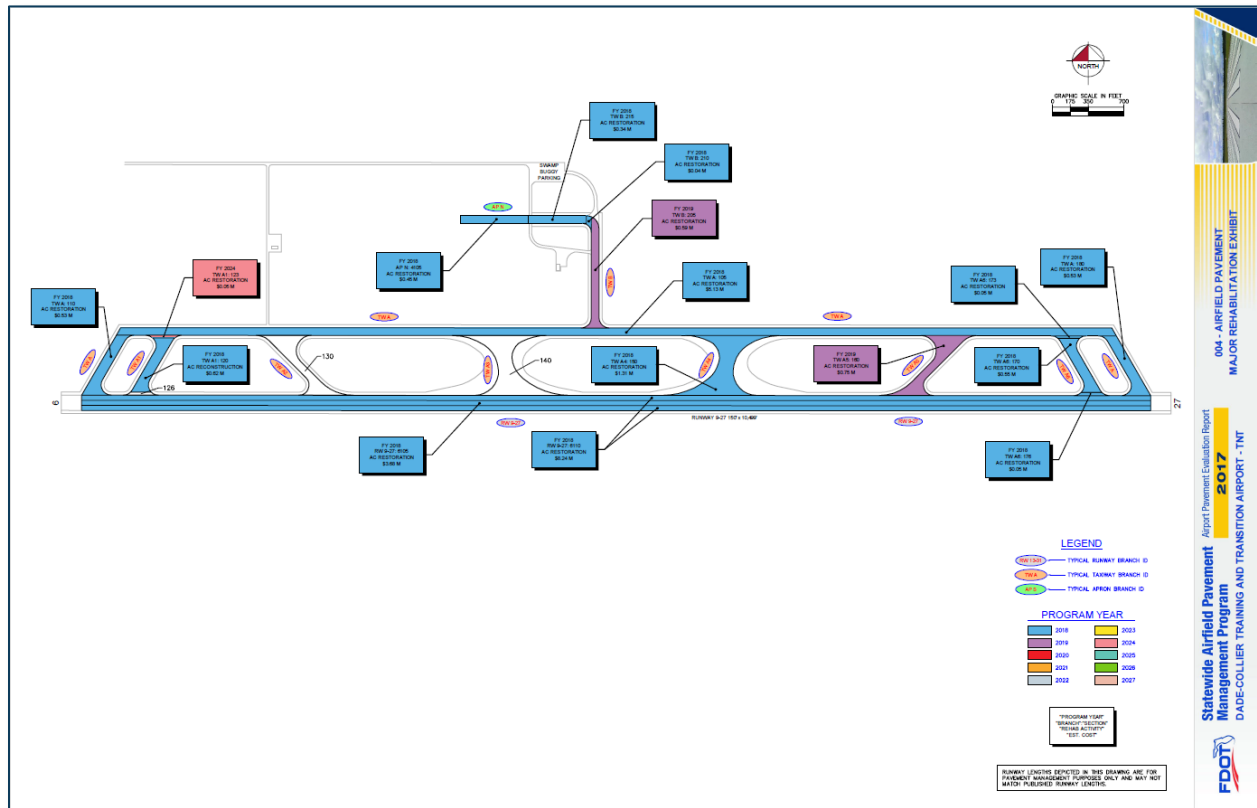
Figure 6.3.1-2 10-Year Major Rehabilitation Needs by Program Year Exhibit

The following **Figure 6.3.1-1** summarizes the section-level major rehabilitation needs for a 10-year period between 2018 and 2027. **Figure 6.3.1-2** provides an inset view of Airfield Pavement Major Rehabilitation Exhibit, a large format exhibit is located in **Appendix C Technical Exhibits**. The exhibit graphically depicts the Major Rehabilitation Needs with rounded costs.
