# **Statewide Airfield Pavement Management Program**

**Airport Pavement  
Evaluation Report  
September 2017**

**Cecil Airport (VQQ)**  
General Aviation Airport  
District 2

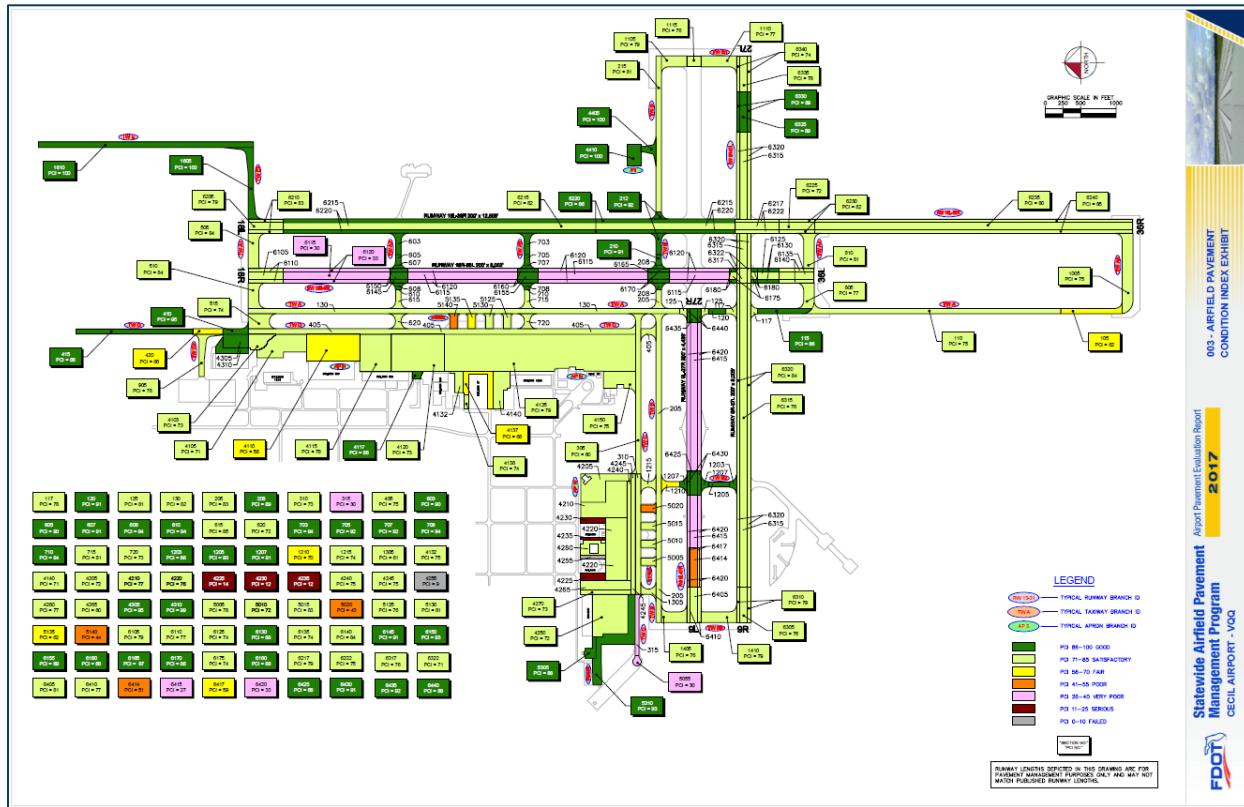
**Figure 4.1.3 2017 Airfield Pavement Condition Index Exhibit**

**Figure 4.1.3** is an inset view of the 2017 Airfield Pavement Condition Index Exhibit that visually represents the results of the latest PCI Survey inspection. A large format exhibit is located in **Appendix C Technical Exhibits**.

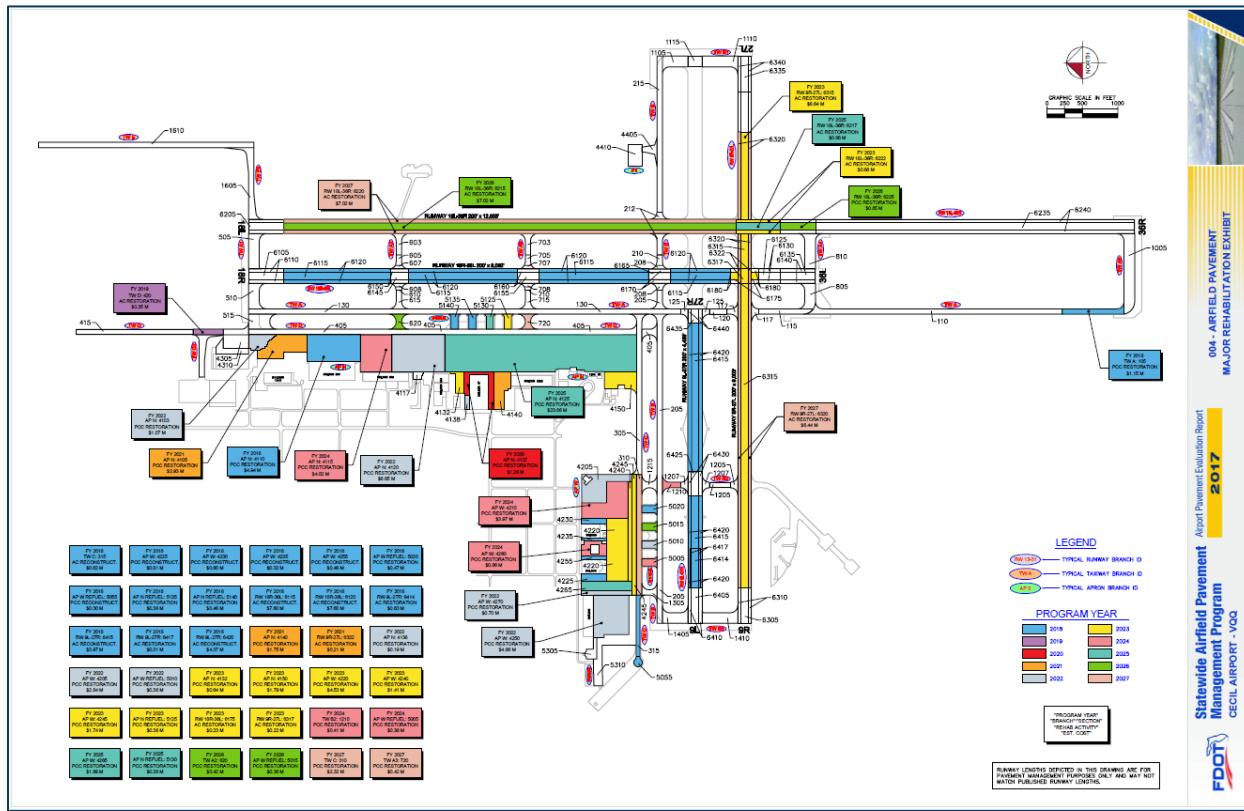
Figure 6.3.1-2 10-Year Major Rehabilitation Needs by Program Year Exhibit

The following **Figure 6.3.1-1** summarizes the section-level major rehabilitation needs for a 10-year period between 2018 and 2027. **Figure 6.3.1-2** provides an inset view of Airfield Pavement Major Rehabilitation Exhibit, a large format exhibit is located in **Appendix C Technical Exhibits**. The exhibit graphically depicts the Major Rehabilitation Needs with rounded costs.
