Florida Department of Transportation

Statewide Airfield Pavement Management Program

Summary of Everglades Airpark

Everglades Airpark was inspected in March 2017 - the overall weighted PCI value was 57, a condition rating of Fair. The results of the maintenance, repair, and major rehabilitation analysis identified \$201,250 in localized M&R needs based on current conditions and a 10-Year major rehabilitation need of \$1,634,000 based on forecasted conditions. The current major rehabilitation needs based on the latest inspection consist of \$1,017,000 for pavements below critical condition.

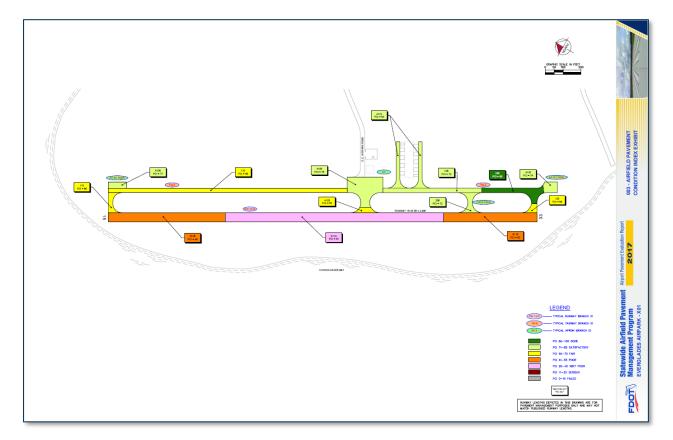
Figure 4.1.3 2017 Airfield Pavement Condition Index Exhibit

Figure 4.1.3 is an inset view of the 2017 Airfield Pavement Condition Index Exhibit that visually represents the results of the latest PCI Survey inspection. A large format exhibit is located in **Appendix C Technical Exhibits.**

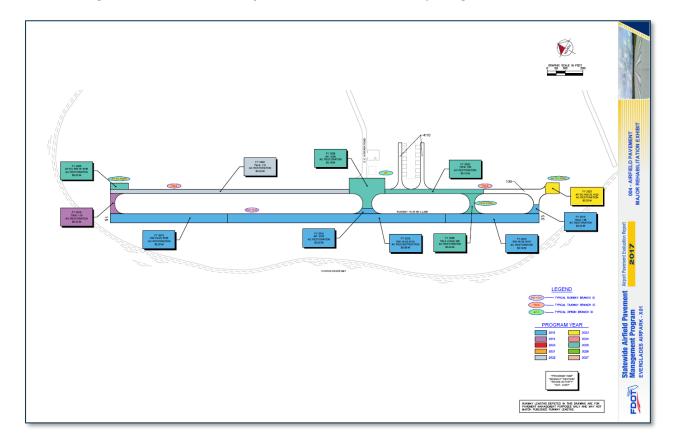
Figure 6.3.1-2 10-Year Major Rehabilitation Needs by Program Year Exhibit

The following Figure 6.3.1-1 summarizes the section-level major rehabilitation needs for a 10year period between 2018 and 2027. Figure 6.3.1-2 provides an inset view of Airfield Pavement Major Rehabilitation Exhibit, a large format exhibit is located in Appendix C Technical **Exhibits**. The exhibit graphically depicts the Major Rehabilitation Needs with rounded costs.
