AVIATION AND SPACEPORTS OFFICE

## Statewide Airfield Pavement Management Program

Arcadia Municipal Airport was inspected in November 2016 – the overall weighted PCI value was 60, a condition rating of Fair. The results of the maintenance, repair, and major rehabilitation analysis identified \$105.270 in localized M&R needs based on current conditions and a 10-Year major rehabilitation need of \$4,091,000 based on forecasted conditions. The current major rehabilitation needs based on the latest inspection consist of \$4,091,000 for pavements below critical condition.

Arcadia Municipal Airport (X06)

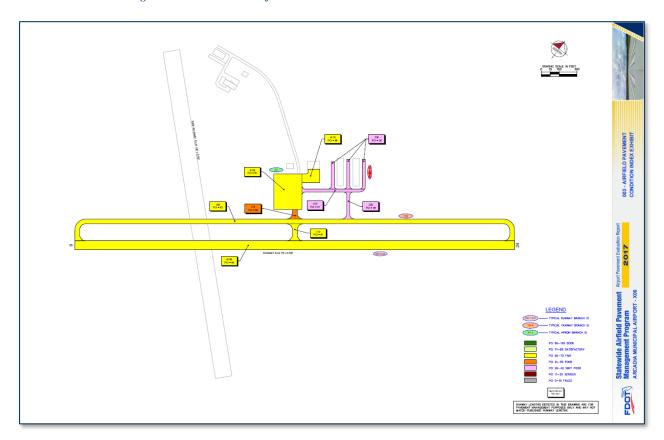
Figure 4.1.3 2017 Airfield Pavement Condition Index Exhibit

Figure 4.1.3 is an inset view of the 2017 Airfield Pavement Condition Index Exhibit that visually represents the results of the latest PCI Survey inspection. A large format exhibit is located in **Appendix C Technical Exhibits.**

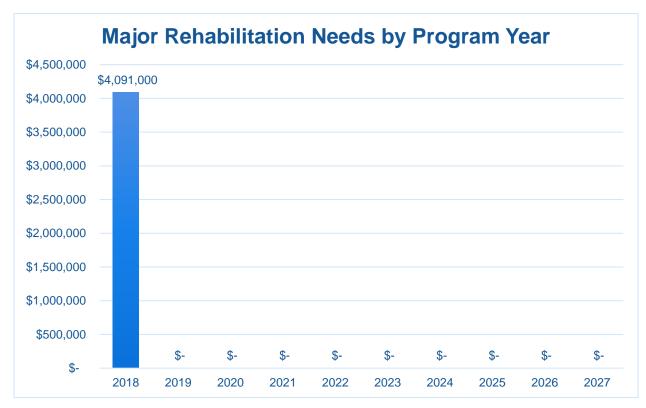
Figure 6.3.1-1 10-Year Major Rehabilitation Needs by Program Year

The following Figure 6.3.1-1 summarizes the section-level major rehabilitation needs for a 10year period between 2018 and 2027. Figure 6.3.1-2 provides an inset view of Airfield Pavement Major Rehabilitation Exhibit, a large format exhibit is located in Appendix C Technical **Exhibits**. The exhibit graphically depicts the Major Rehabilitation Needs with rounded costs.
