Florida Department of Transportation

Statewide Airfield Pavement Management **Program**

Summary of Lake Wales Municipal Airport

Lake Wales Municipal Airport was inspected in March 2017 – the overall weighted PCI value was 73, a condition rating of Satisfactory. The results of the maintenance, repair, and major rehabilitation analysis identified \$724,810 in localized M&R needs based on current conditions and a 10-Year major rehabilitation need of \$4,676,000 based on forecasted conditions. The current major rehabilitation needs based on the latest inspection consist of \$4,676,000 for pavements below critical condition.

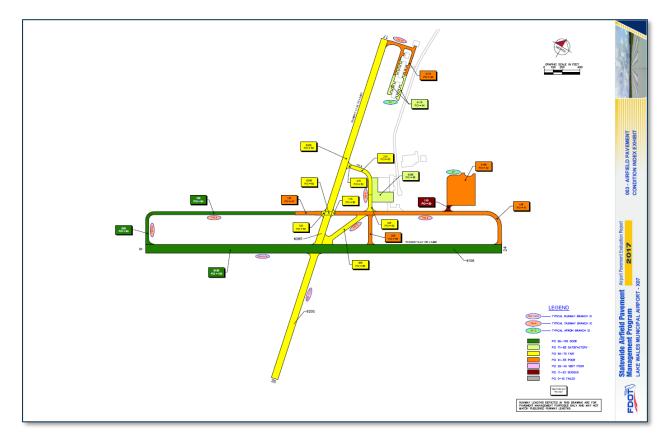
Figure 4.1.3 2017 Airfield Pavement Condition Index Exhibit

Figure 4.1.3 is an inset view of the 2017 Airfield Pavement Condition Index Exhibit that visually represents the results of the latest PCI Survey inspection. A large format exhibit is located in **Appendix C Technical Exhibits.**

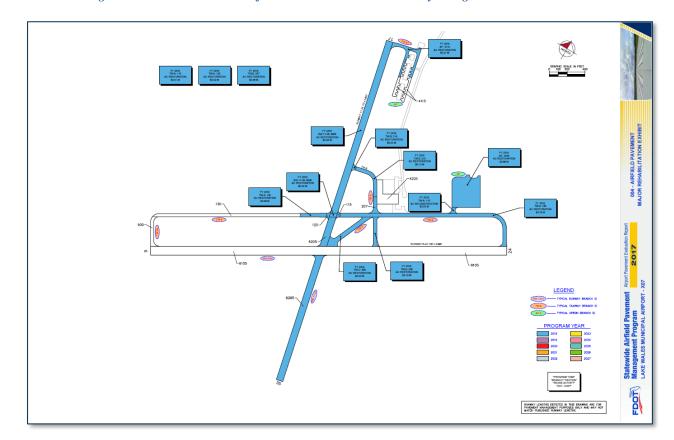
Figure 6.3.1-2 10-Year Major Rehabilitation Needs by Program Year Exhibit

The following Figure 6.3.1-1 summarizes the section-level major rehabilitation needs for a 10year period between 2018 and 2027. Figure 6.3.1-2 provides an inset view of Airfield Pavement Major Rehabilitation Exhibit, a large format exhibit is located in Appendix C Technical **Exhibits**. The exhibit graphically depicts the Major Rehabilitation Needs with rounded costs.
