# **Statewide Airfield Pavement Management Program**

**Airport Pavement  
Evaluation Report  
September 2017**

**LaBelle**  
**Municipal Airport (X14)**  
General Aviation Airport  
District 1

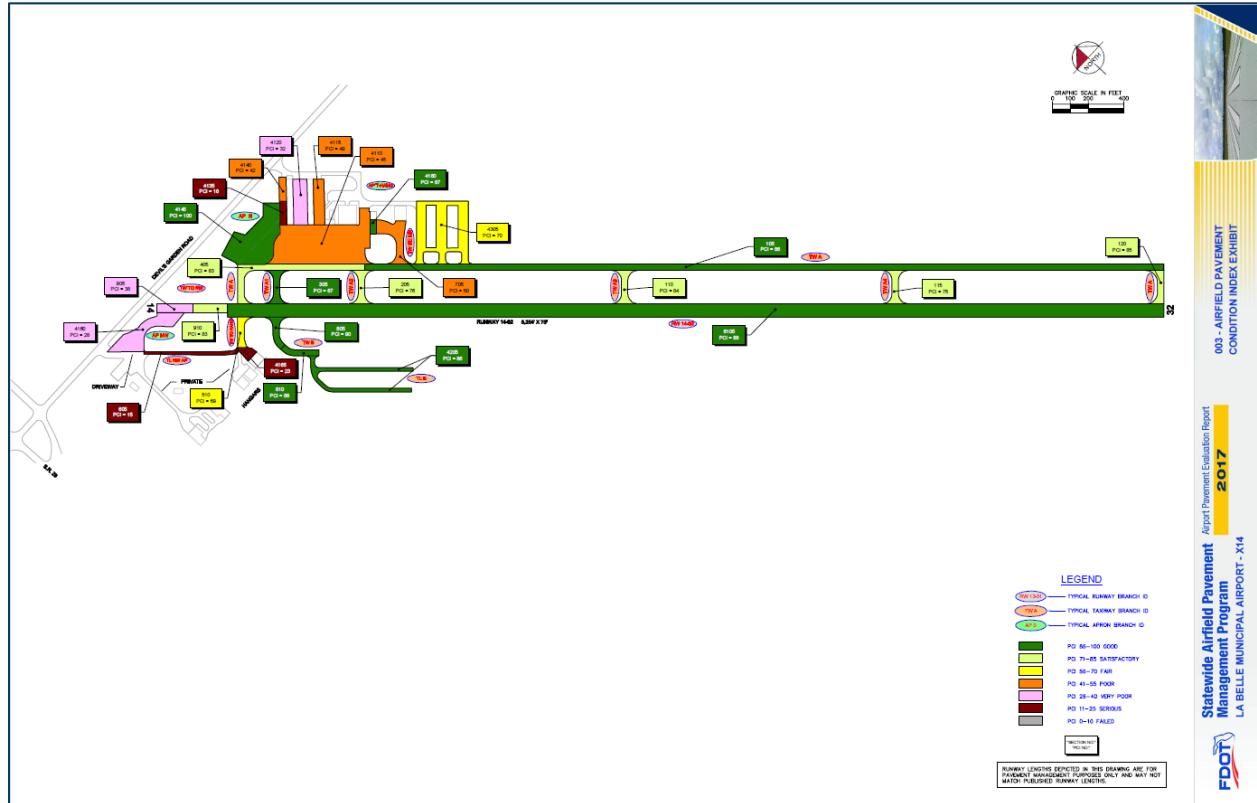
*Figure 4.1.3 2017 Airfield Pavement Condition Index Exhibit*

**Figure 4.1.3** is an inset view of the 2017 Airfield Pavement Condition Index Exhibit that visually represents the results of the latest PCI Survey inspection. A large format exhibit is located in **Appendix C Technical Exhibits**.
