Statewide Airfield Pavement Management Program

**Airport Pavement
Evaluation Report
September 2017**

**Marion County
Airport (X35)**
General Aviation Airport
District 5

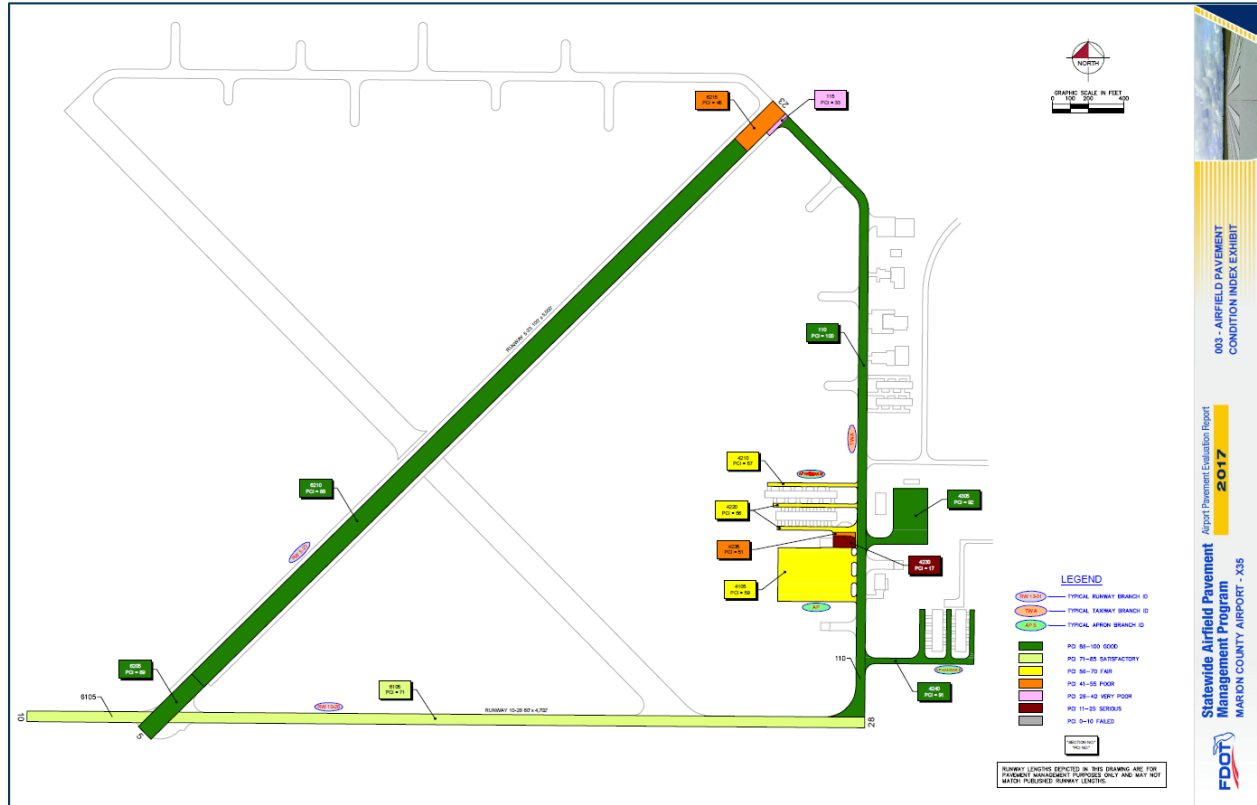
Figure 4.1.3 2017 Airfield Pavement Condition Index Exhibit

Figure 4.1.3 is an inset view of the 2017 Airfield Pavement Condition Index Exhibit that visually represents the results of the latest PCI Survey inspection. A large format exhibit is located in **Appendix C Technical Exhibits**.

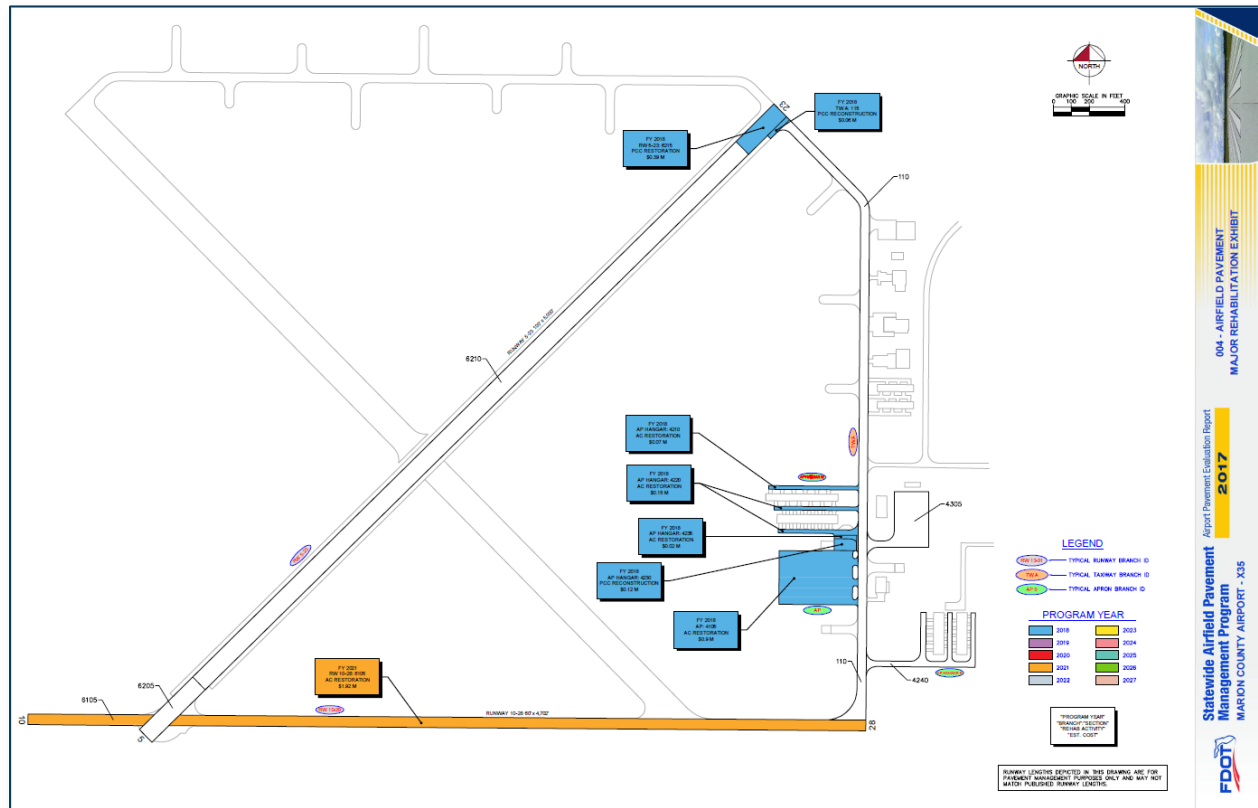
Figure 6.3.1-2 10-Year Major Rehabilitation Needs by Program Year Exhibit

The following **Figure 6.3.1-1** summarizes the section-level major rehabilitation needs for a 10-year period between 2018 and 2027. **Figure 6.3.1-2** provides an inset view of Airfield Pavement Major Rehabilitation Exhibit, a large format exhibit is located in **Appendix C Technical Exhibits**. The exhibit graphically depicts the Major Rehabilitation Needs with rounded costs.
