# **Statewide Airfield Pavement Management Program**

## **Airport Pavement Evaluation Report September 2017**

**Miami Homestead  
General Aviation  
Airport (X51)**

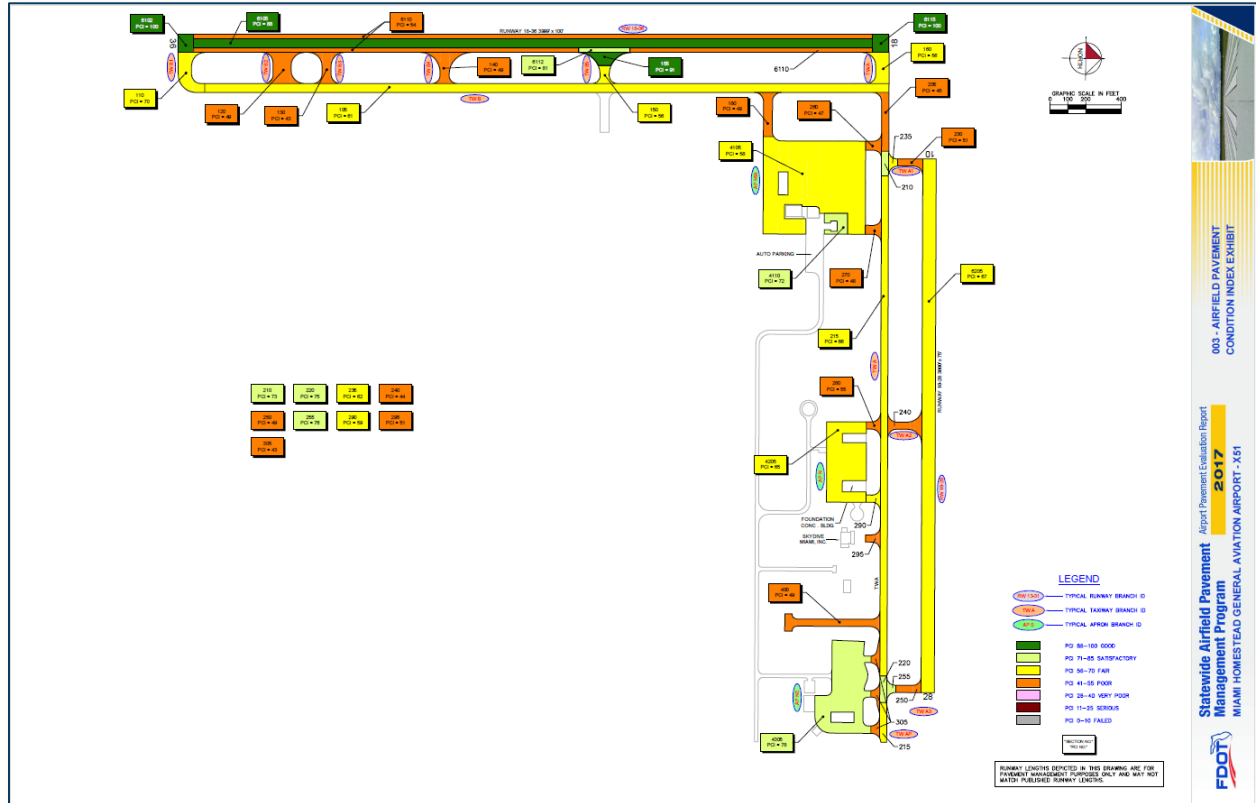
*Figure 4.1.3 2017 Airfield Pavement Condition Index Exhibit*

**Figure 4.1.3** is an inset view of the 2017 Airfield Pavement Condition Index Exhibit that visually represents the results of the latest PCI Survey inspection. A large format exhibit is located in **Appendix C Technical Exhibits**.

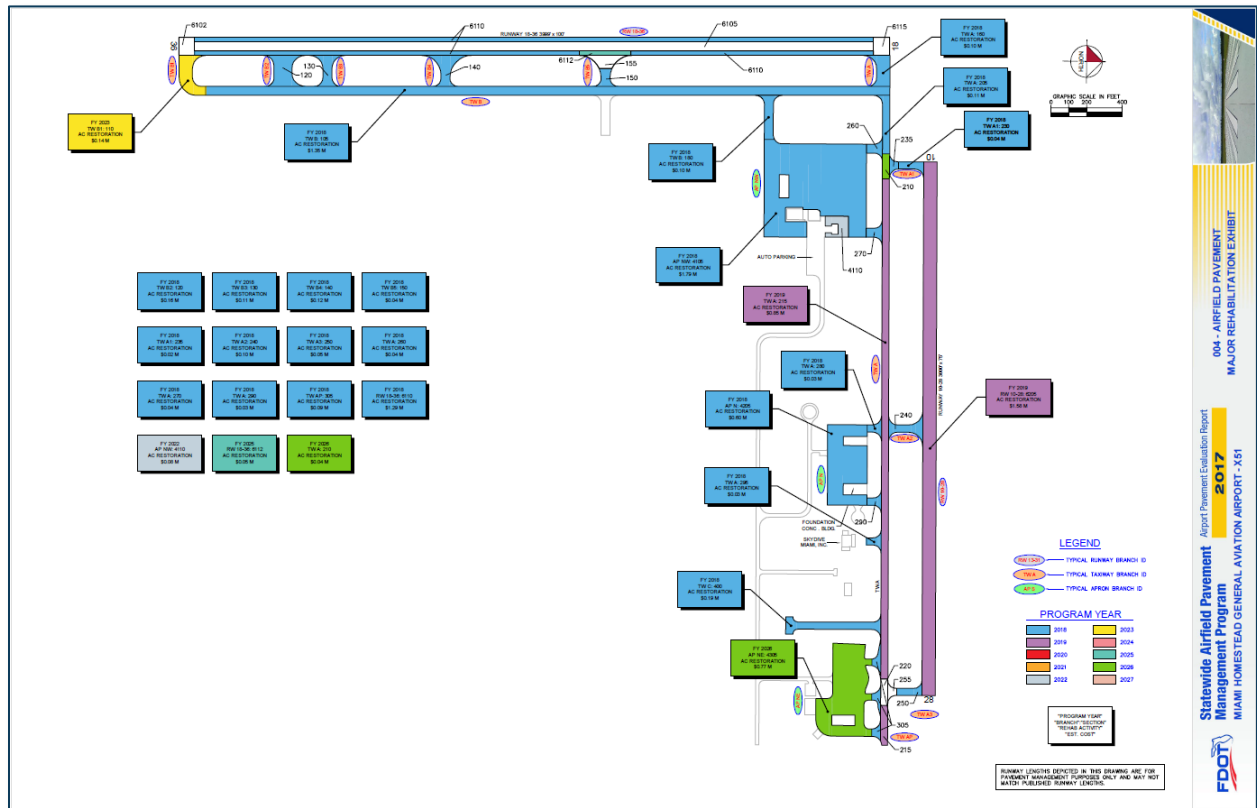
Figure 6.3.1-2 10-Year Major Rehabilitation Needs by Program Year Exhibit

The following **Figure 6.3.1-1** summarizes the section-level major rehabilitation needs for a 10-year period between 2018 and 2027. **Figure 6.3.1-2** provides an inset view of Airfield Pavement Major Rehabilitation Exhibit, a large format exhibit is located in **Appendix C Technical Exhibits**. The exhibit graphically depicts the Major Rehabilitation Needs with rounded costs.
