FLORIDA DEPARTMENT OF TRANSPORTATION
AVIATION AND SPACEPORTS OFFICE

Statewide Airfield Pavement Management Program

**Airport Pavement
Evaluation Report
September 2017**

Valkaria Airport (X59)
General Aviation Airport
District 5

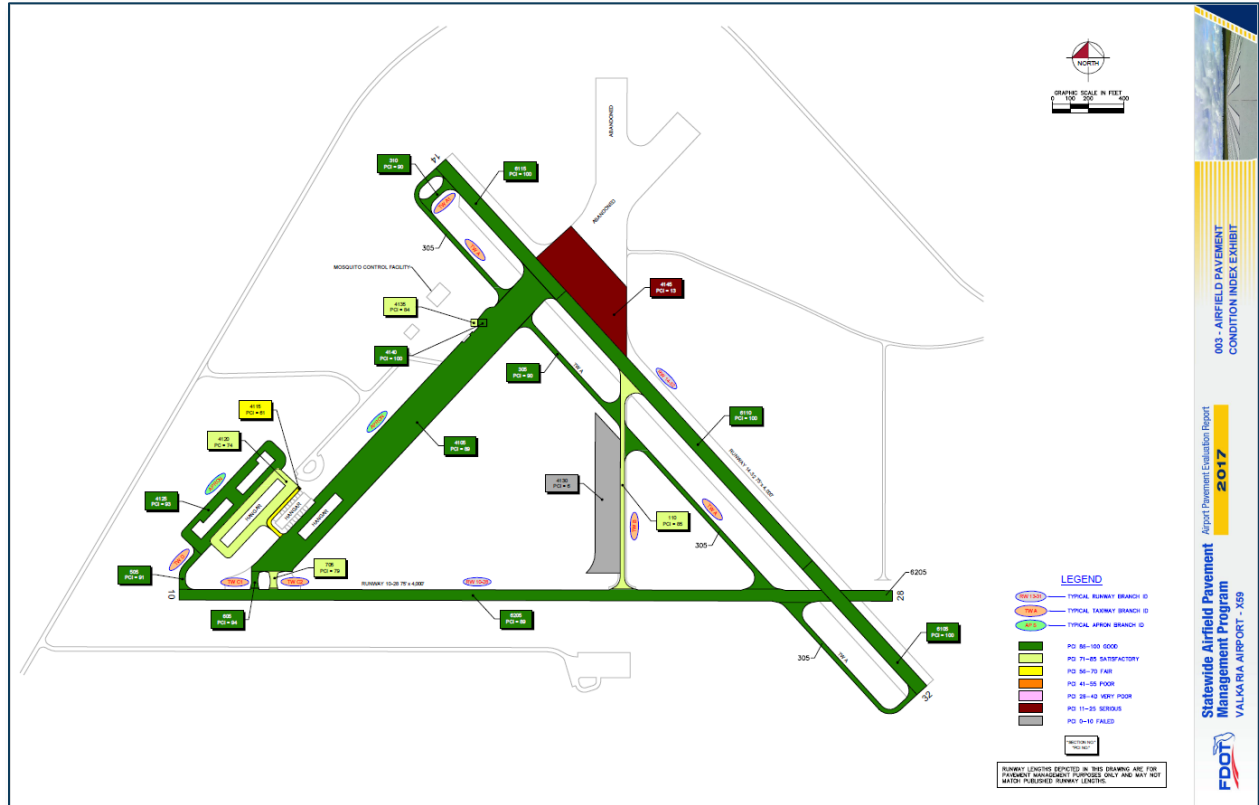
Figure 4.1.3 2017 Airfield Pavement Condition Index Exhibit

Figure 4.1.3 is an inset view of the 2017 Airfield Pavement Condition Index Exhibit that visually represents the results of the latest PCI Survey inspection. A large format exhibit is located in **Appendix C Technical Exhibits**.
