Florida Department of Transportation

Statewide Airfield Pavement Management Program

Summary of Okeechobee County Airport

Okeechobee County Airport was inspected in April 2017 – the overall weighted PCI value was 71, a condition rating of Satisfactory. The results of the maintenance, repair, and major rehabilitation analysis identified \$170,050 in localized M&R needs based on current conditions and a 10-Year major rehabilitation need of \$8,139,000 based on forecasted conditions. The current major rehabilitation needs based on the latest inspection consist of \$3,644,000 for pavements below critical condition.

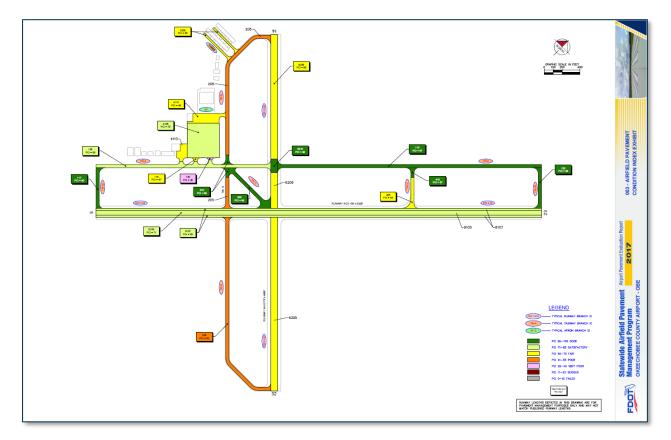
Figure 4.1.3 2017 Airfield Pavement Condition Index Exhibit

Figure 4.1.3 is an inset view of the 2017 Airfield Pavement Condition Index Exhibit that visually represents the results of the latest PCI Survey inspection. A large format exhibit is located in **Appendix C Technical Exhibits.**

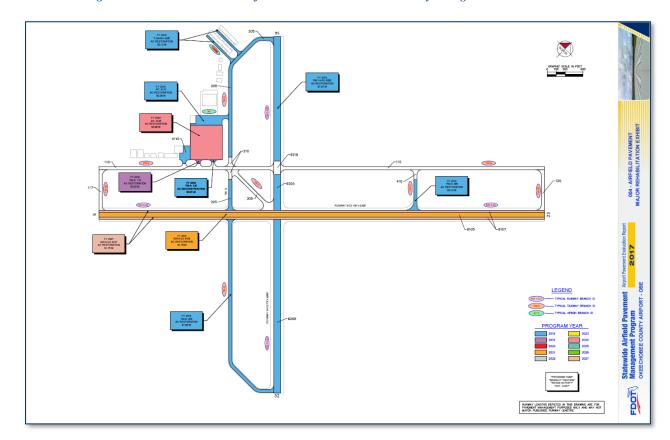
Figure 6.3.1-2 10-Year Major Rehabilitation Needs by Program Year Exhibit

The following Figure 6.3.1-1 summarizes the section-level major rehabilitation needs for a 10year period between 2018 and 2027. Figure 6.3.1-2 provides an inset view of Airfield Pavement Major Rehabilitation Exhibit, a large format exhibit is located in Appendix C Technical **Exhibits**. The exhibit graphically depicts the Major Rehabilitation Needs with rounded costs.
