FLORIDA DEPARTMENT OF TRANSPORTATION
AVIATION AND SPACEPORTS OFFICE

Statewide Airfield Pavement Management Program

Airport Pavement Evaluation Report November 2019

**Ocala International/
Jim Taylor Field (OCF)**
Commercial Airport
District 5

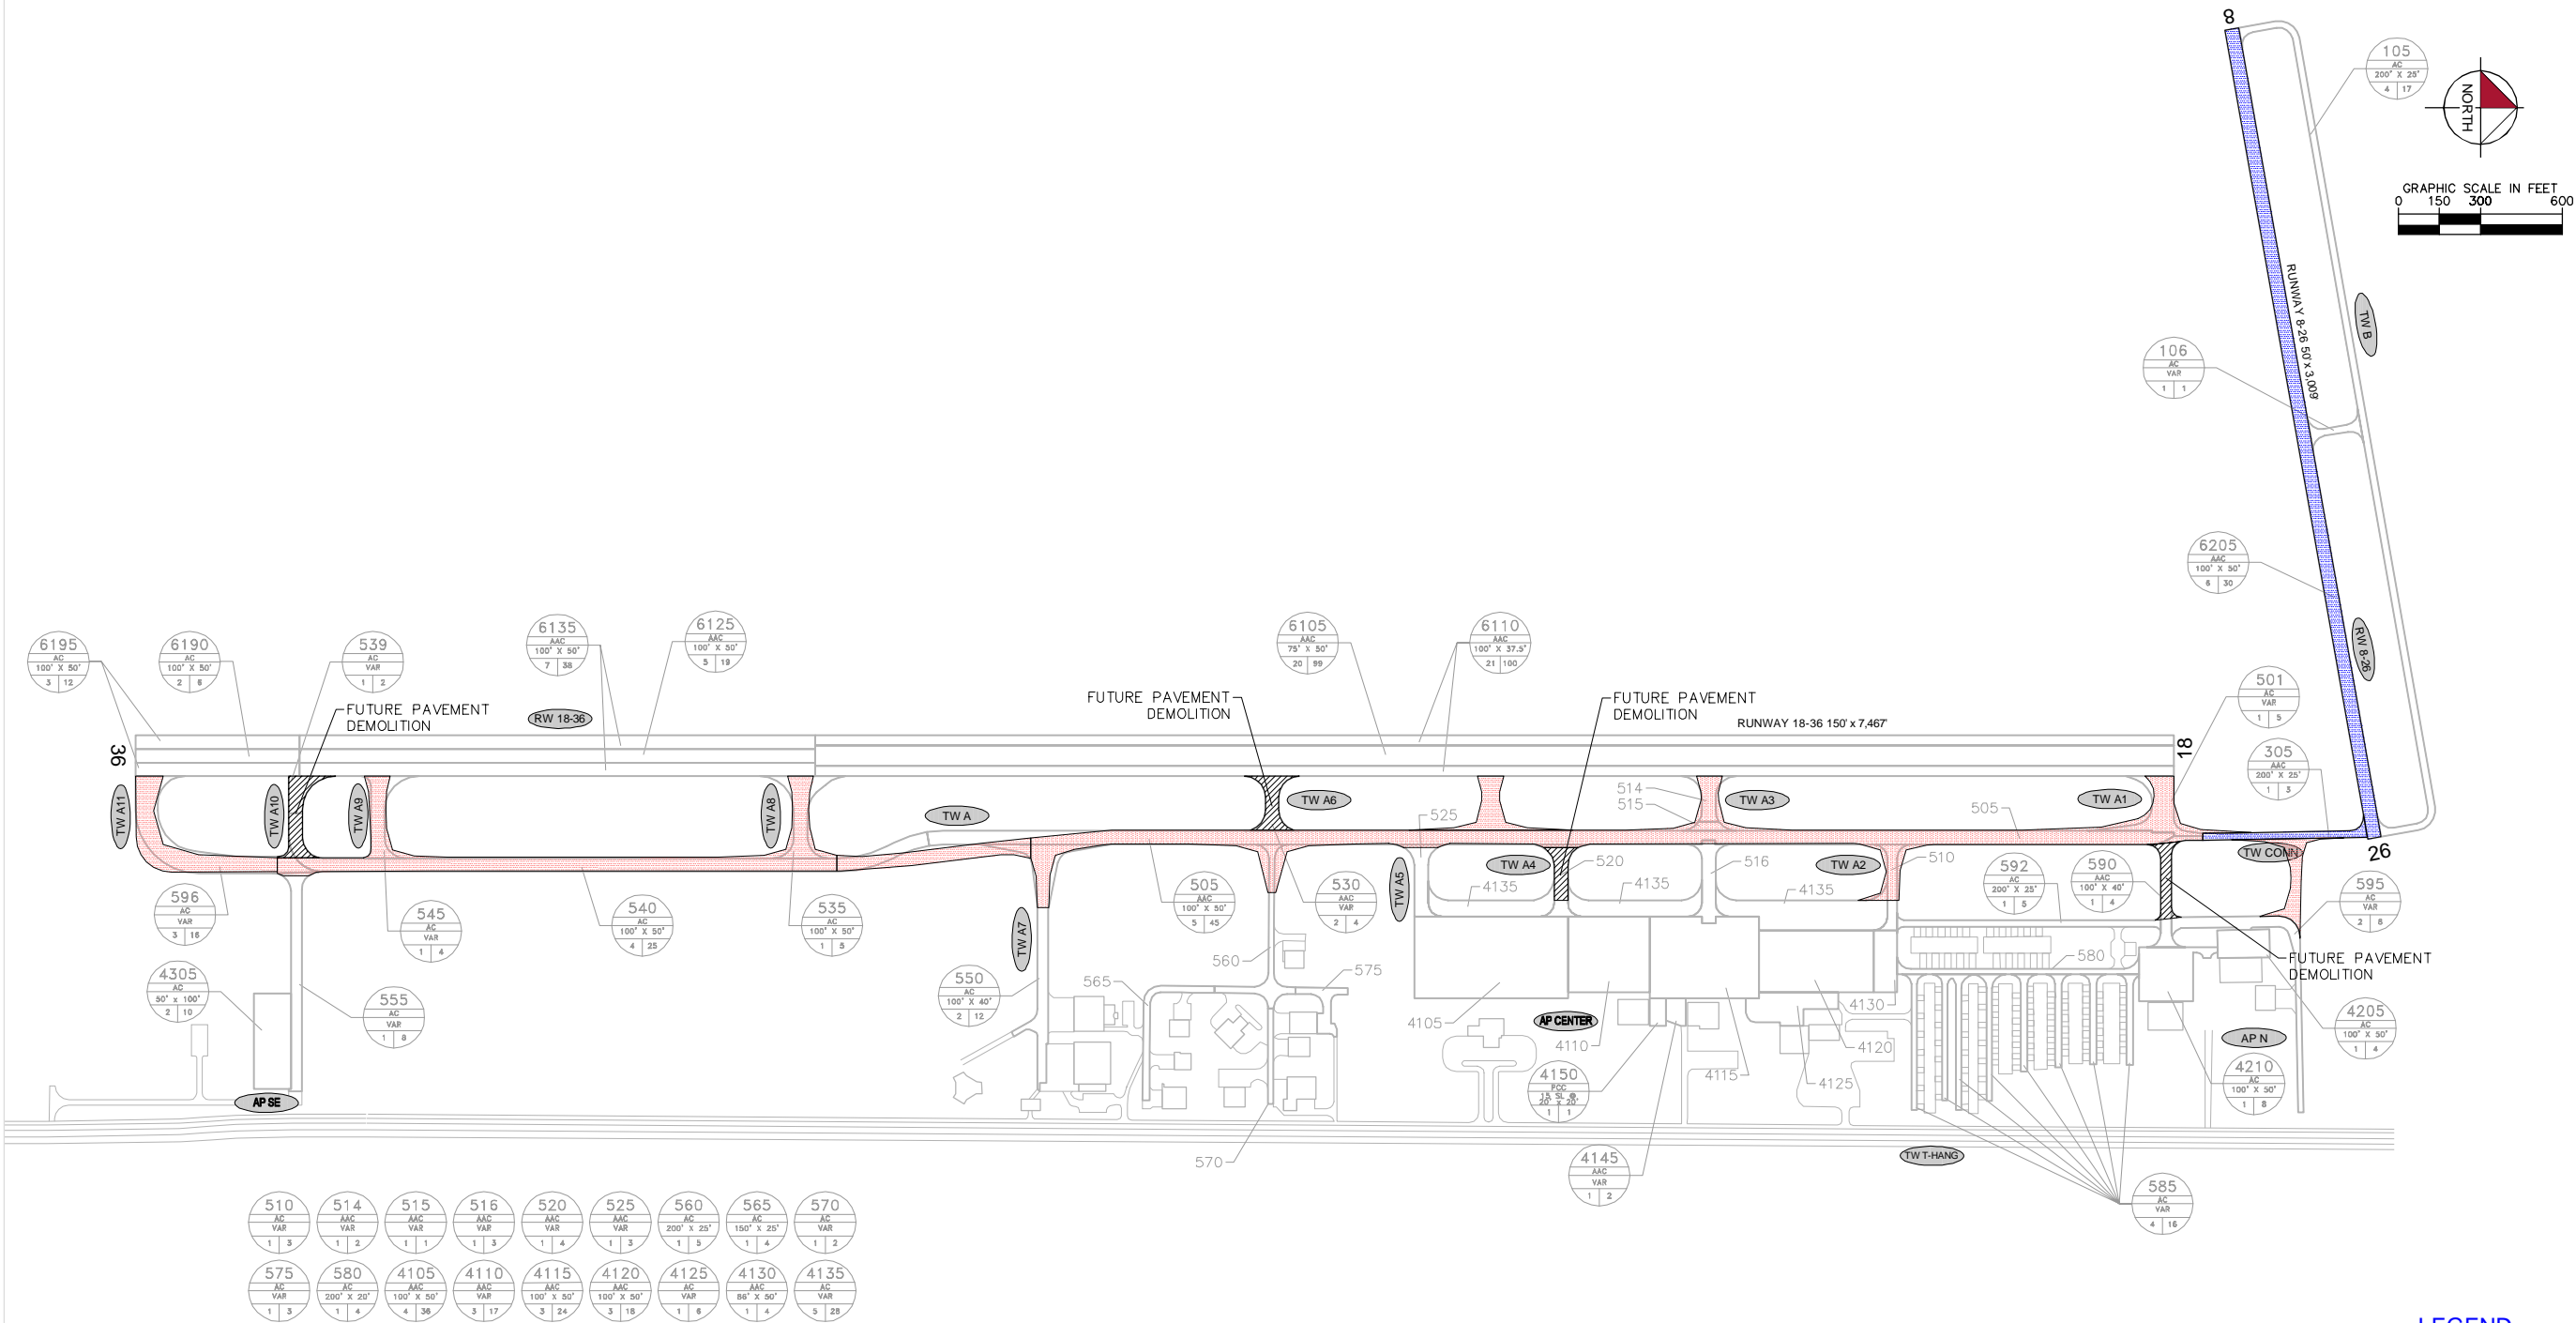
002 - AIRFIELD PAVEMENT
SYSTEM INVENTORY EXHIBIT

CONSTRUCTION SINCE LAST INSPECTION & ANTICIPATED CONSTRUCTION ACTIVITY		
CONSTRUCTION YEAR	LOCATION	WORK TYPE / PAVEMENT SECTION
2013	RW 8-26, TW CONN	MILL AND OVERLAY
2019	TW A, TW A1-A7, TW A11	MILL AND OVERLAY / 3" MILL AND VARIABLE P-401 OVERLAY
2019	TW A, TW A8, TW A9	MILL AND OVERLAY / 4" MILL AND VARIABLE P-401 OVERLAY
2019	TW A, NEW TW A CONNECTORS	NEW CONSTRUCTION - AC / 4" P-401, 12" P-211, COMPACTED P-152
