## Statewide Airfield Pavement Management Program

Airport Pavement Evaluation Report 2019

Ormond Beach Municipal Airport (OMN)

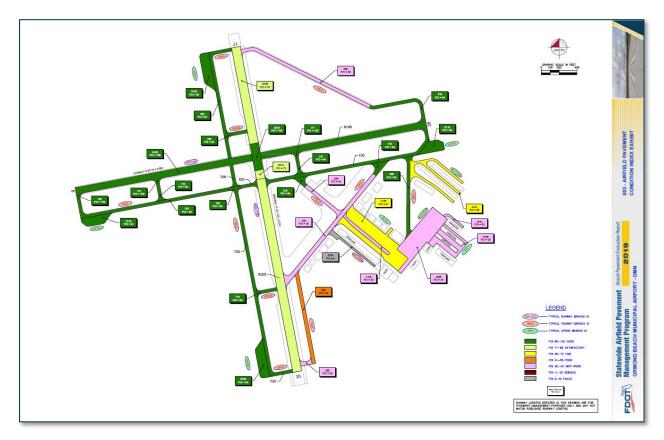
Figure 4.1.3 2019 Airfield Pavement Condition Index Exhibit

Figure 4.1.3 is an inset view of the 2019 Airfield Pavement Condition Index Exhibit that visually represents the results of the latest PCI Survey inspection. A large format exhibit is located in **Appendix C Technical Exhibits.**

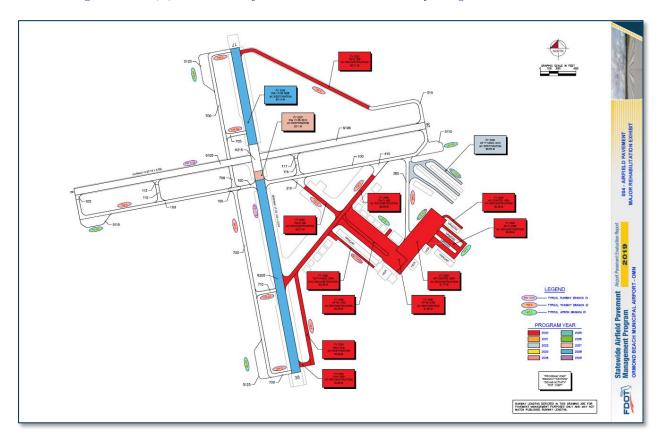
Figure 6.3.1 (b) 10-Year Major Rehabilitation Needs by Program Year Exhibit

The following Figure 6.3.1 (a) summarizes the section-level major rehabilitation needs for a 10year period between 2020 and 2029. Figure 6.3.1 (b) provides an inset view of Airfield Pavement Major Rehabilitation Exhibit, a large format exhibit is located in Appendix C Technical Exhibits. The exhibit graphically depicts the Major Rehabilitation Needs with rounded costs.
