FLORIDA DEPARTMENT OF TRANSPORTATION
AVIATION AND SPACEPORTS OFFICE

Airport Pavement Evaluation Report November 2019

**Fernandina Beach
Municipal Airport (FHB)**
General Aviation Airport
District 2

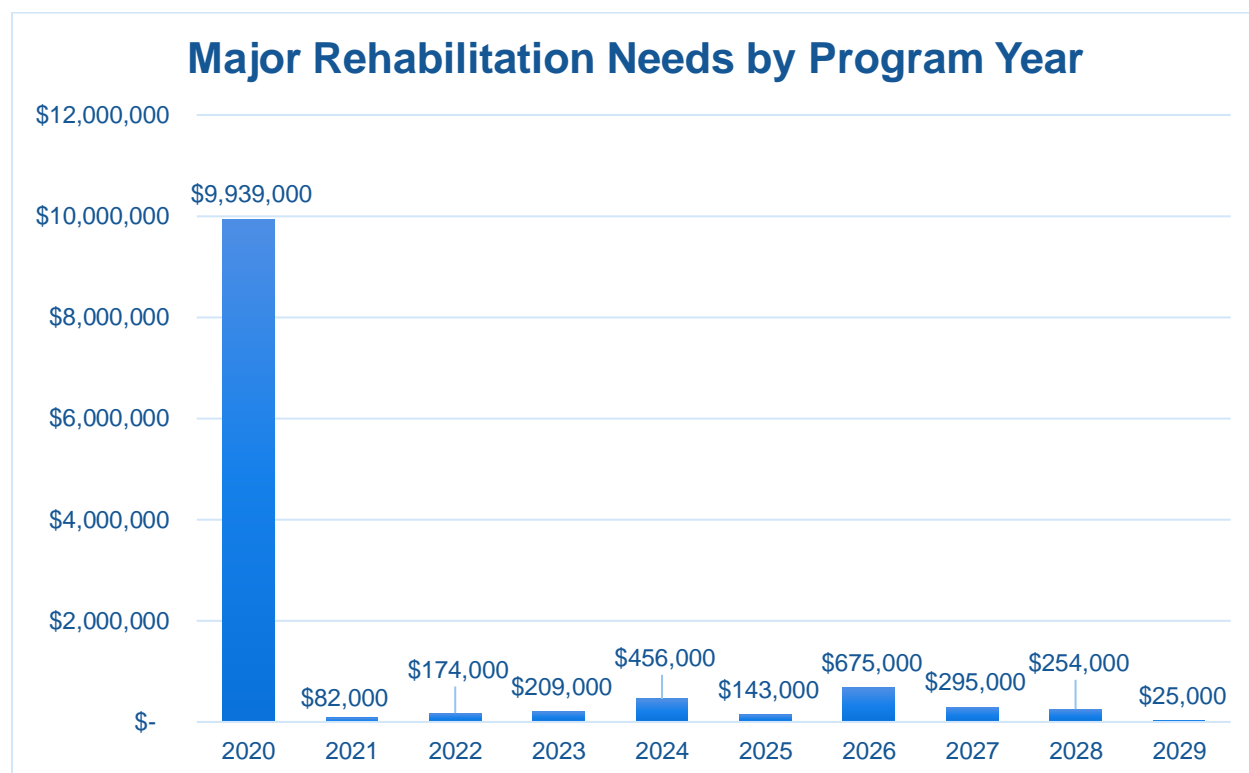
Figure 6.3.1 (a) 10-Year Major Rehabilitation Needs by Program Year

The following **Figure 6.3.1 (a)** summarizes the section-level major rehabilitation needs for a 10-year period between 2020 and 202*. **Figure 6.3.1 (b)** provides an inset view of Airfield Pavement Major Rehabilitation Exhibit, a large format exhibit is located in **Appendix C Technical Exhibits**. The exhibit graphically depicts the Major Rehabilitation Needs with rounded costs.
