Statewide Airfield Pavement Management Program

Airport Pavement Evaluation Report November 2019

**Palm Beach County
Park Airport (LNA)**
Reliever Airport
District 4

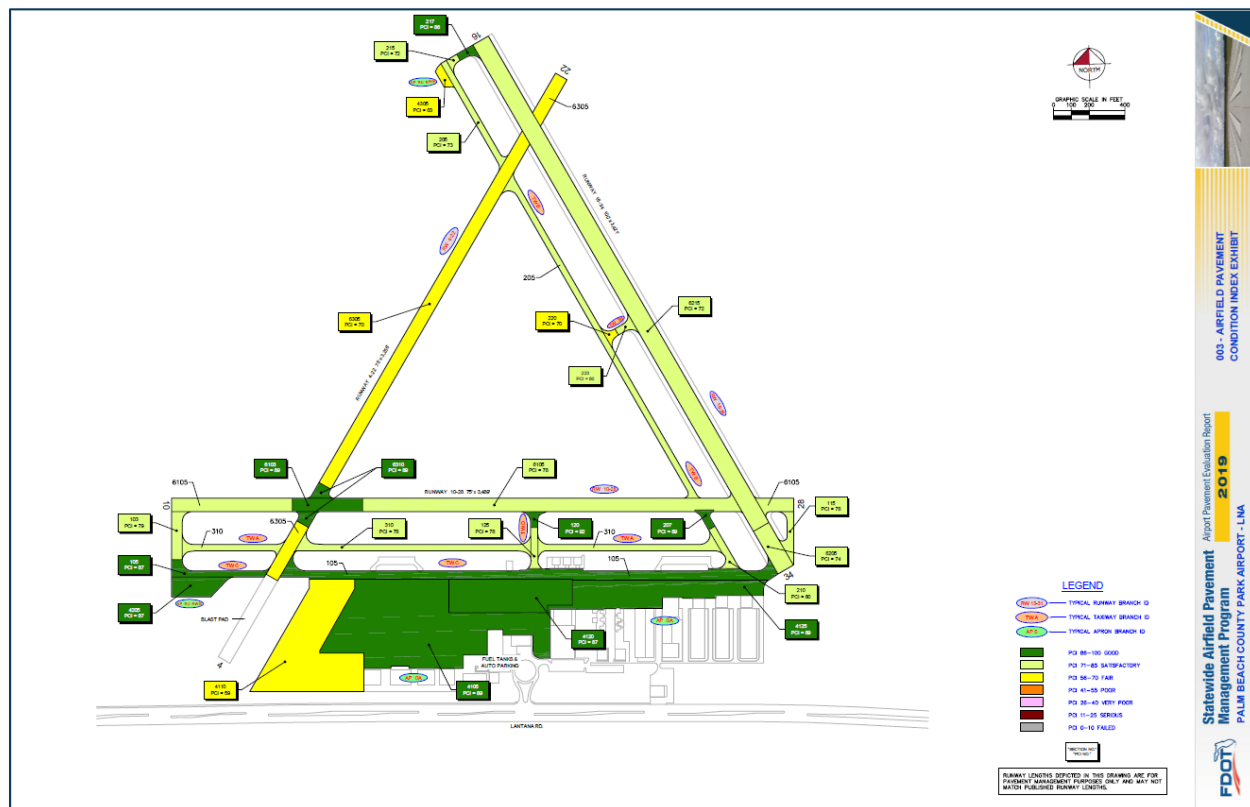
Figure 4.1.3 2019 Airfield Pavement Condition Index Exhibit

Figure 4.1.3 is an inset view of the 2019 Airfield Pavement Condition Index Exhibit that visually represents the results of the latest PCI Survey inspection. A large format exhibit is located in **Appendix C Technical Exhibits**.

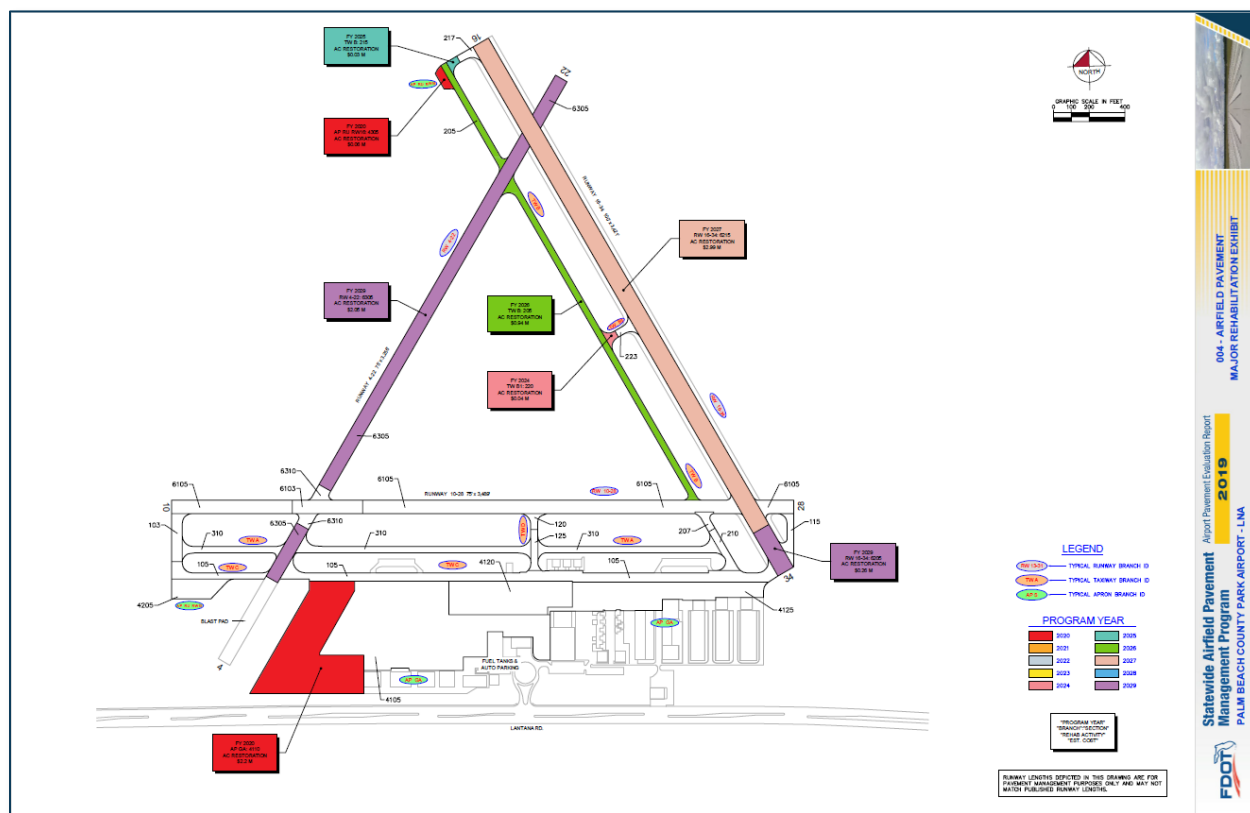
Figure 6.3.1 (b) 10-Year Major Rehabilitation Needs by Program Year Exhibit

The following **Figure 6.3.1 (a)** summarizes the section-level major rehabilitation needs for a 10-year period between 2020 and 2029. **Figure 6.3.1 (b)** provides an inset view of Airfield Pavement Major Rehabilitation Exhibit, a large format exhibit is located in **Appendix C Technical Exhibits**. The exhibit graphically depicts the Major Rehabilitation Needs with rounded costs.

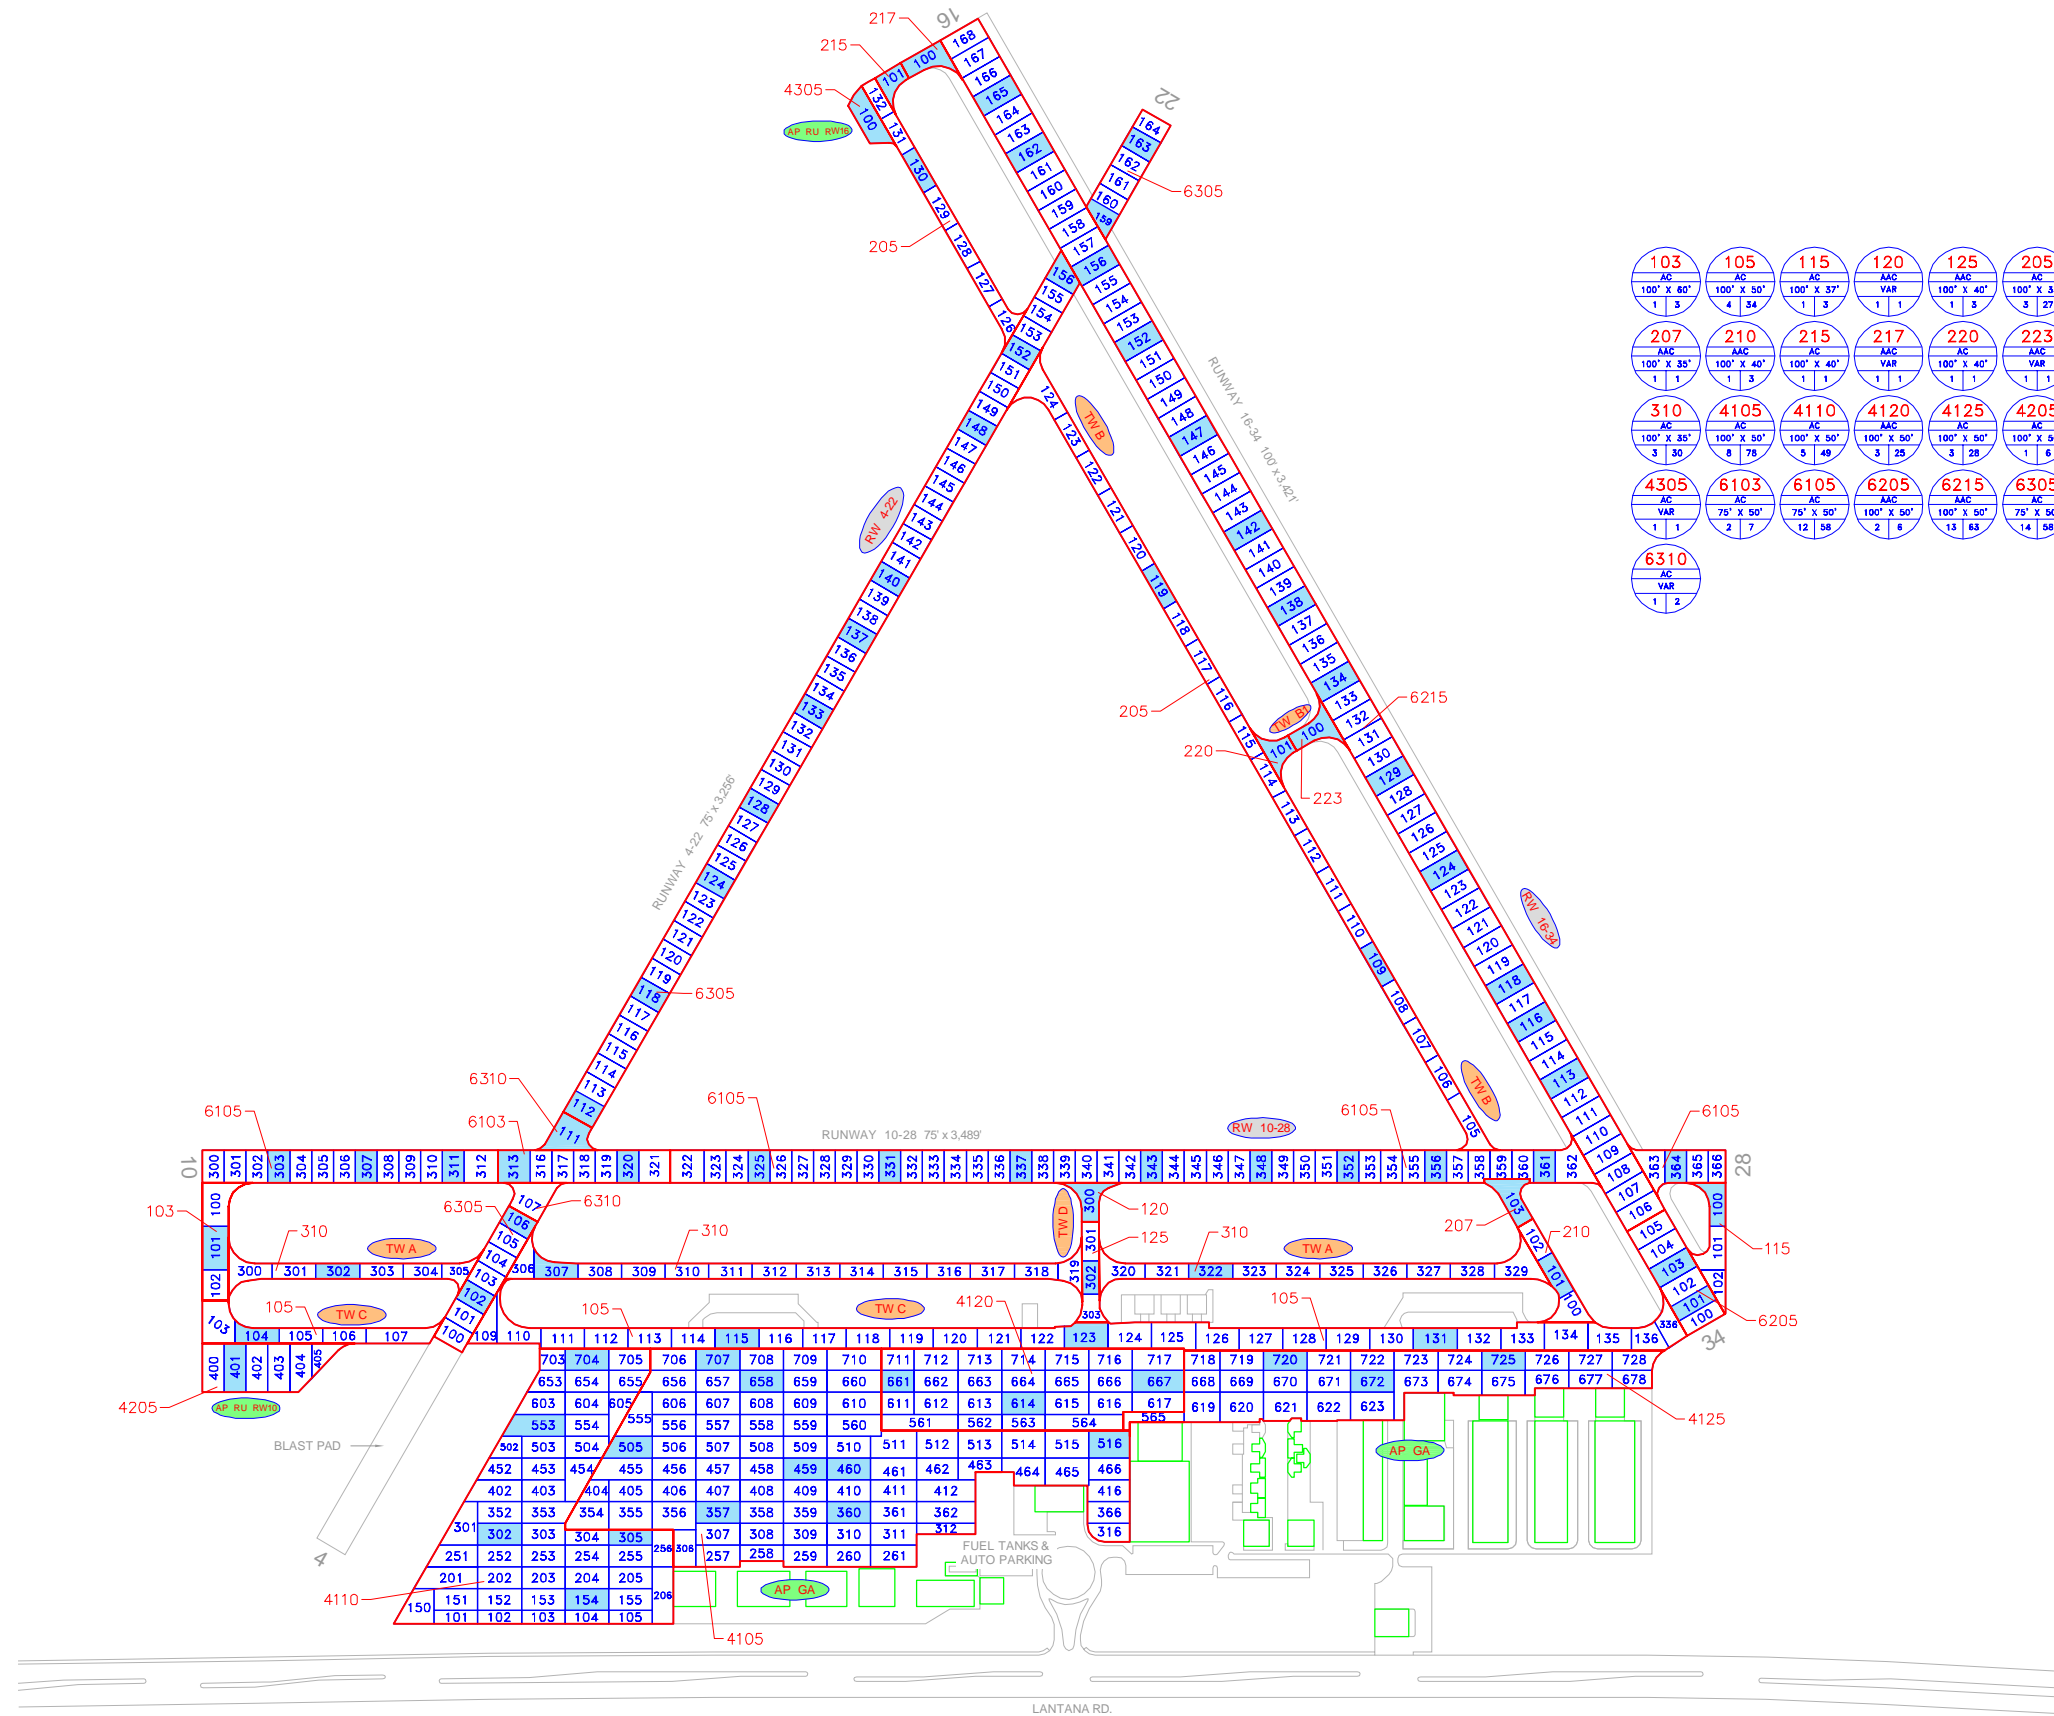
TOTAL SAMPLES INSPECTED = 85
AC: 85 PCC: 0

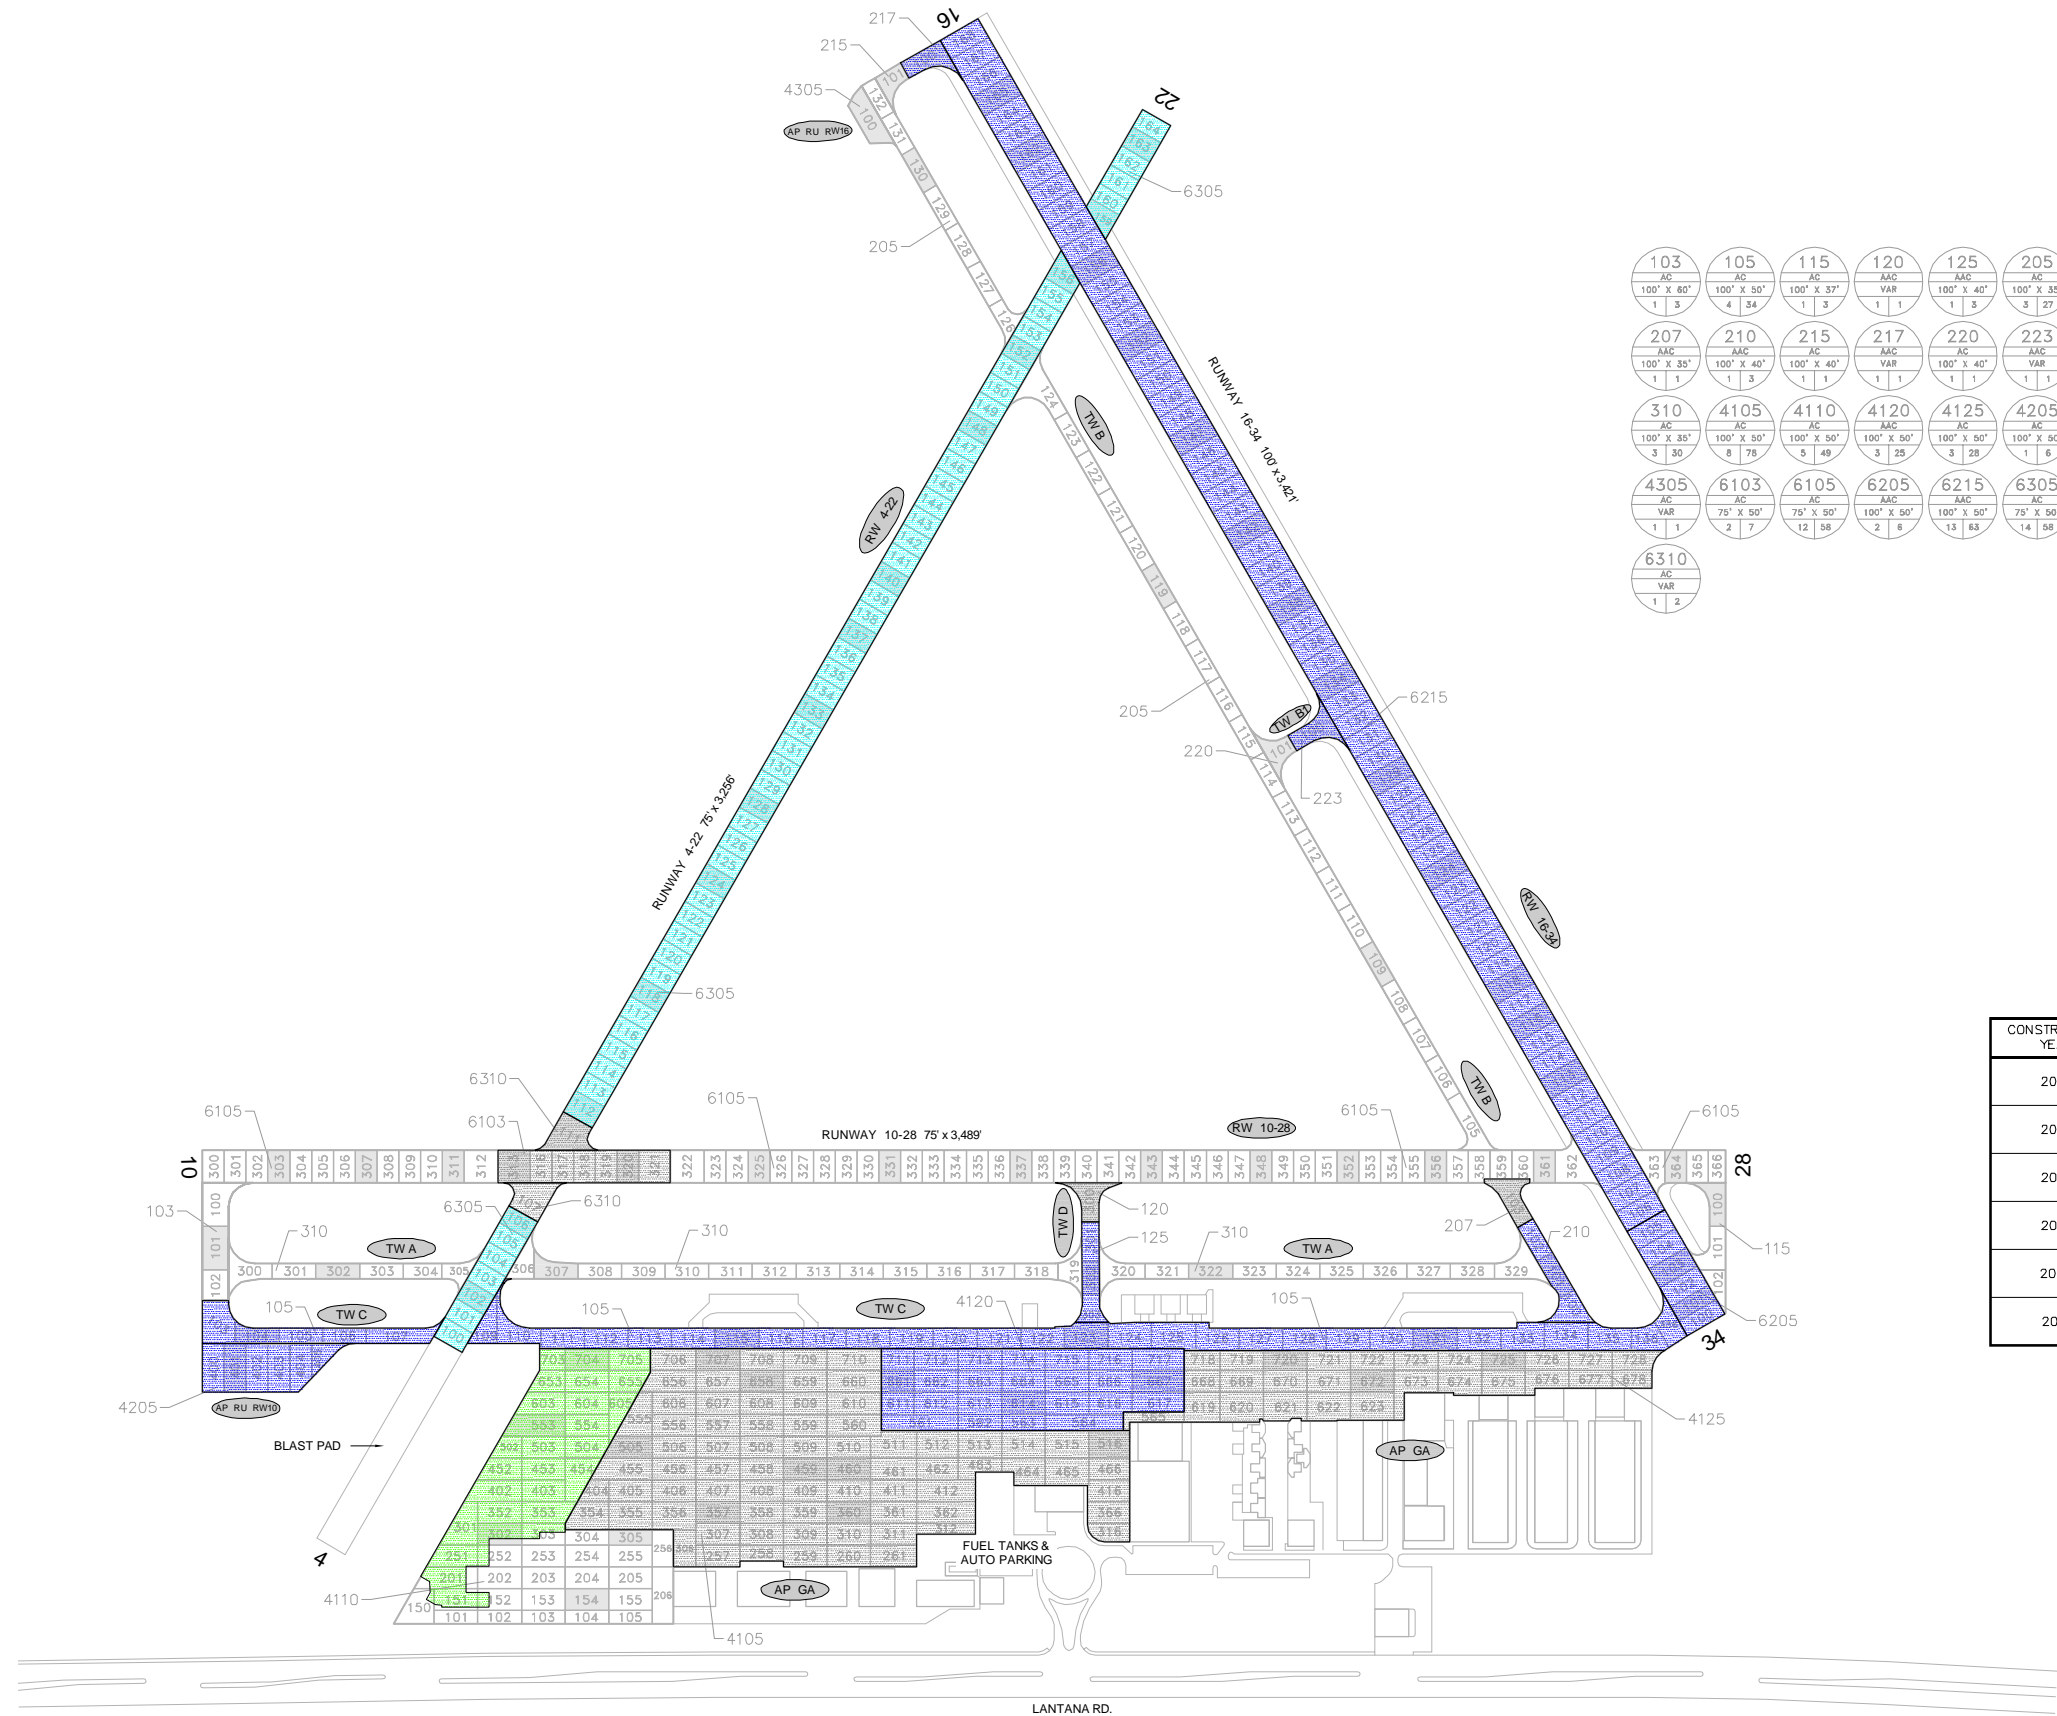
CONSTRUCTION SINCE LAST INSPECTION & ANTICIPATED CONSTRUCTION ACTIVITY		
CONSTRUCTION YEAR	LOCATION	WORK TYPE / PAVEMENT SECTION
2013	RW 16-34, TW B, TW B1, TW D	MILL AND OVERLAY / 1"-2" MILL, 2" P-401SP OVERLAY
2013	TW C, AP RU RW10	COMPLETE RECONSTRUCTION - AC / 2" P-401, 6" P-211, 4" P-154, 24" P-152
2016	TW B, TW D	MILL AND OVERLAY / 2" MILL, 2" P-403
2016	AP GA, RW 4-22, RW 10-28	COMPLETE RECONSTRUCTION - AC / 2" P-403, 6" P-211, 4" P-154, P-152
2020	AP GA	PAVEMENT REHABILITATION
2021	RW 4-22	PAVEMENT REHABILITATION
