FLORIDA DEPARTMENT OF TRANSPORTATION
AVIATION AND SPACEPORTS OFFICE

Statewide Airfield Pavement Management Program

**Airport Pavement
Evaluation Report
November 2019**

Boca Raton Airport (BCT)
Reliever Airport
District 4

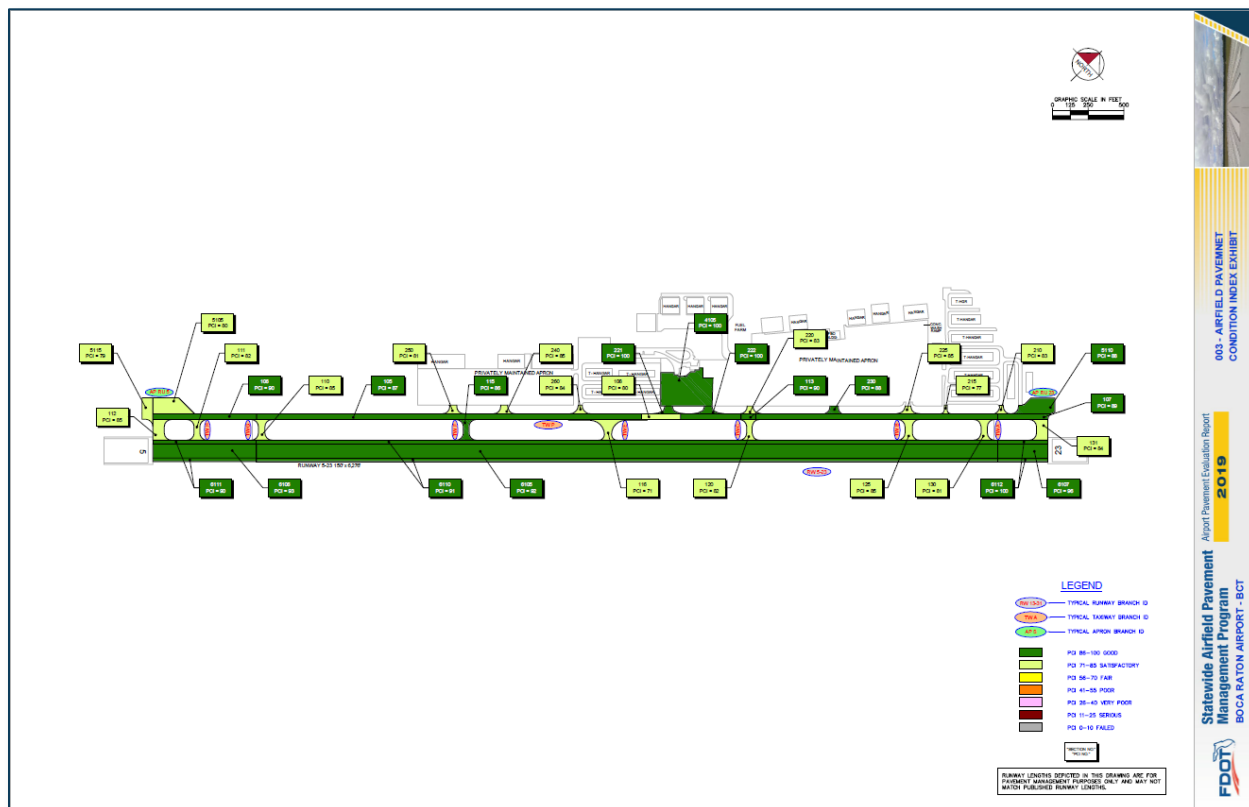
Figure 4.1.3 2019 Airfield Pavement Condition Index Exhibit

Figure 4.1.3 is an inset view of the 2019 Airfield Pavement Condition Index Exhibit that visually represents the results of the latest PCI Survey inspection. A large format exhibit is located in **Appendix C Technical Exhibits**.

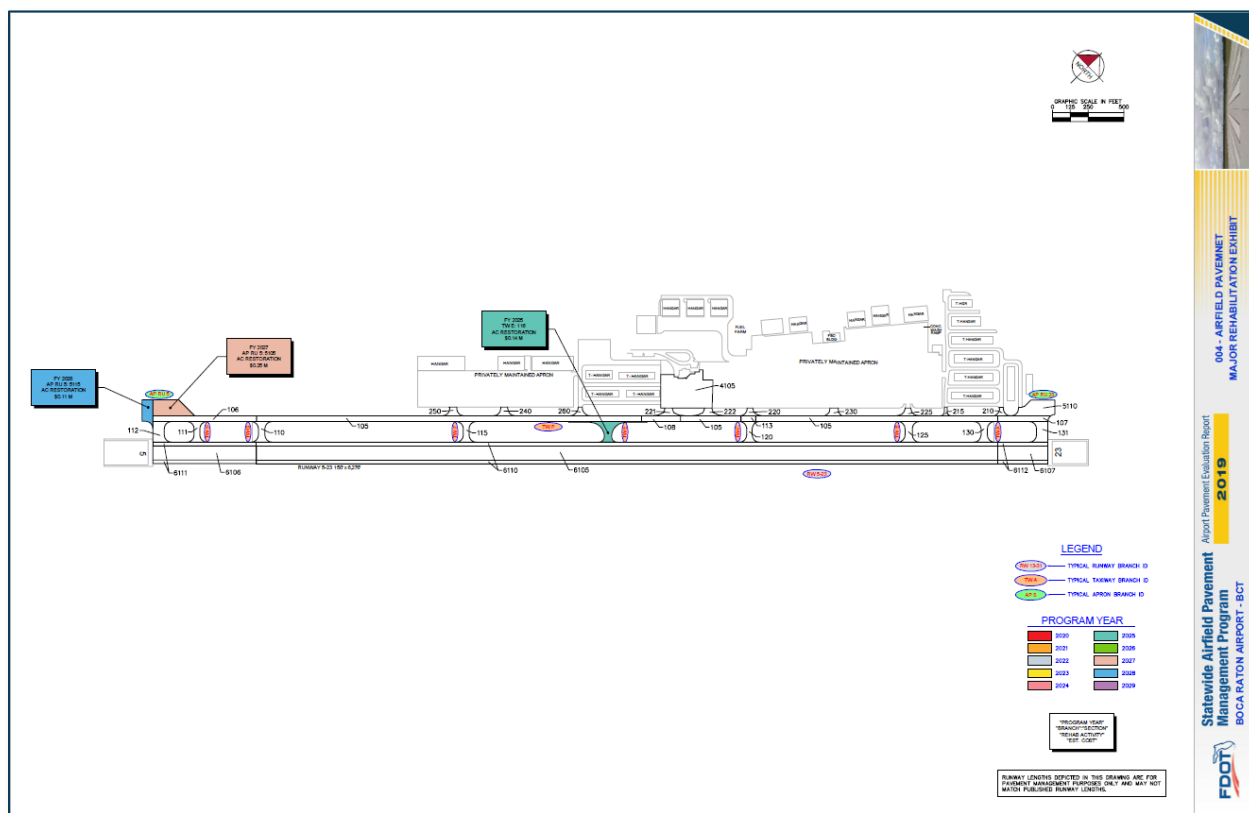
Figure 6.3.1 (b) 10-Year Major Rehabilitation Needs by Program Year Exhibit

The following **Figure 6.3.1 (a)** summarizes the section-level major rehabilitation needs for a 10-year period between 2020 and 2029. **Figure 6.3.1 (b)** provides an inset view of Airfield Pavement Major Rehabilitation Exhibit, a large format exhibit is located in **Appendix C Technical Exhibits**. The exhibit graphically depicts the Major Rehabilitation Needs with rounded costs.
