Statewide Airfield Pavement Management Program

Airport Pavement Evaluation Report

INF - Inverness Airport | District 7

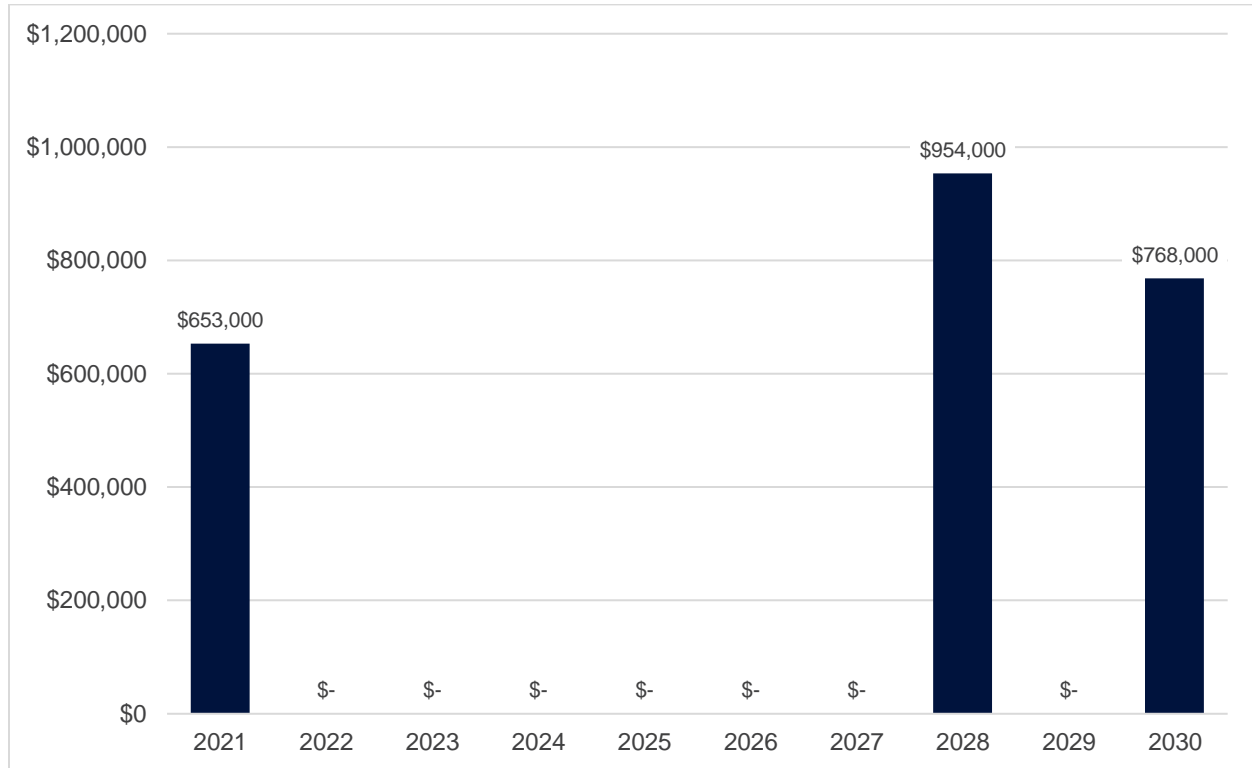
Figure 6.2.1 (a): 10-Year Major Rehabilitation Needs by Program Year

Figure 6.2.1 (a) summarizes the section-level major rehabilitation needs for a 10-year period between 2021 and 2030. **Figure 6.2.1 (b)**, the Airfield Pavement Major Rehabilitation Exhibit, graphically depicts the major rehabilitation needs with rounded costs. As suggested previously, this is planning-level data that can be used by the Airport to support developing a practical CIP.
