*Statewide Airfield Pavement Management Program*

# Airport Pavement Evaluation Report

CLW - Clearwater Air Park | *District 7*

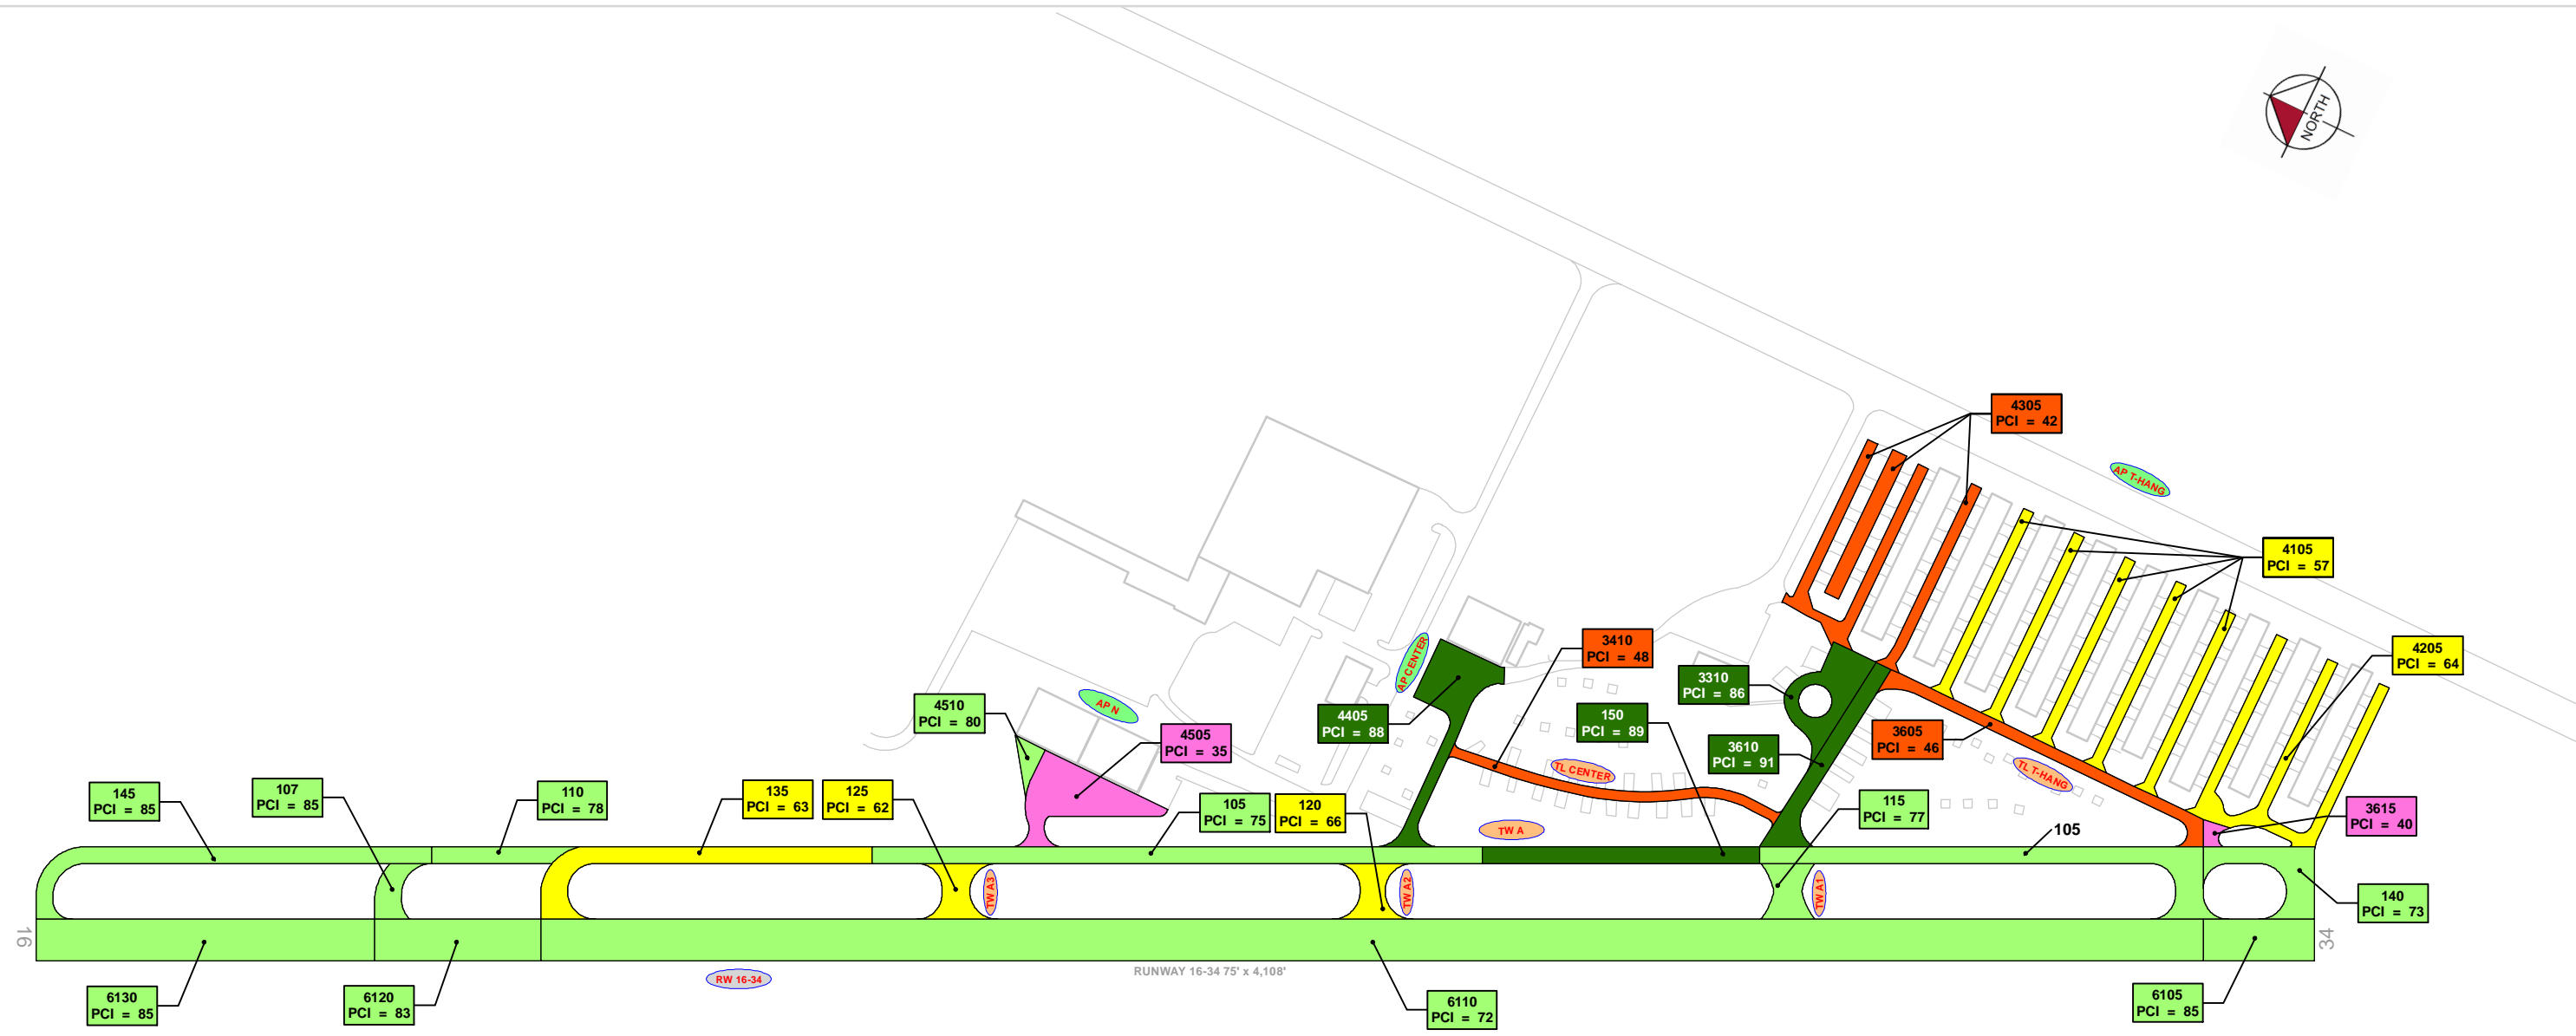
**2022 PAVEMENT CONDITION INDEX**

The Airfield Pavement Condition Index Exhibit is located in **Chapter 4** and **Appendix C**. The Exhibit is a visual summary of the latest conditions reported from the PCI assessment performed at the Airport. Distress analysis occurred in accordance with ASTM D5340-20 (referenced in **Appendix E**), with results being analyzed using PAVER™ software to determine PCI values. The PCI values are identified in the Exhibit and graphically represented using the standard ASTM D5340-20 condition rating categories.
