Statewide Airfield Pavement Management Program

Airport Pavement Evaluation Report

FHB - Fernandina Beach Municipal Airport | *District 2*

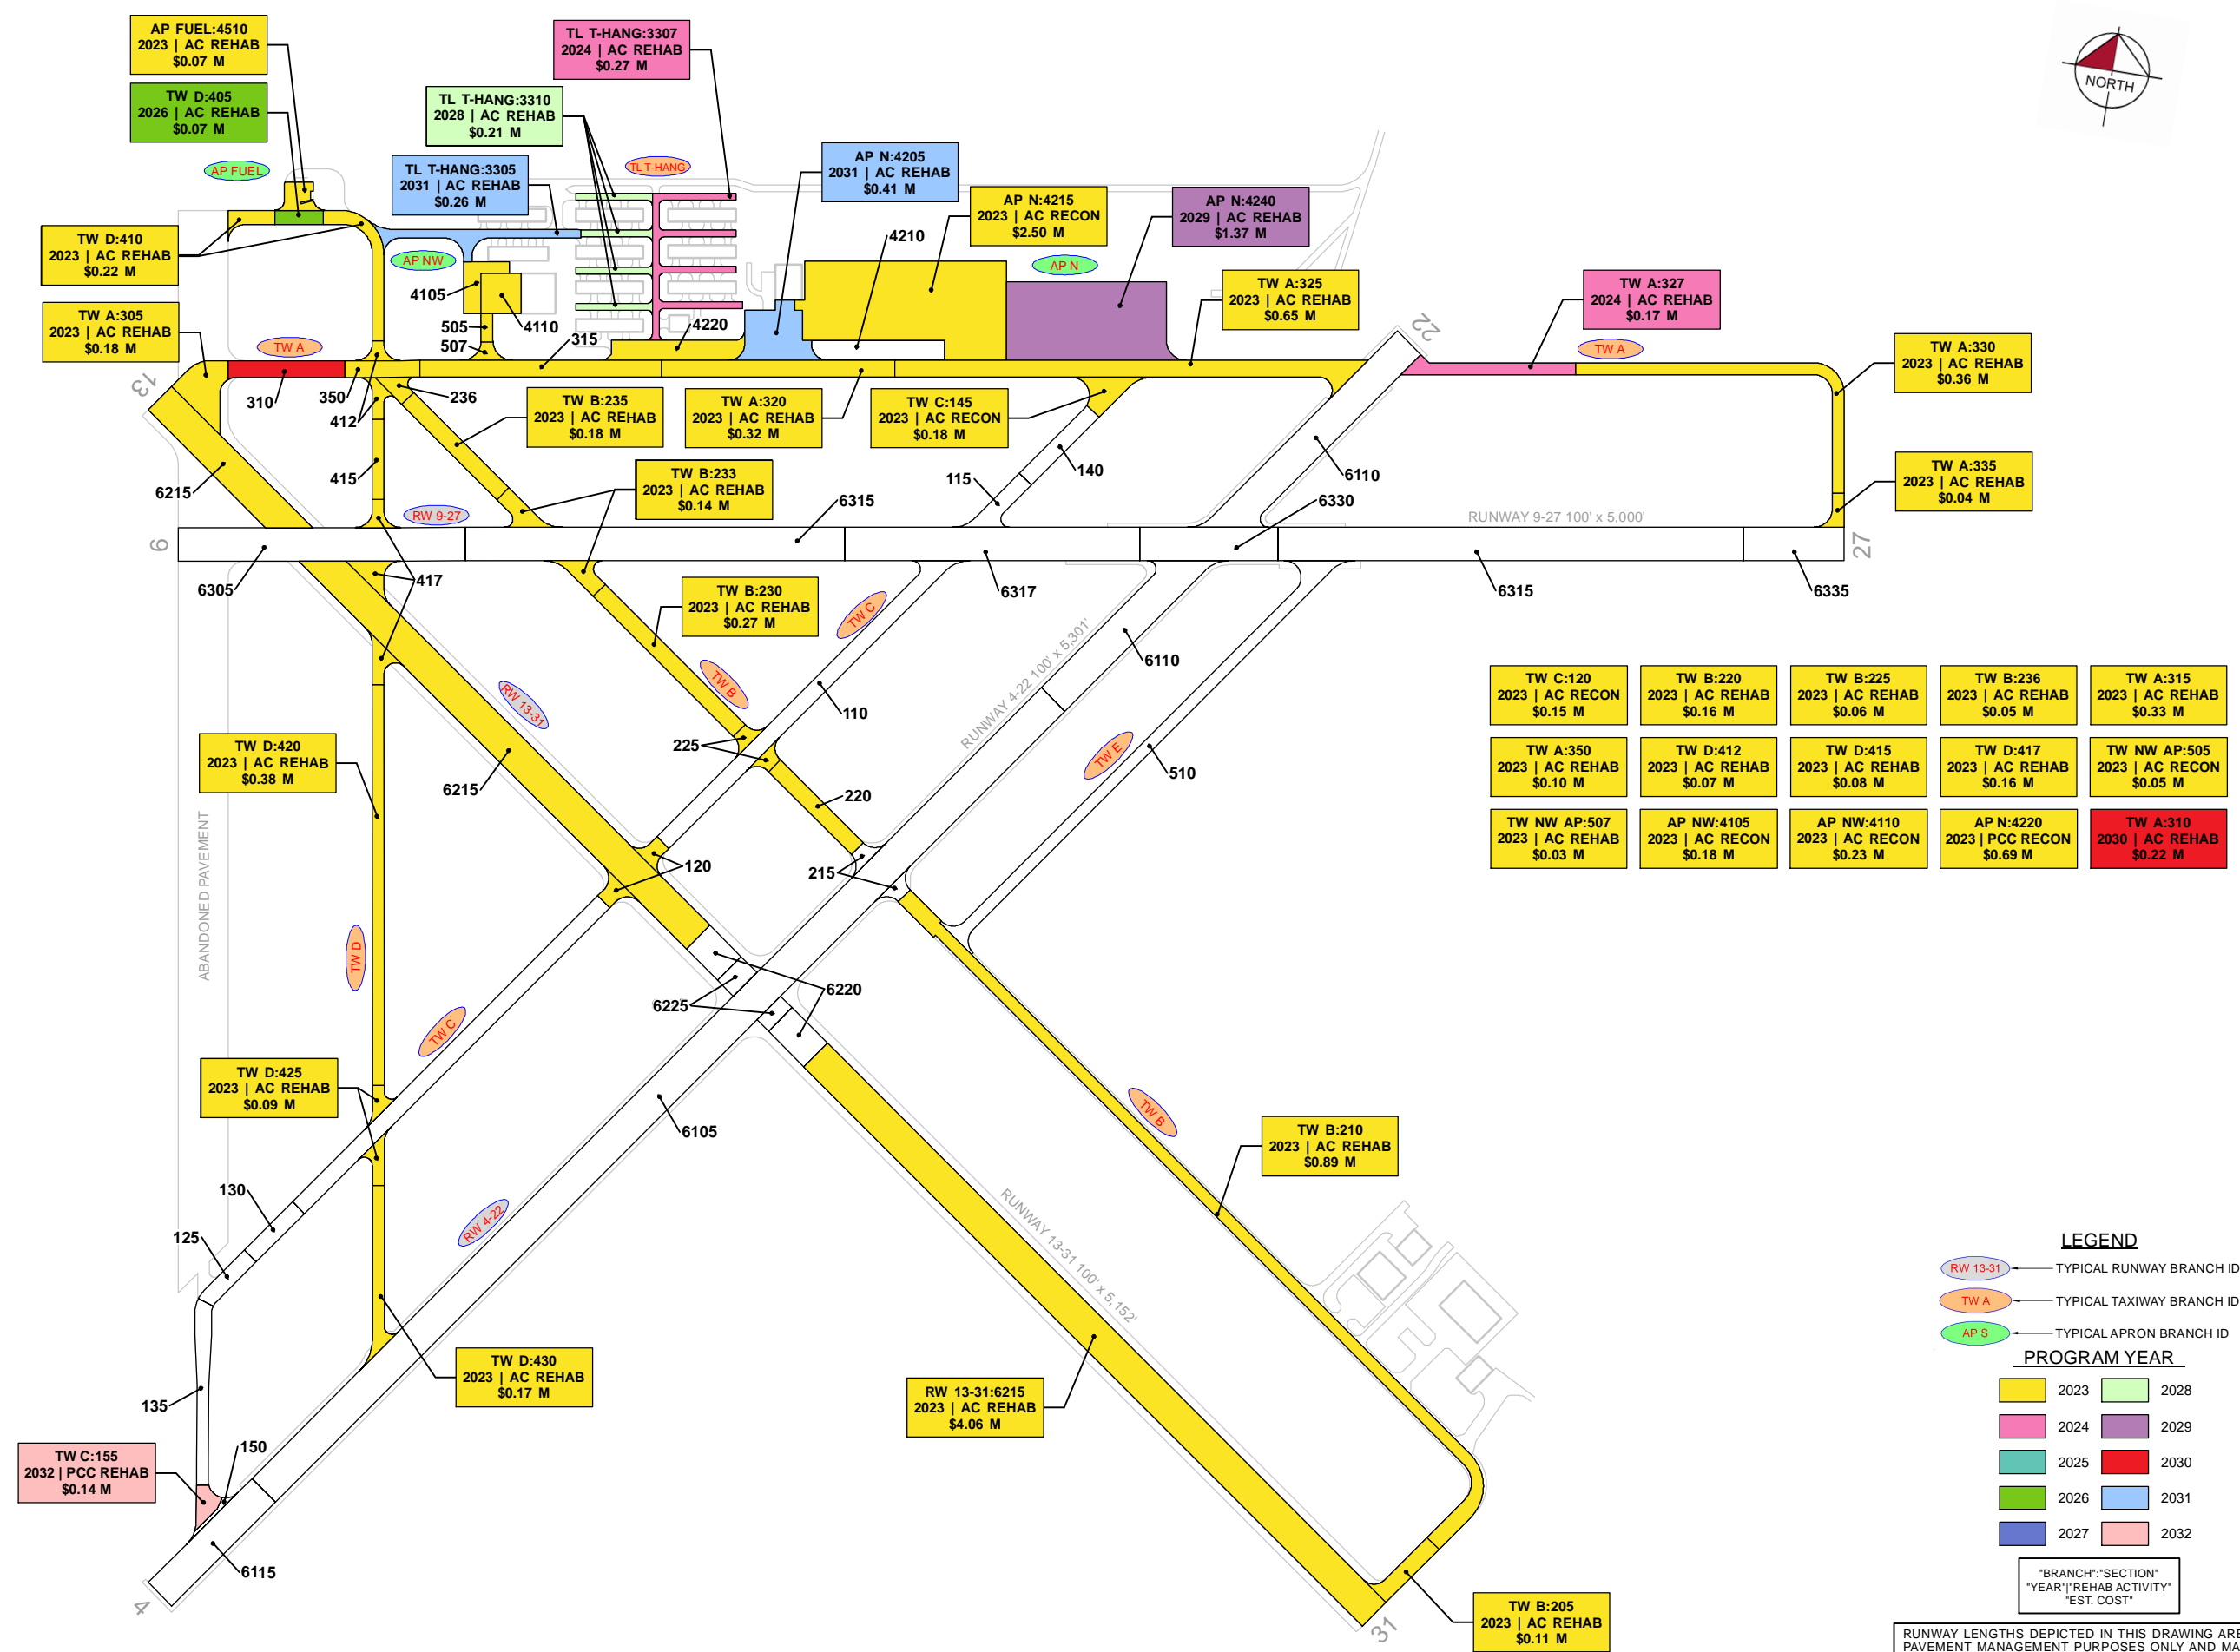
Figure 6.2.1 (a) summarizes the section-level major rehabilitation needs for a 10-year period between 2023 and 2032. **Figure 6.2.1 (b)**, the Airfield Pavement Major Rehabilitation Exhibit, graphically depicts the major rehabilitation needs with rounded costs. As suggested previously, this is planning-level data that can be used by the Airport to support developing a practical CIP.
