Statewide Airfield Pavement Management Program

# Airport Pavement Evaluation Report

LNA - Palm Beach County Park Airport | *District 4*

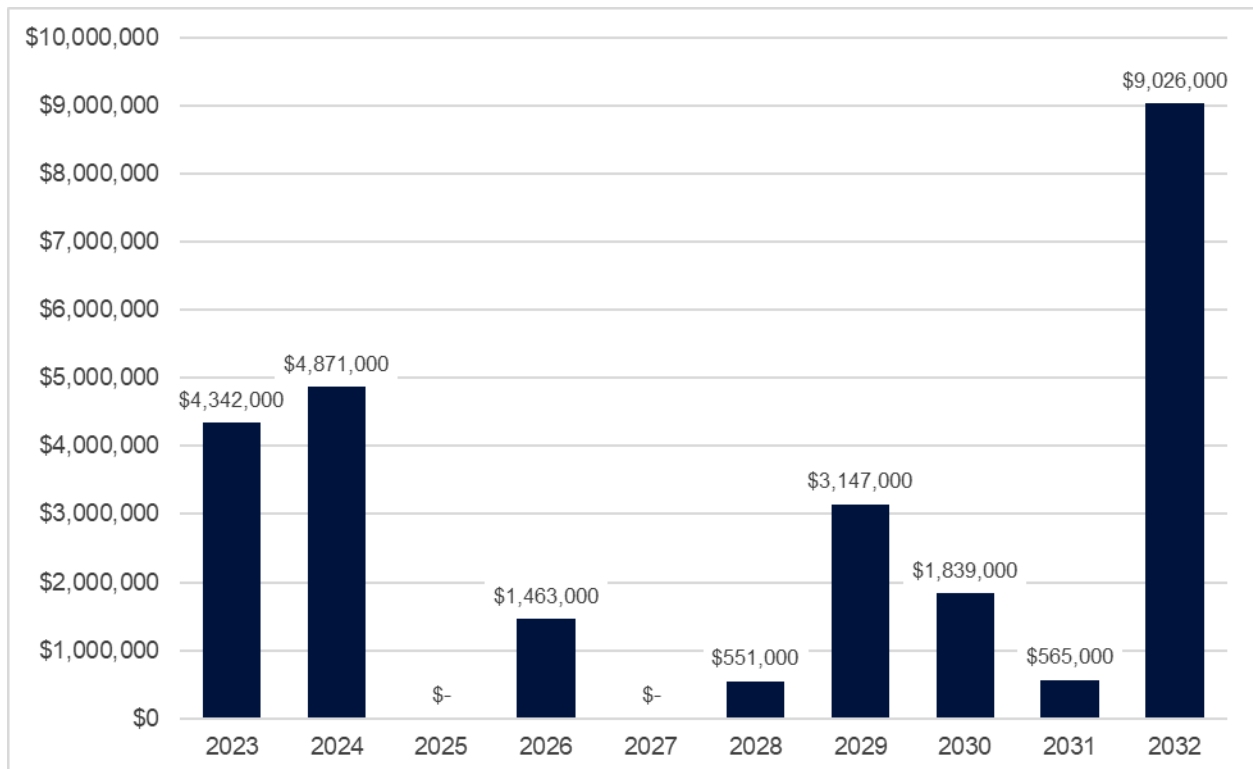
*Figure 6.2.1 (a): 10-Year Major Rehabilitation Needs by Program Year*

**Figure 6.2.1 (a)** summarizes the section-level major rehabilitation needs for a 10-year period between 2023 and 2032. **Figure 6.2.1 (b)**, the Airfield Pavement Major Rehabilitation Exhibit, graphically depicts the major rehabilitation needs with rounded costs. As suggested previously, this is planning-level data that can be used by the Airport to support developing a practical CIP.
