**STATE OF FLORIDA  
DEPARTMENT OF TRANSPORTATION  
AVIATION OFFICE**

**Statewide Airfield Pavement Management Program  
Marianna Municipal Airport  
(General Aviation)  
Marianna, Florida  
(District 3)**

**March 31, 2008**

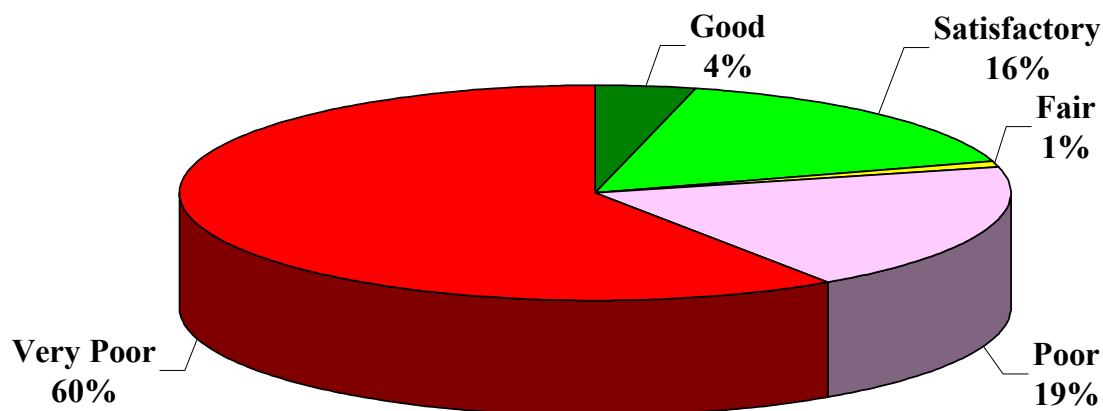
### Network PCI Distribution by Rating Category

The figure below provides the PCI distribution by rating category for the network. Approximately 20% of the network is in Good and Satisfactory condition while 79% of the network is in Poor to Very Poor condition.

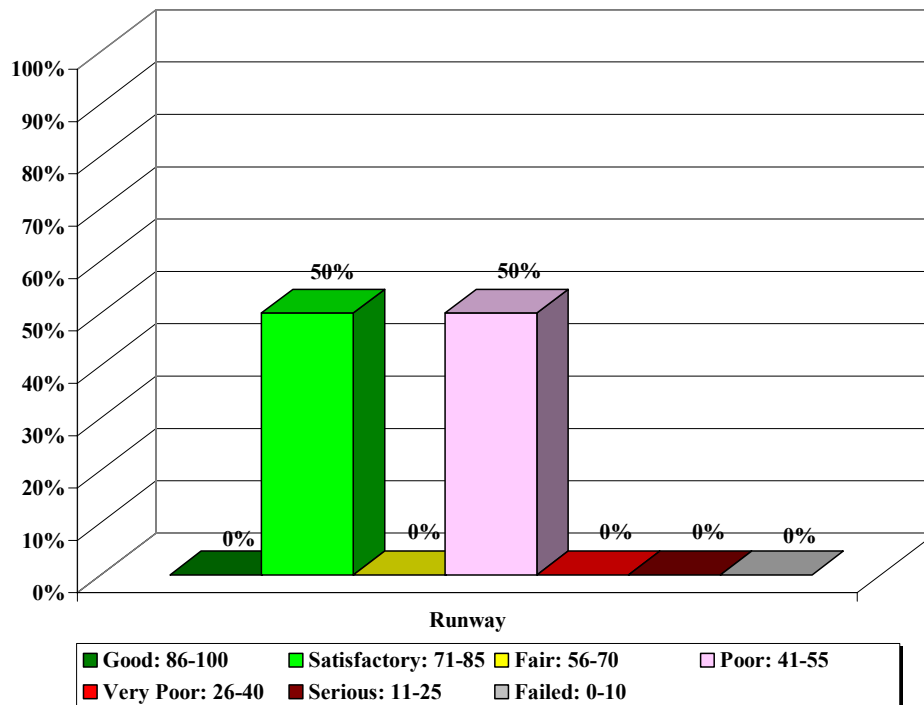
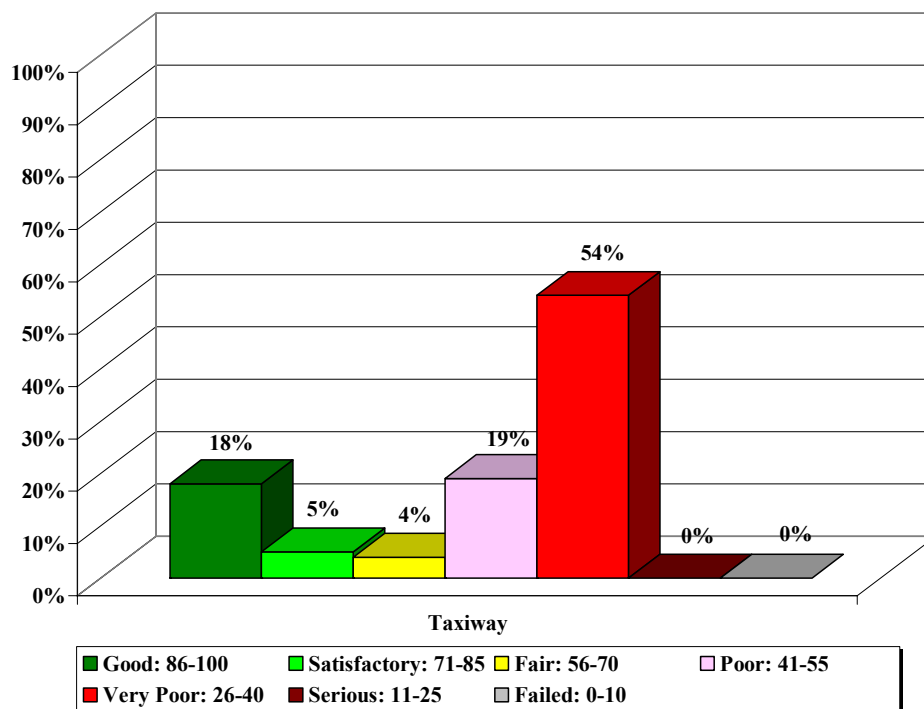
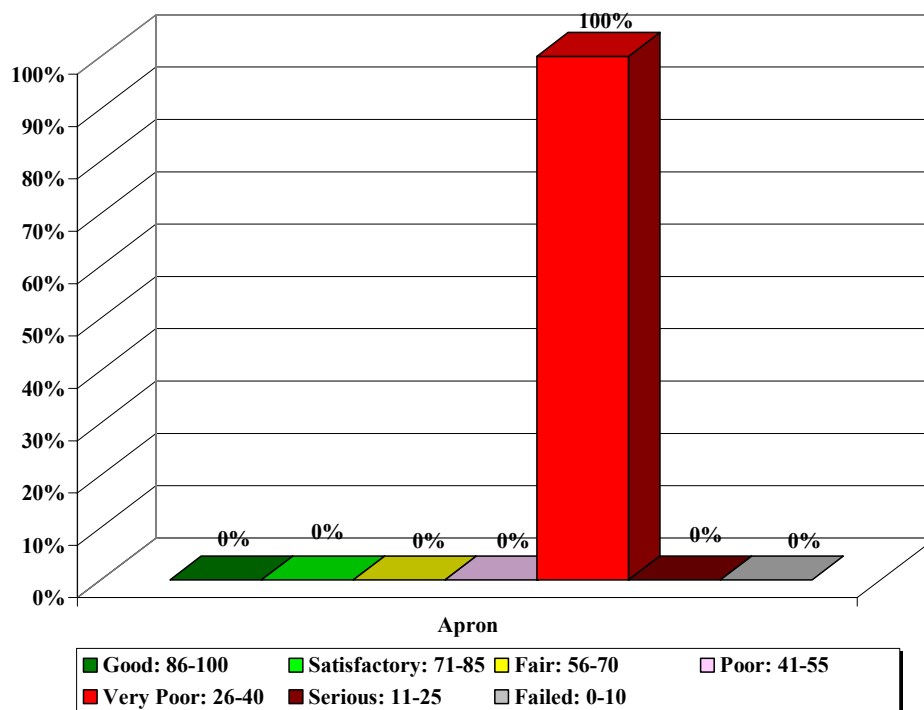
**Figure 4-2: Percentage of Pavement Area within Each PCI Range by Pavement Use**

The condition summary by pavement use table illustrates the area-weighted PCI computed individually for each use. On average, the runways, taxiways, and aprons are in Fair, Poor, and Very Poor condition, respectively.

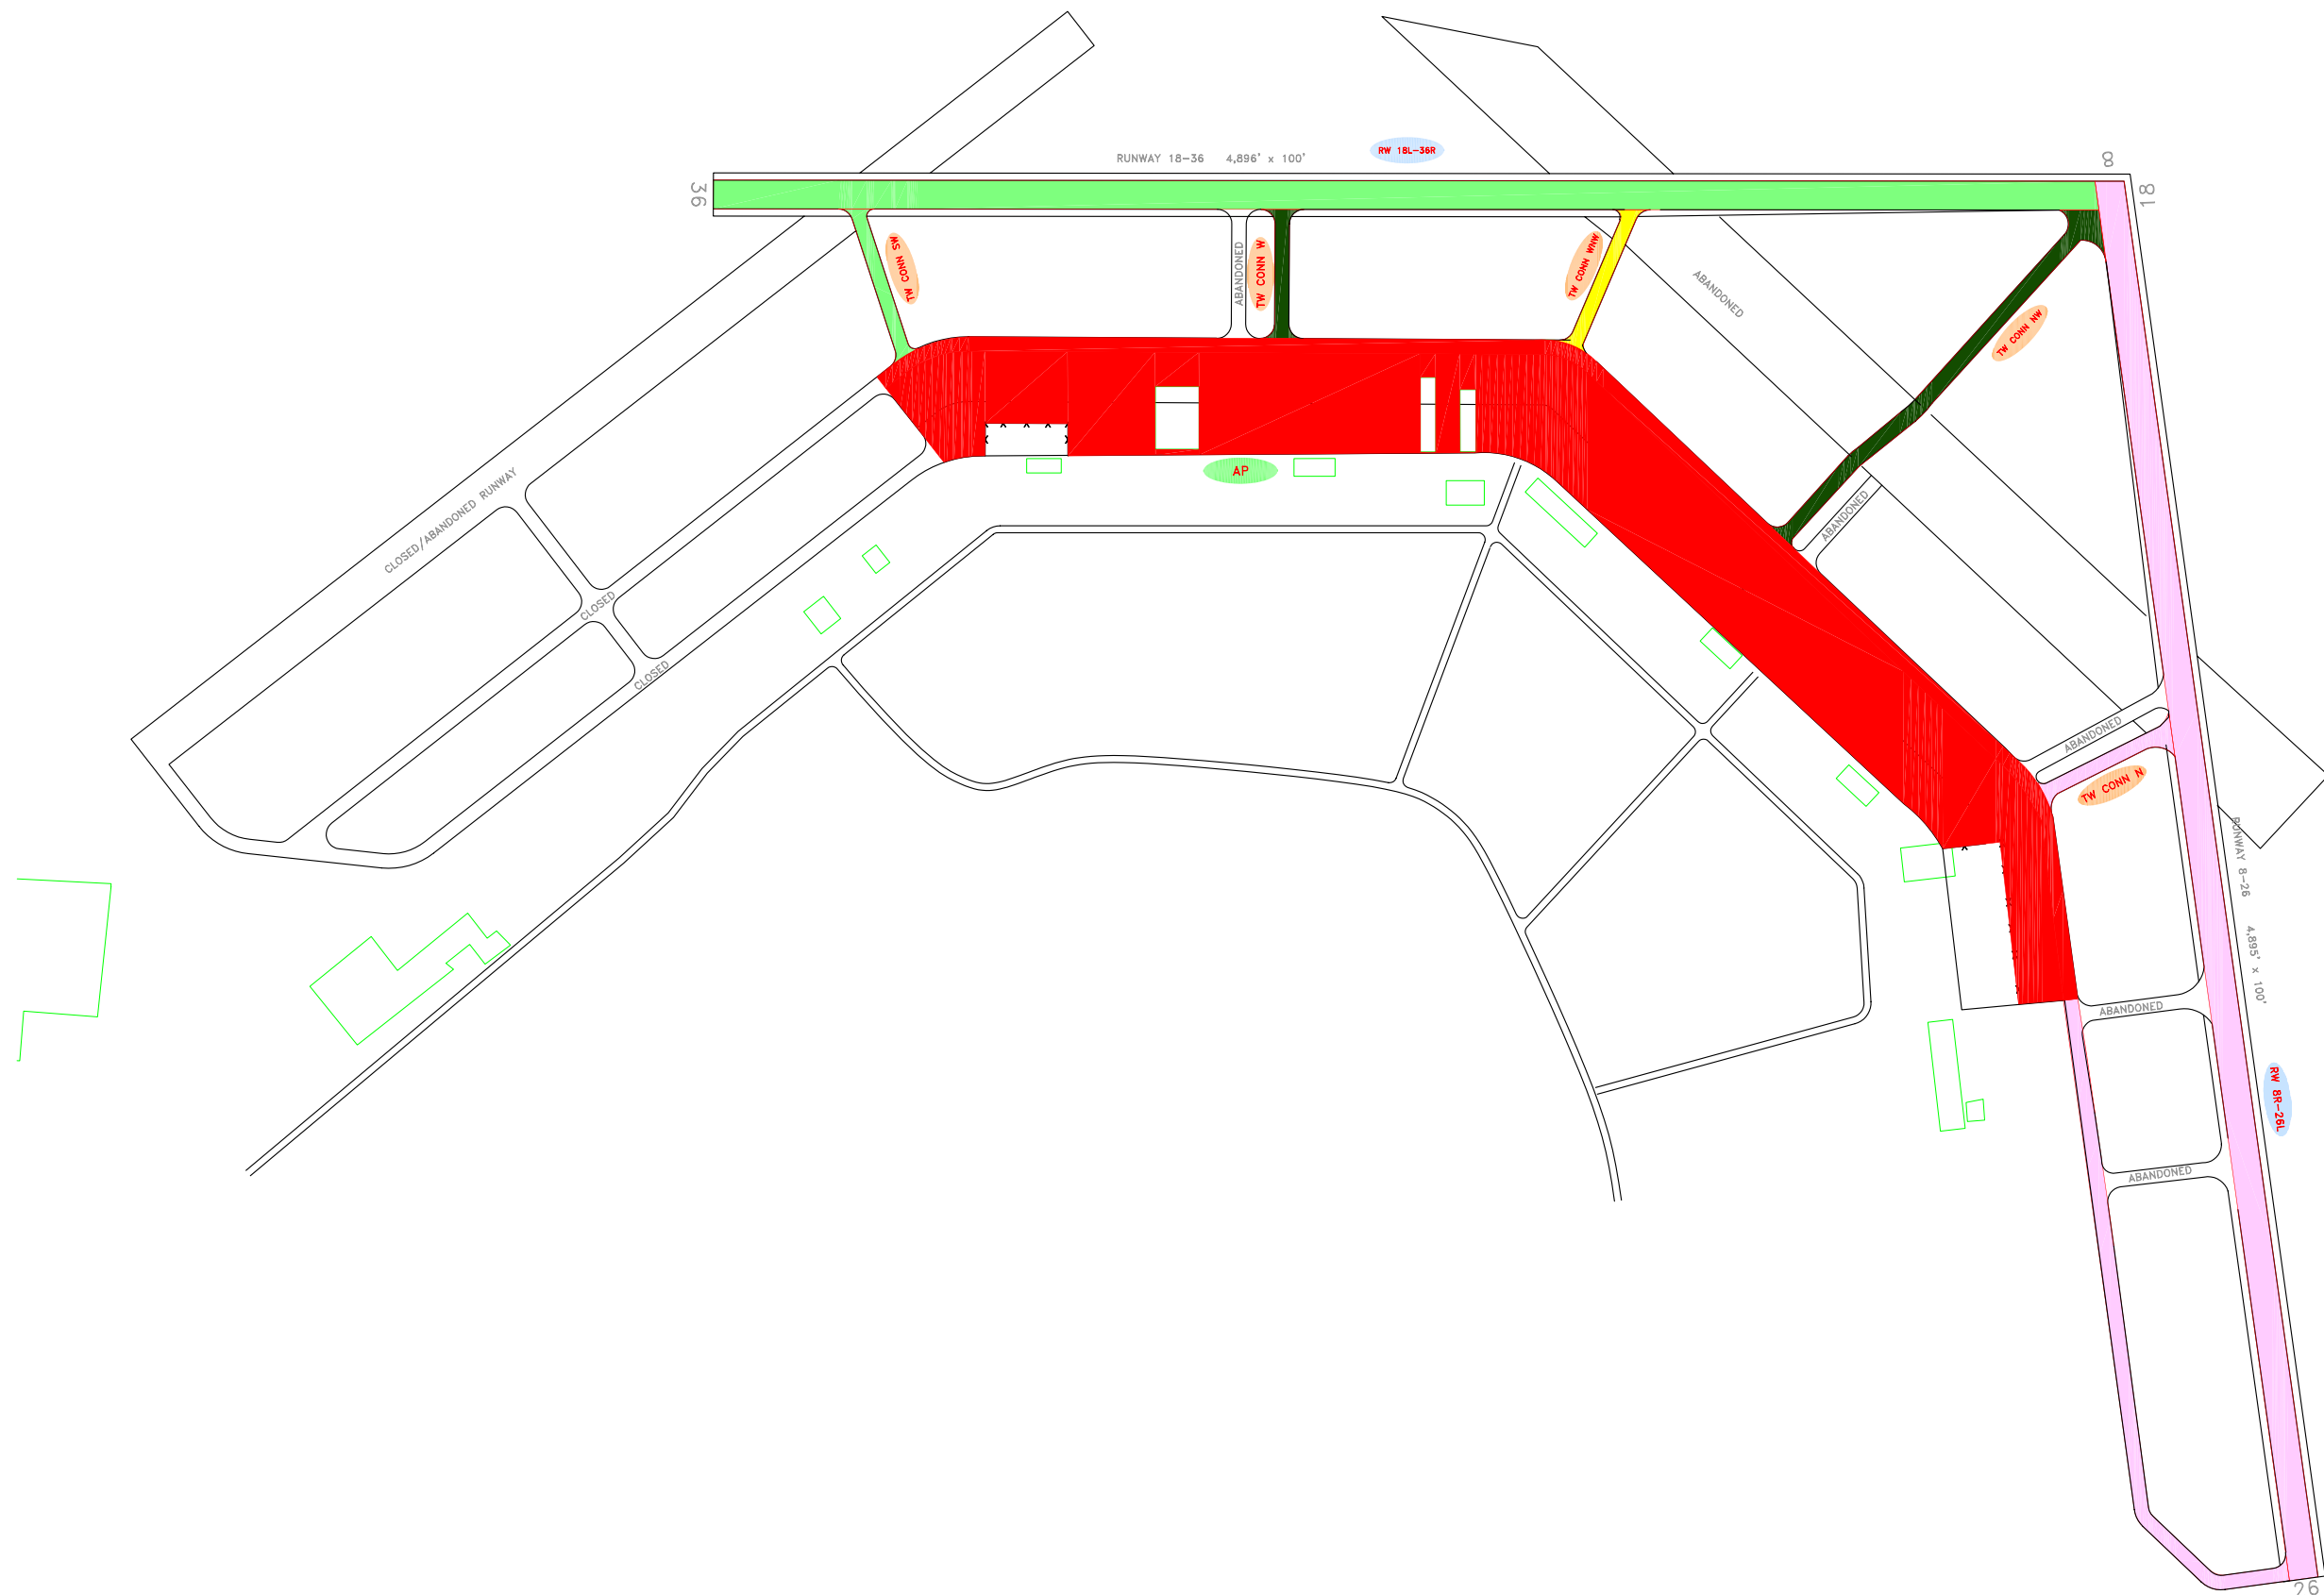
### **2006 CONDITION MAP AND TABLES**

The overall area-weighted Pavement Condition Index (PCI) of the areas in 2006 is 42, representing a Poor overall network condition.
