**STATE OF FLORIDA  
DEPARTMENT OF TRANSPORTATION  
AVIATION OFFICE**

**Statewide Airfield Pavement Management Program  
Merritt Island Airport  
(General Aviation)  
Merritt Island, Florida  
(District 5)**

February 1, 2008

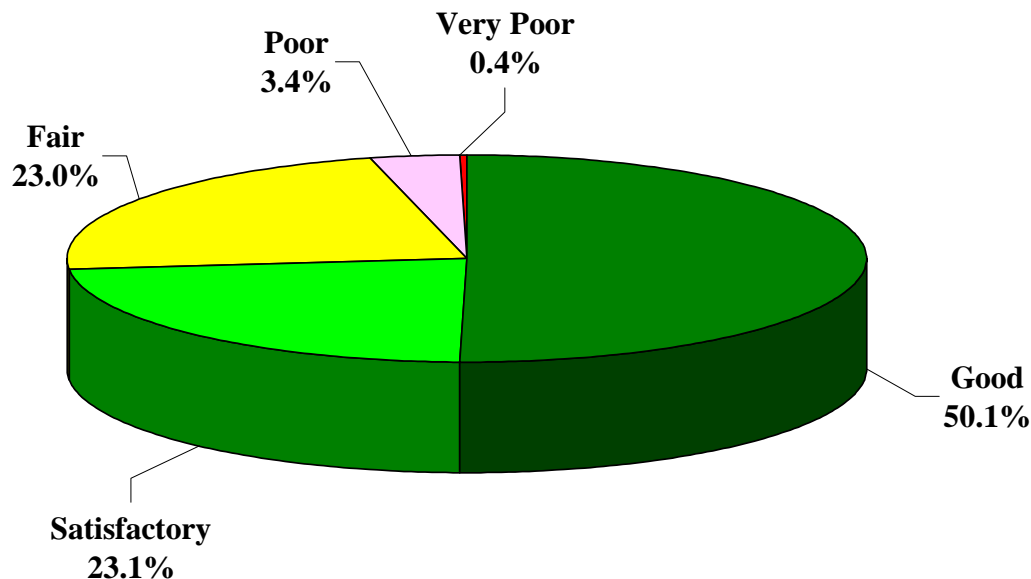
### Network PCI Distribution by Rating Category

The figure below provides the PCI distribution by rating category for the network. Approximately 73% of the network is in Good and Satisfactory condition while 4% of the network is in Poor to Very Poor condition.

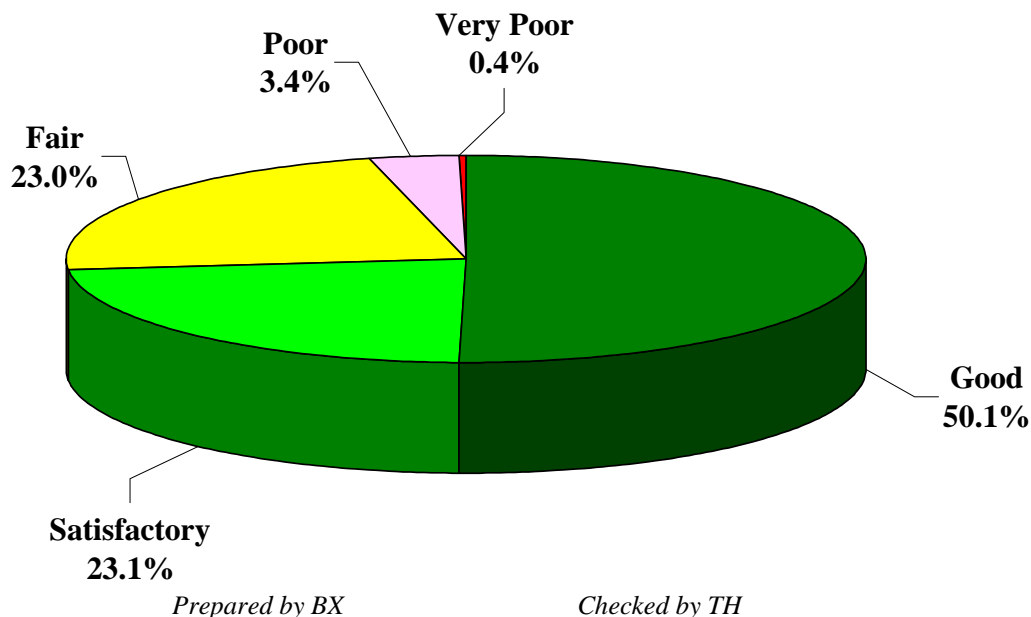
**Figure 4-1: Network PCI Distribution by Rating Category**

Approximately 73% of the network is in Good and Satisfactory condition while 4% of the network is in Poor to Very Poor condition. Table 4-1 illustrates the area-weighted PCI computed individually for each pavement use.

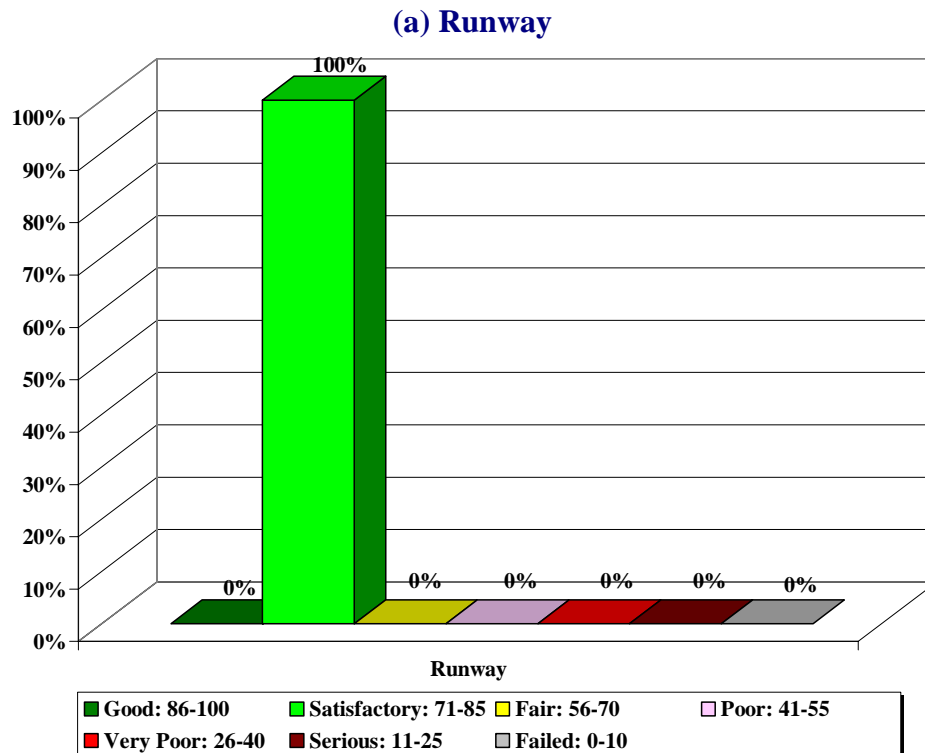
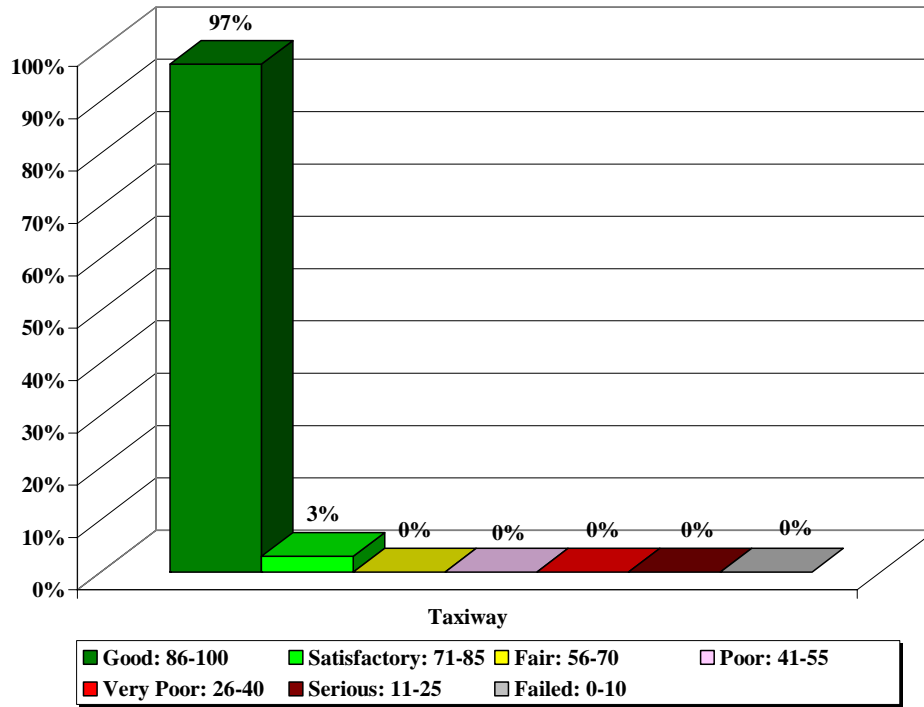
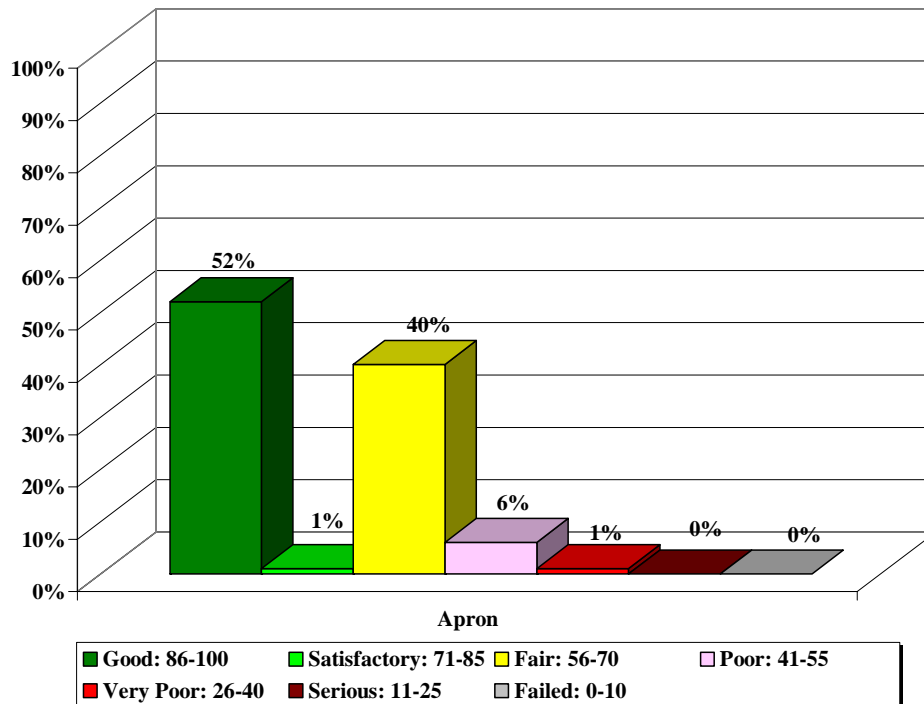
**Figure 4-2: Percentage of Pavement Area within Each PCI Range by Pavement Use**

Figure 4-2 presents the breakdown of PCI by range for each pavement use.

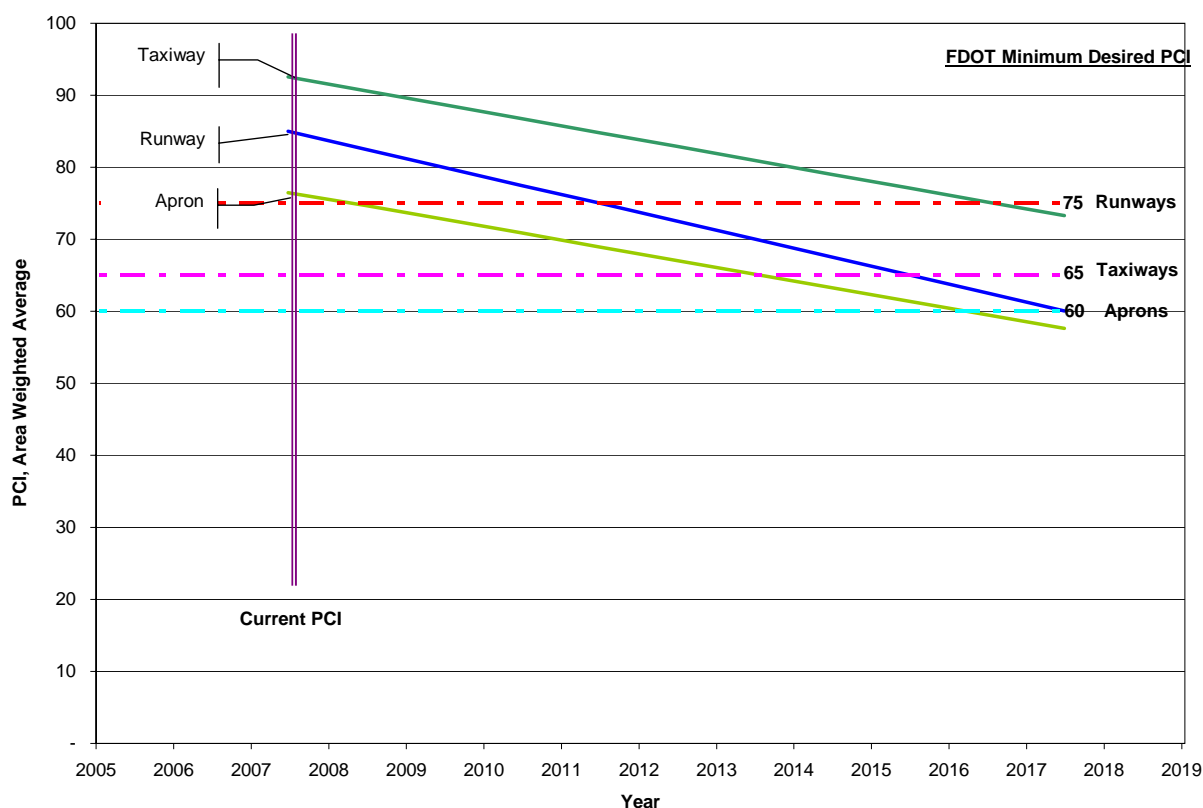
**Figure 5-1: Predicted PCI by Pavement Use**

Performance prediction models or deterioration curves for PCI were used to develop a condition forecast. The performance models were developed for combinations of variables such as pavement use (runway, taxiway or apron), surface type (AC or PCC) and airport category (GA, RL, or PR). Figure 5-1 illustrates the predicted performance of pavements at Merritt Island Airport based on current condition, age since last construction and the deterioration model appropriate for the type of pavement. The figure presents the forecast for each pavement use and displays the FDOT minimum condition criteria for General Aviation (GA) airports.

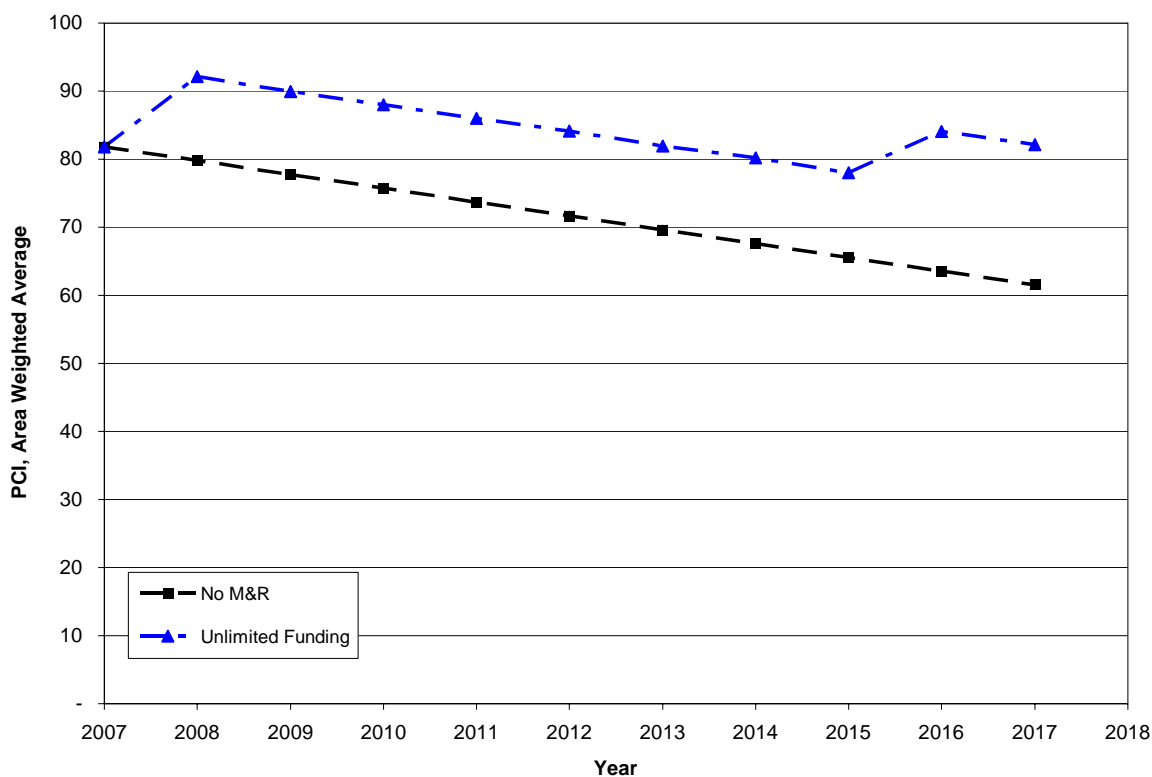
**Figure 7-1: Budget Scenario Analysis**

The 10 year forecast results are shown in Figure 7-1, illustrating the effect on pavement condition (PCI) of doing no maintenance versus having unlimited funds and performing all M&R actions based on the policies.
