**STATE OF FLORIDA
DEPARTMENT OF TRANSPORTATION
AVIATION OFFICE**

**Statewide Airfield Pavement Management Program
Dade-Collier Training and Transition Airport – TNT
(General Aviation)
Miami, Florida
(District 6)**

February 26, 2008

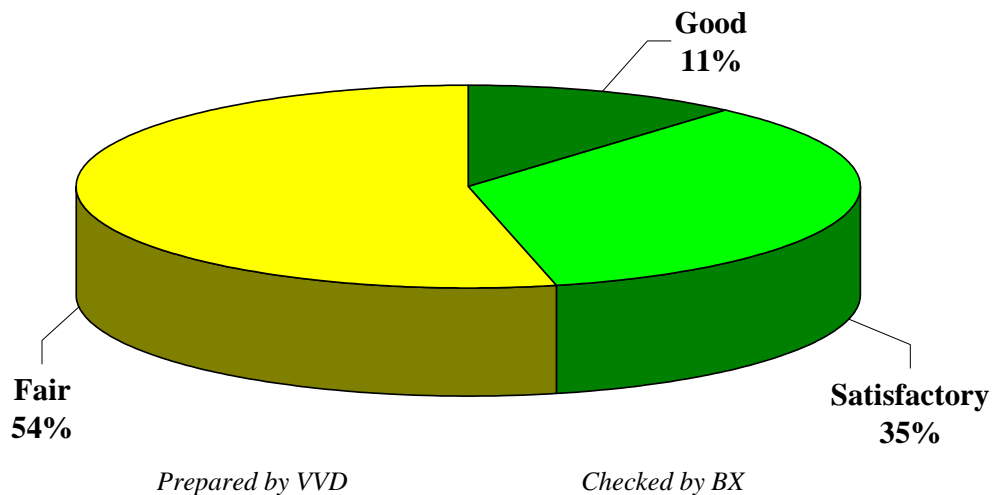
Network PCI Distribution by Rating Category

The figure below provides the PCI distribution by rating category for the network. Approximately 46% of the network is in Good and Satisfactory condition while 54% of the network is in Fair condition.

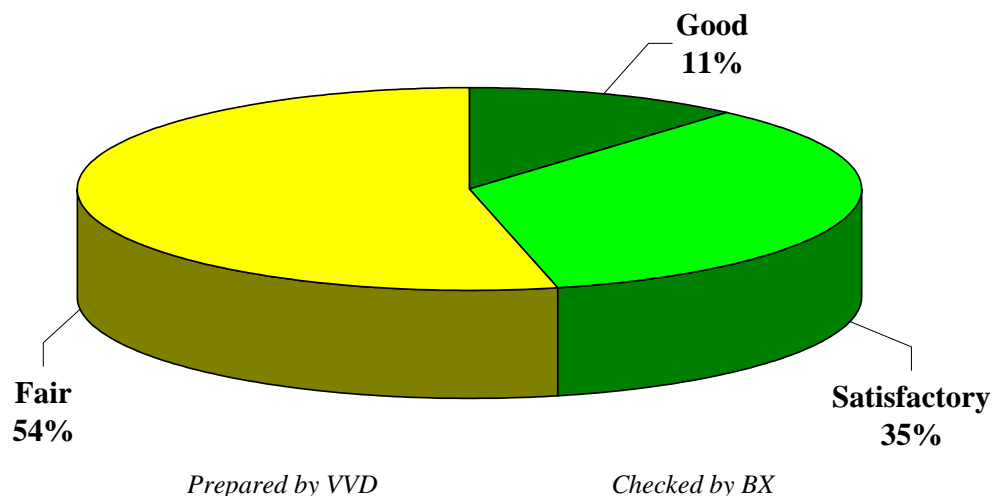
Figure 4-1: Network PCI Distribution by Rating Category

Approximately 46% of the network is in Good and Satisfactory condition while 54% of the network is in Fair condition. Table 4-1 illustrates the area-weighted PCI computed individually for each pavement use.

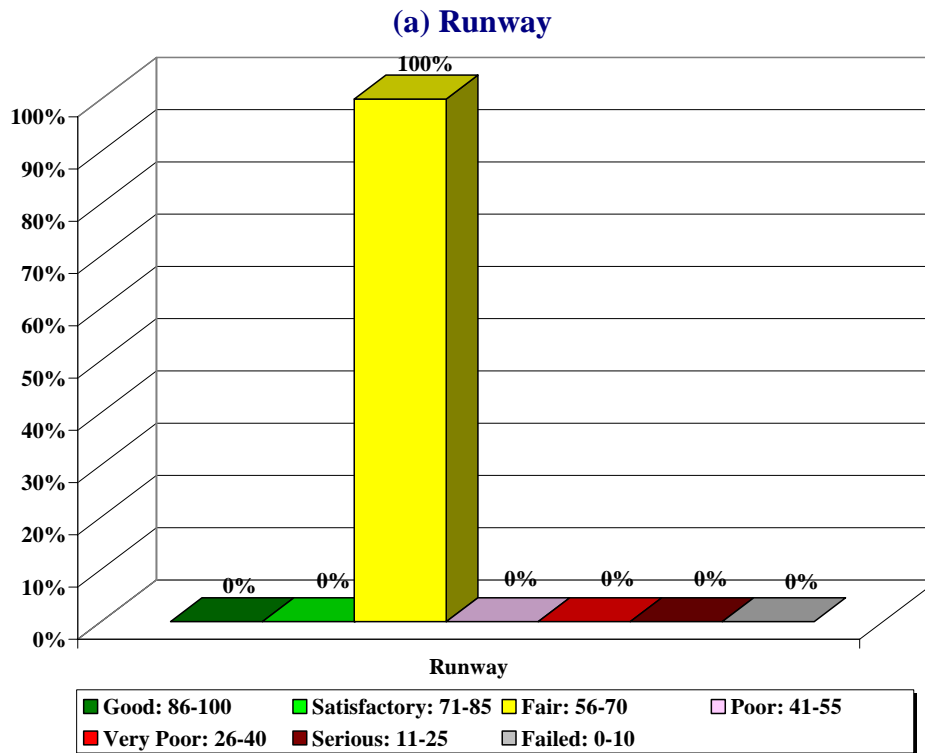
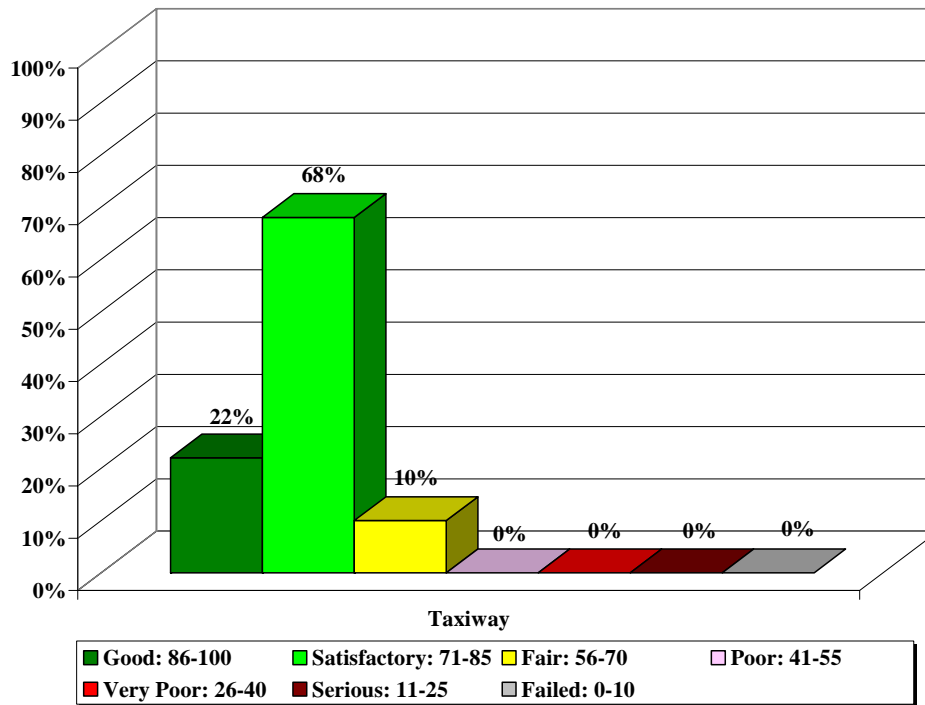
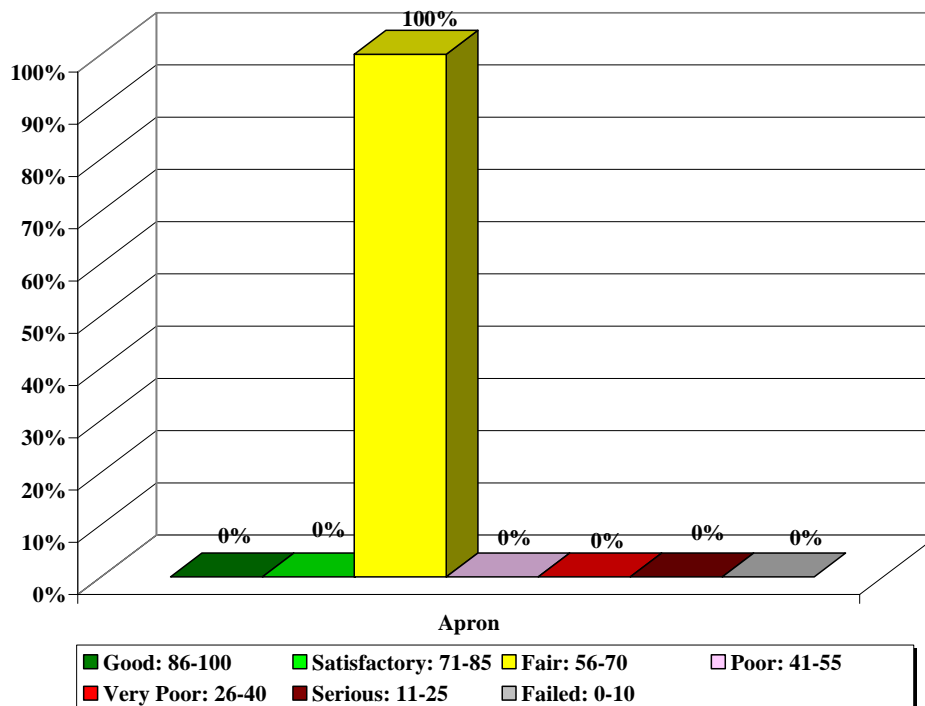
Figure 4-2: Percentage of Pavement Area within Each PCI Range by Pavement Use

Figure 4-2 presents the breakdown of PCI by range for each pavement use.
