**STATE OF FLORIDA  
DEPARTMENT OF TRANSPORTATION  
AVIATION OFFICE**

**Statewide Airfield Pavement Management Program  
Lake City Municipal Airport – LCQ  
(General Aviation)  
Lake City, Florida  
(District 2)**

**March 17, 2008**

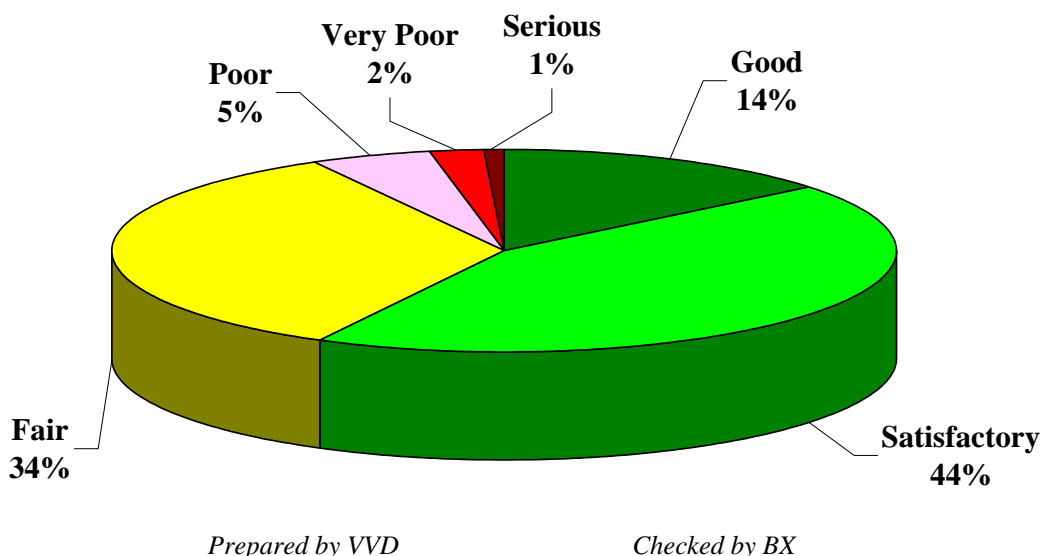
**Figure 4-1: Network PCI Distribution by Rating Category**

Approximately 58% of the network is in Good and Satisfactory condition while 8% of the network is in Poor to Serious condition. Table 4-1 illustrates the area-weighted PCI computed individually for each pavement use.

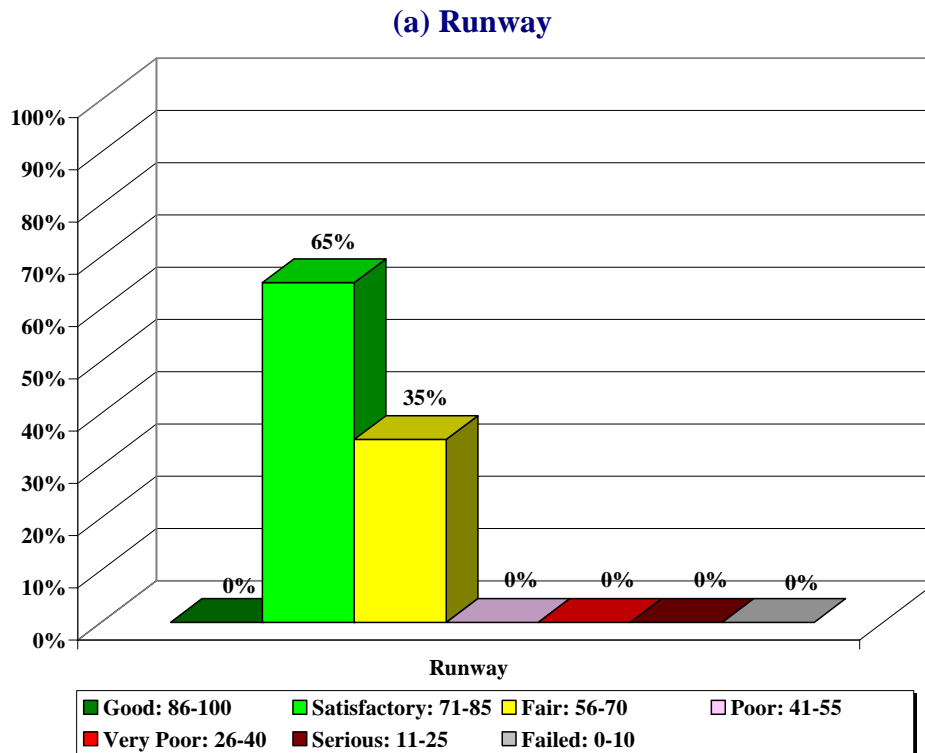
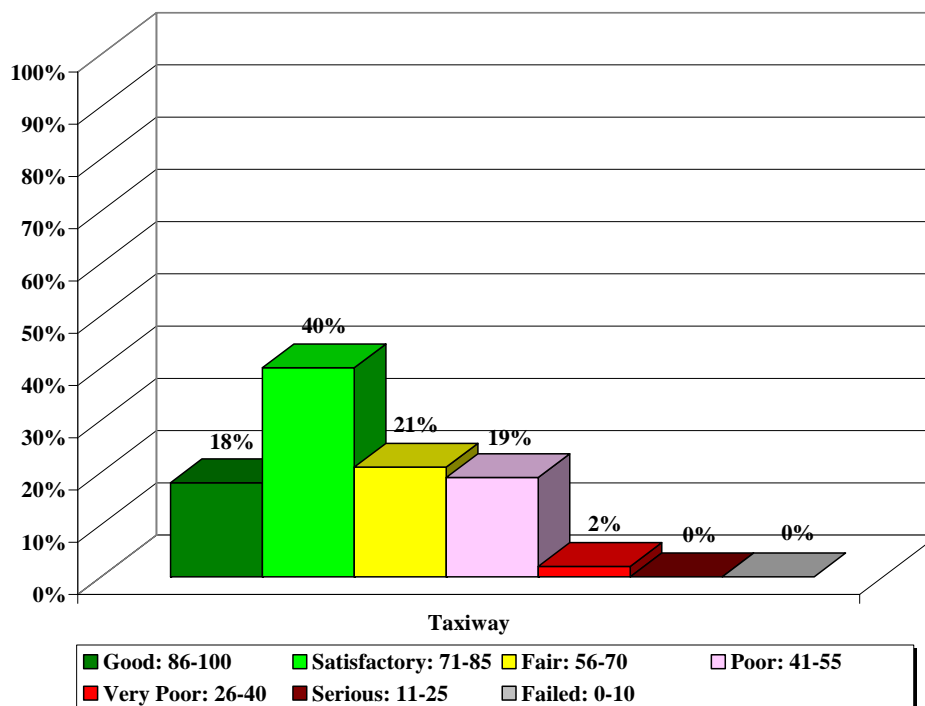
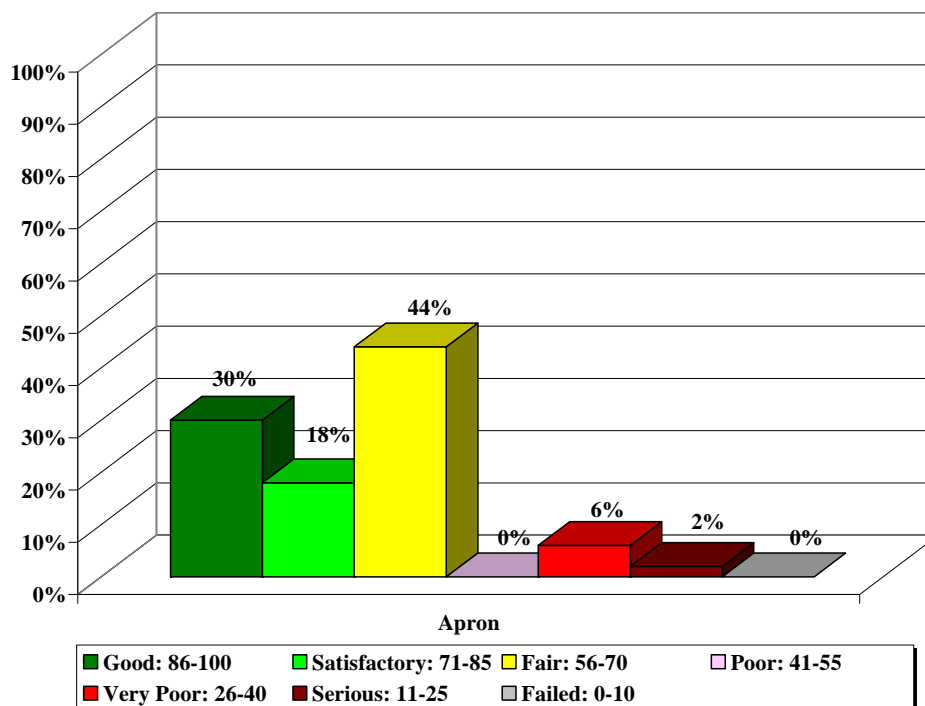
**Figure 4-2: Percentage of Pavement Area within Each PCI Range by Pavement Use**

Figure 4-2 presents the breakdown of PCI by range for each pavement use.

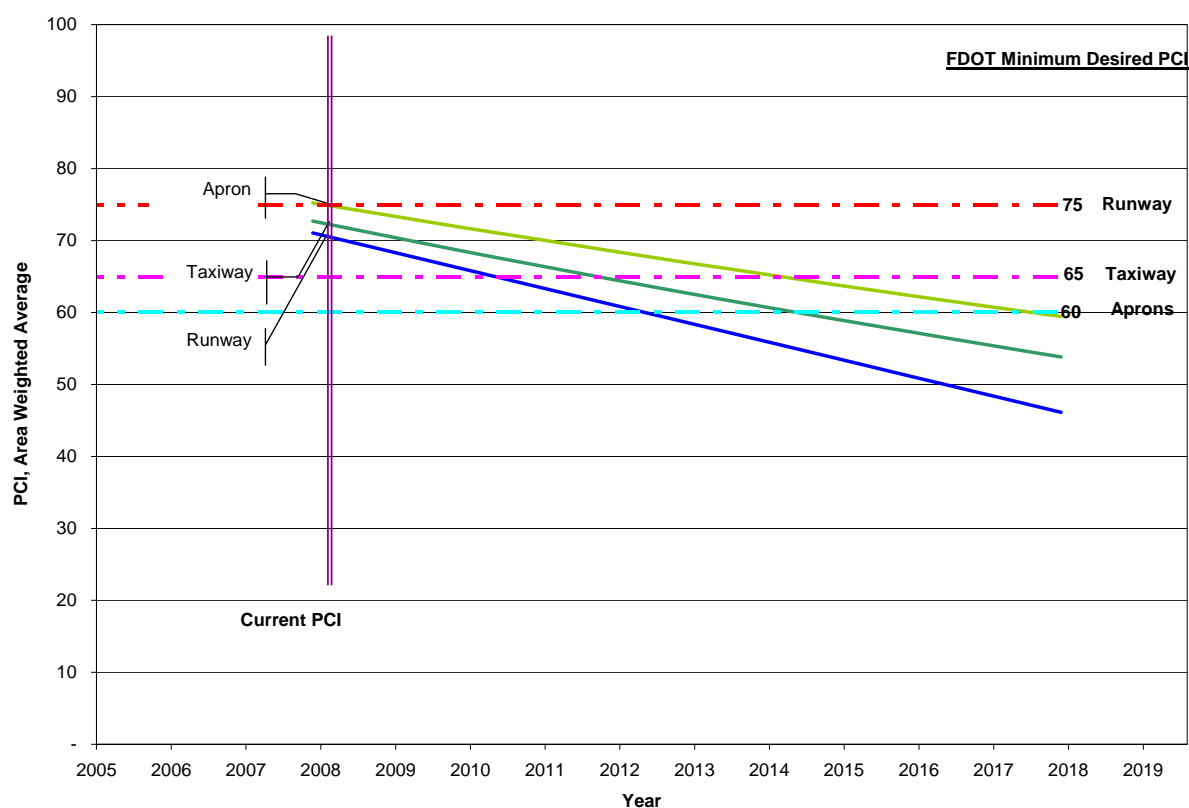
**Figure 5-1: Predicted PCI by Pavement Use**

Performance prediction models or deterioration curves for PCI were used to develop a condition forecast. The performance models were developed for combinations of variables such as pavement use (runway, taxiway or apron), surface type (AC or PCC) and airport category (GA, RL, or PR). Figure 5-1 illustrates the predicted performance of pavements at Lake City Municipal Airport based on current condition, age since last construction and the deterioration model appropriate for the type of pavement. The figure presents the forecast for each pavement use and displays the FDOT minimum condition criteria for General Aviation (GA) airports.

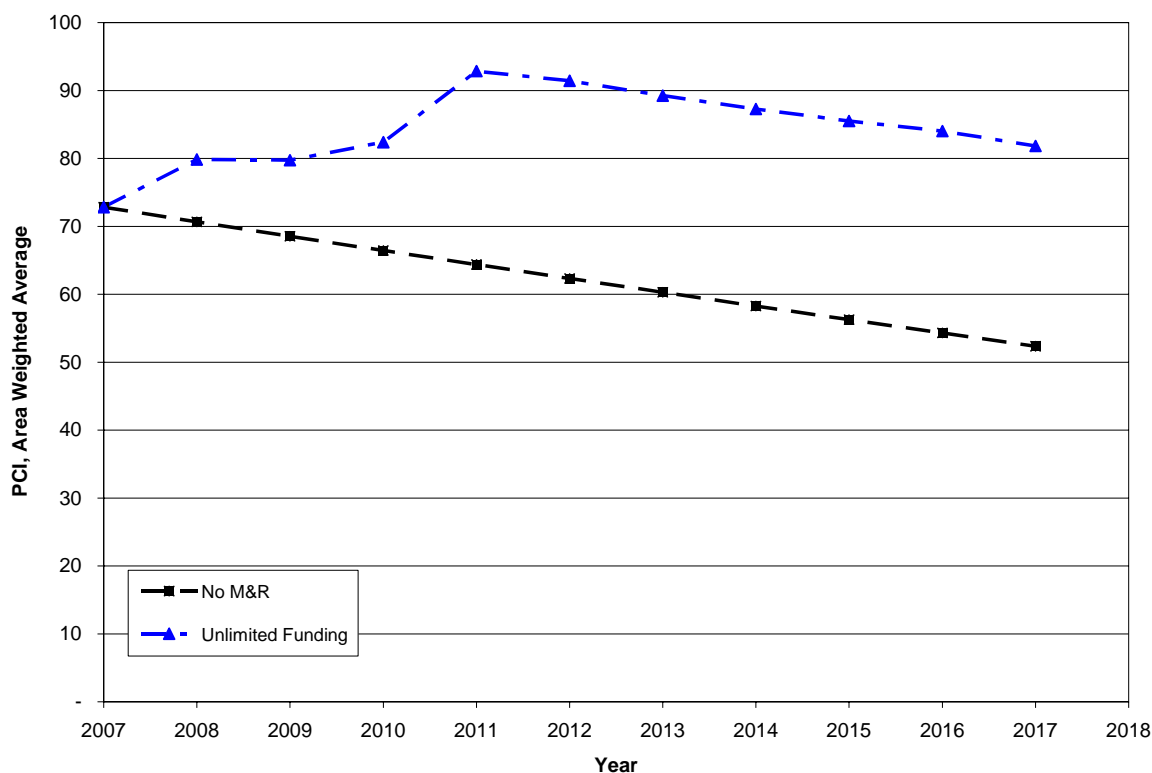
**Figure 7-1: Budget Scenario Analysis**

The 10 year forecast results are shown in Figure 7-1, illustrating the effect on pavement condition (PCI) of doing no maintenance versus having unlimited funds and performing all M&R actions based on the policies.
