FLORIDA DEPARTMENT OF TRANSPORTATION
AVIATION AND SPACEPORTS OFFICE

**Statewide Airfield
Pavement Management Program**

DISTRICT

NOVEMBER 2019

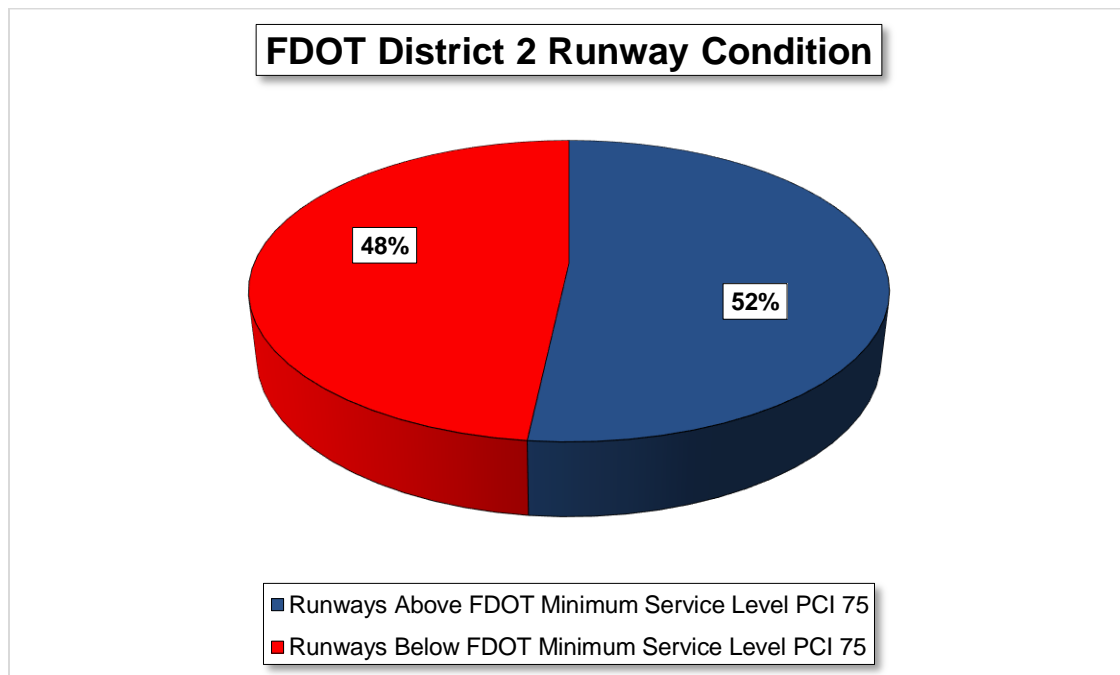
Figure E-3 Runway Condition

| Network ID | Airport Type | Branch ID | Branch Name | Length (Feet) | Width (Feet) | Area-Weighted PCI | PCI Rating | Below FDOT Minimum PCI of 75 |
|---|---|---|---|---|---|---|---|---|
| X60 | GA | RW 5-23 | RUNWAY 5-23 | 6,669 | 100 | 53 | POOR | X |

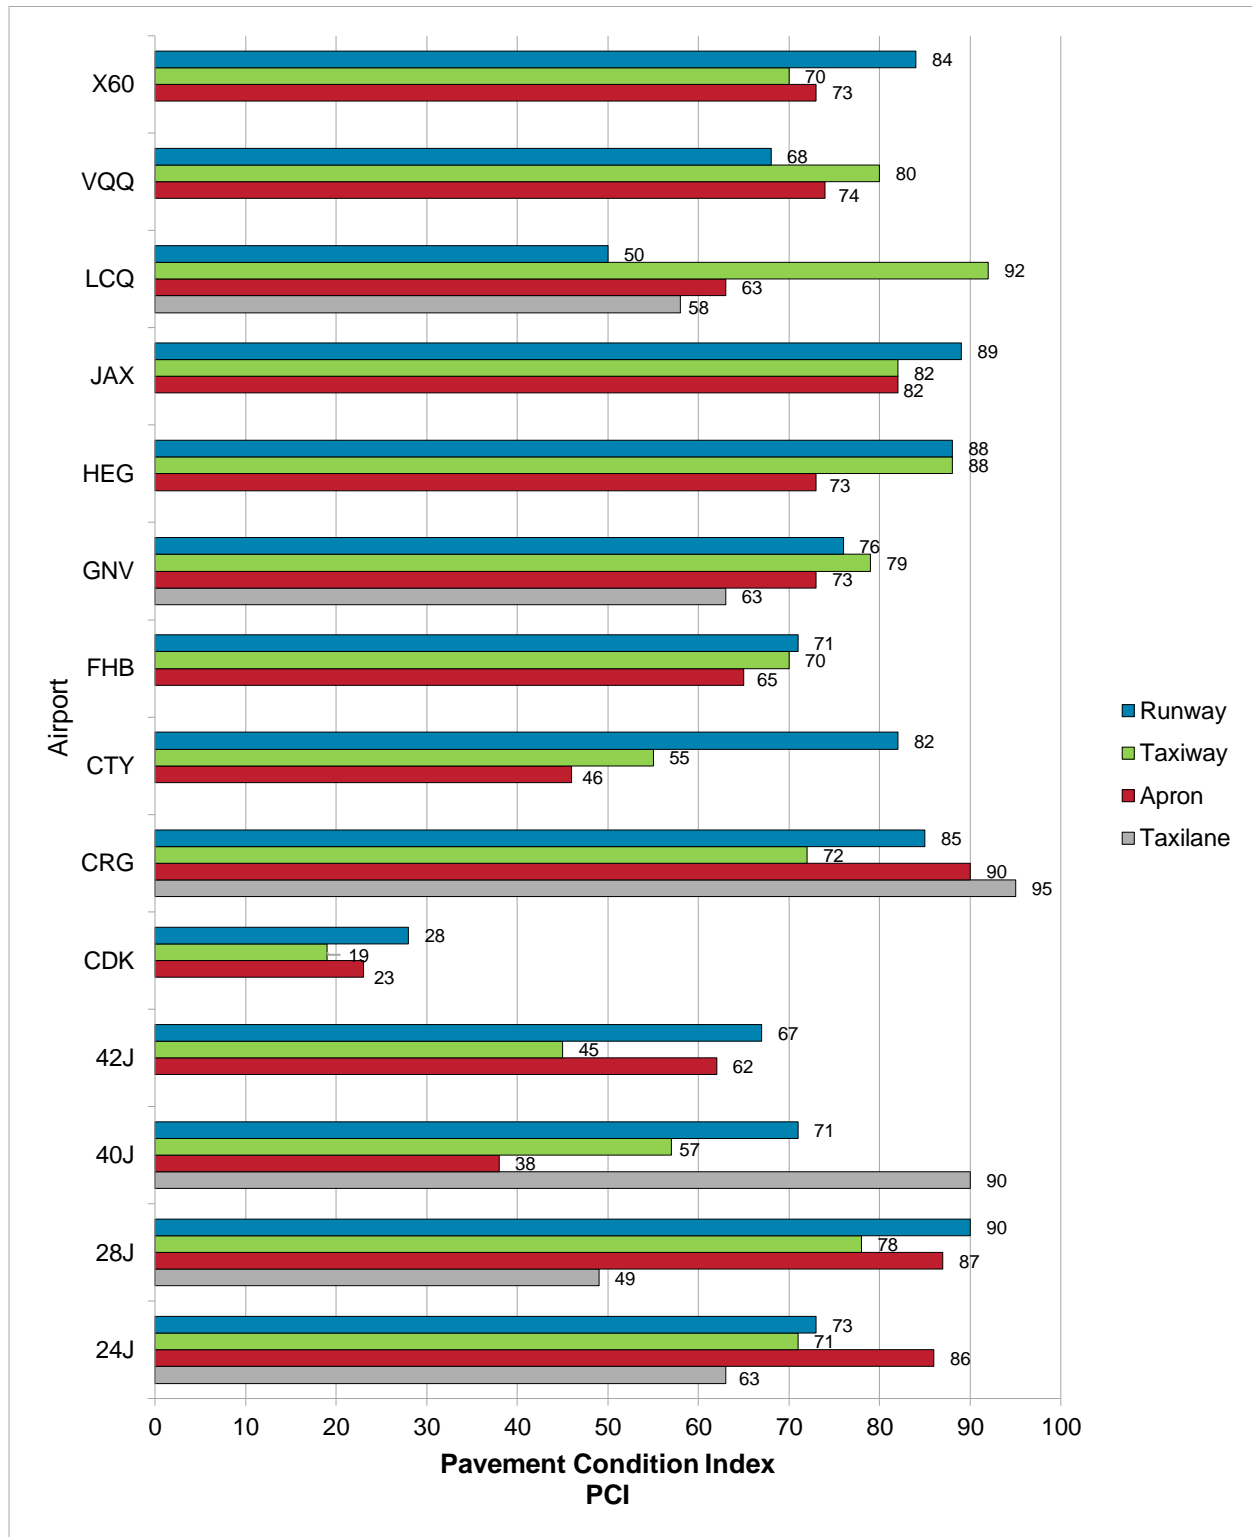
Figure 4.1.2 (a) PCI by Pavement Functional Use by Airport

Pavements are subject to varying aircraft loading patterns based on utilization and overall operations. For this SAPMP Update, the following categories of airfield functional use have been identified and associated with the following possible pavement branch facilities: Apron, Runway, Taxiway, and Taxilane. **Figure 4.1.2 (a)** graphically depicts the PCI for each pavement functional use (Apron, Runway, Taxiway, and Taxilane) at each participating airport within the District. The pavement areas reviewed exclude shoulder pavement facilities. Separately, **Figure 4.1.2 (b)** depicts the District's area-weighted PCI for each pavement functional use.

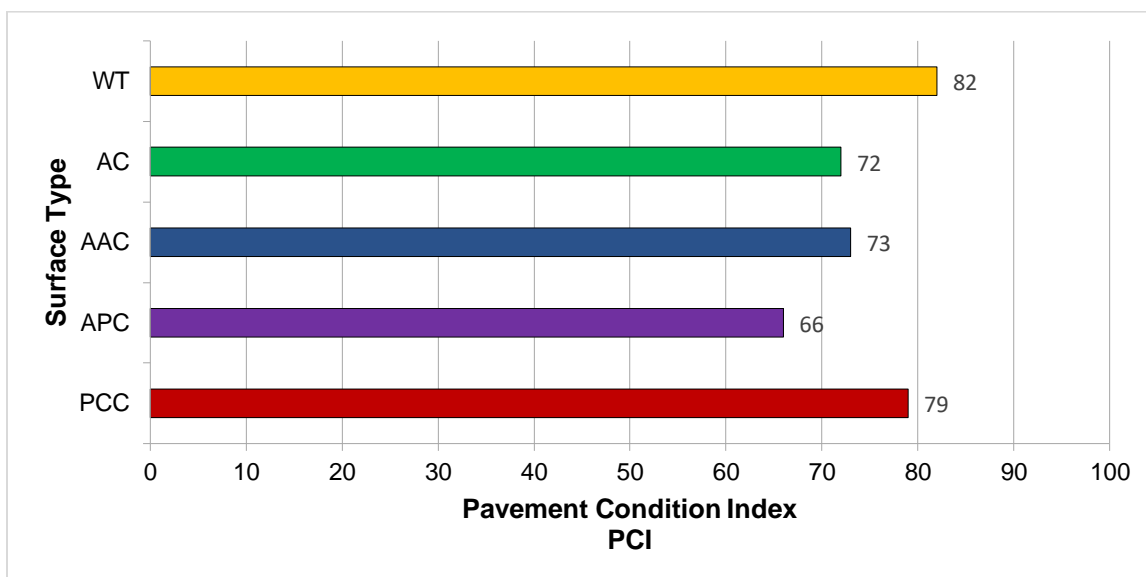
Figure 4.1.3 PCI by Pavement Surface Type

Pavement facility surface types considered for the SAPMP update consist of the four common types within the Florida Airport System: Portland Cement Concrete (PCC), Asphalt Concrete Overlaid on Portland Cement Concrete Pavement (APC), Asphalt Concrete Pavement (AC), and Asphalt Concrete Overlaid on Asphalt Concrete (AAC). **Figure 4.1.3** summarizes the PCI determined based on the various pavement types within the participating District airports. Whitetopping, a composite pavement type that consists of a thin concrete overlay on asphalt concrete pavement exists at certain airports within the Florida Airport System and is discussed within the specific individual airport pavement evaluation report document for those airports.
