STATE OF FLORIDA DEPARTMENT OF TRANSPORTATION AVIATION OFFICE

Statewide Airfield Pavement Management Program

Pensacola Gulf Coast Regional Airport– PNS (Primary Airport) Pensacola, Florida (District 3)

March 2012

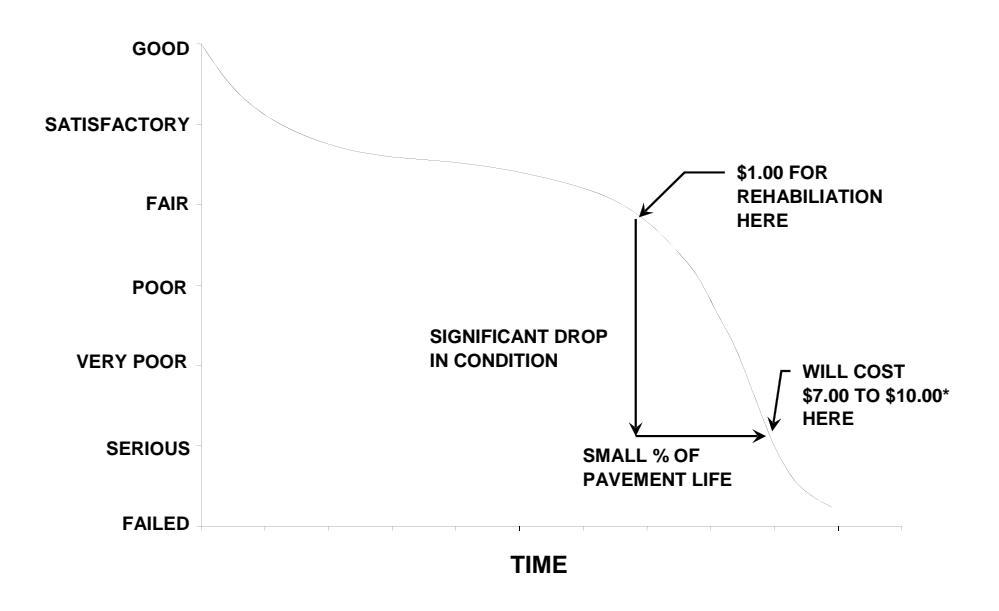
Figure 1-1: Pavement Life Cycle

Pavements deteriorate at an accelerated rate with increasing traffic and limited M&R resources. Planned maintenance and rehabilitation, essentially preventing pavements from reaching deteriorated conditions, helps managers/owners/agencies maximize the use of their budgets and prolong the life of the pavements. A PMS provides a tool to schedule and plan maintenance and rehabilitation based on engineering information and existing and predicted conditions of pavements.

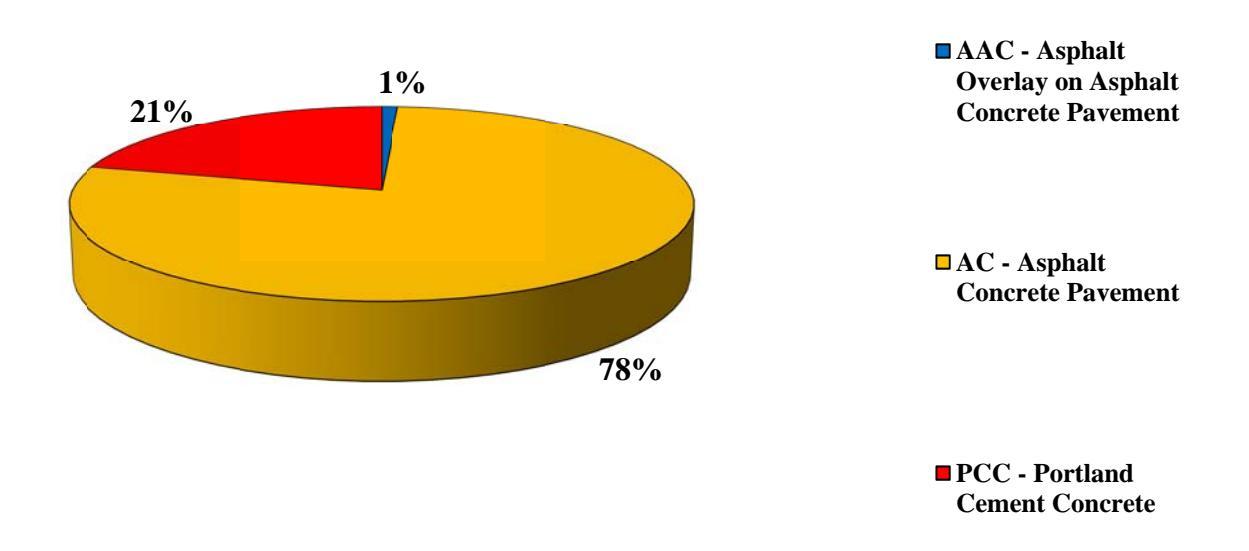
Figure 2-1: Pavement Area by Surface Type

Figure 2-1 presents the breakdown of the pavement area at Pensacola Gulf Coast Regional Airport by surface type.

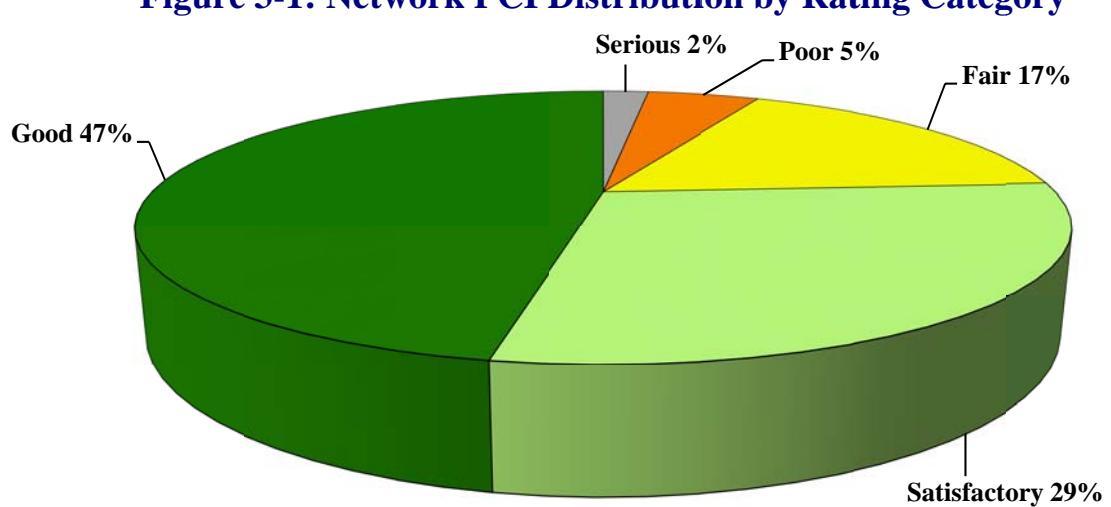
Figure 3-1: Network PCI Distribution by Rating Category

Condition Rating	Total Area (ft ²)	Percent
Good	3,070,745	47%
Satisfactory	1,913,595	29%
Fair	1,137,025	17%
Poor	338,265	5%
Very Poor	0	0%
Serious	118,345	2%
Failed	0	0%

Approximately 76% of the network is in Good and Satisfactory condition while 2% of the network is in Serious condition. Table 3-3 illustrates the area-weighted PCI computed individually for each pavement use.

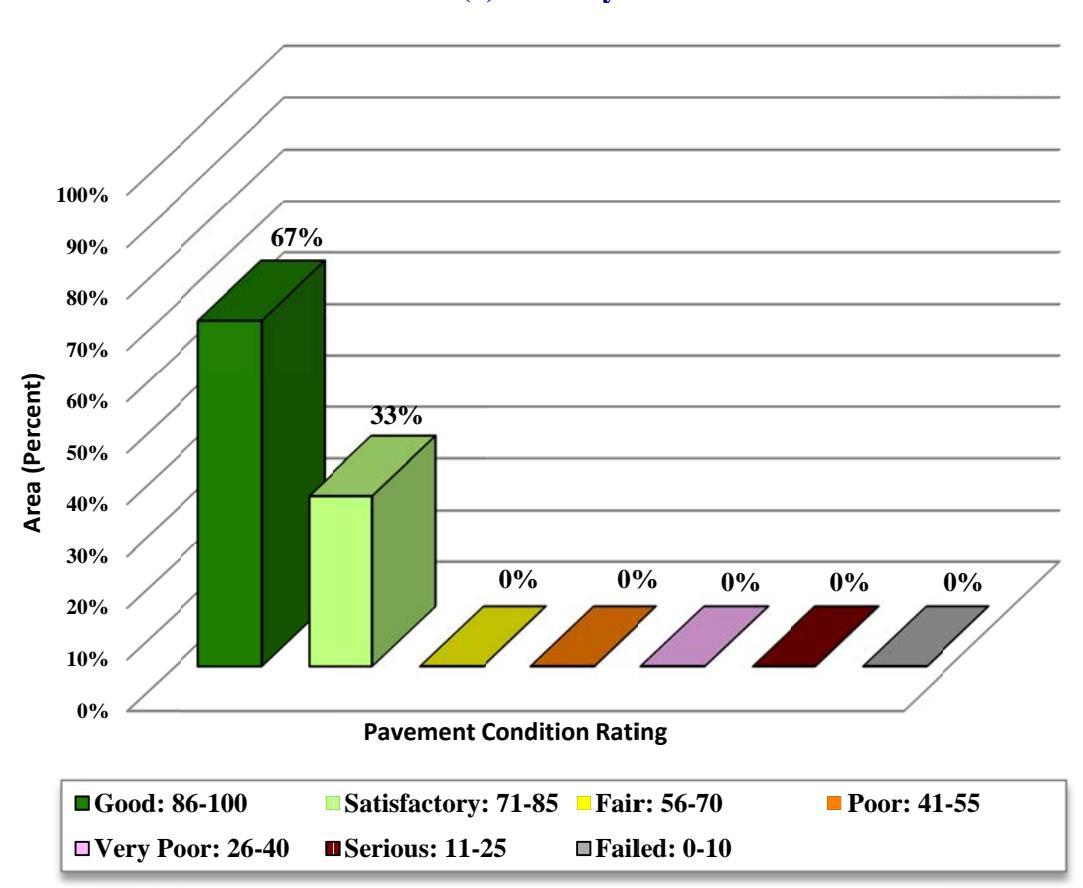
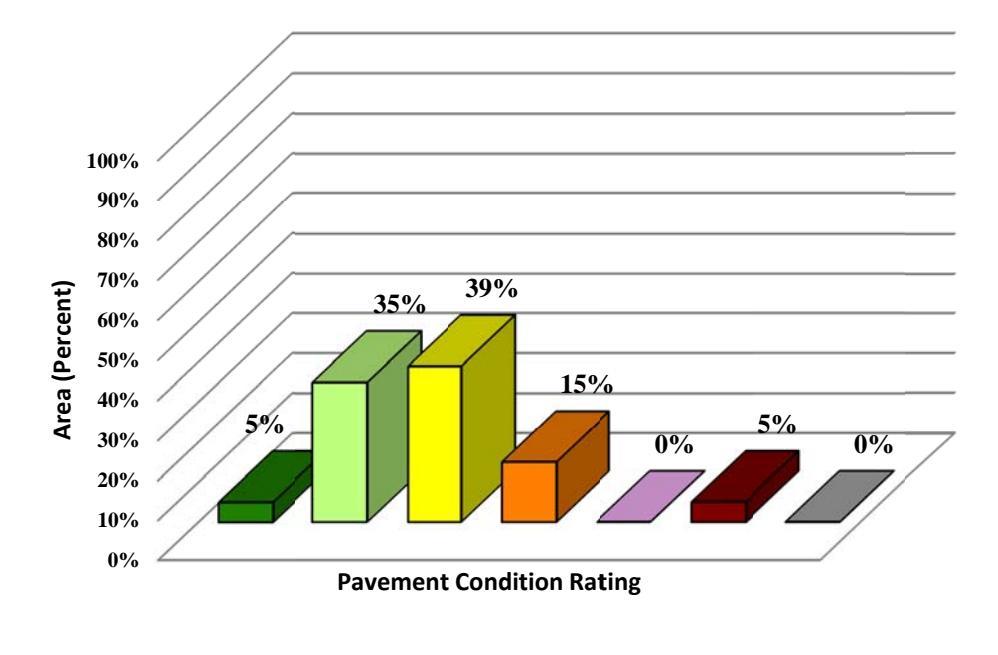
Figure 3-2: Percentage of Pavement Area within Each PCI Range by Pavement Use

Figure 3-2 presents the breakdown of PCI by range for each pavement use.

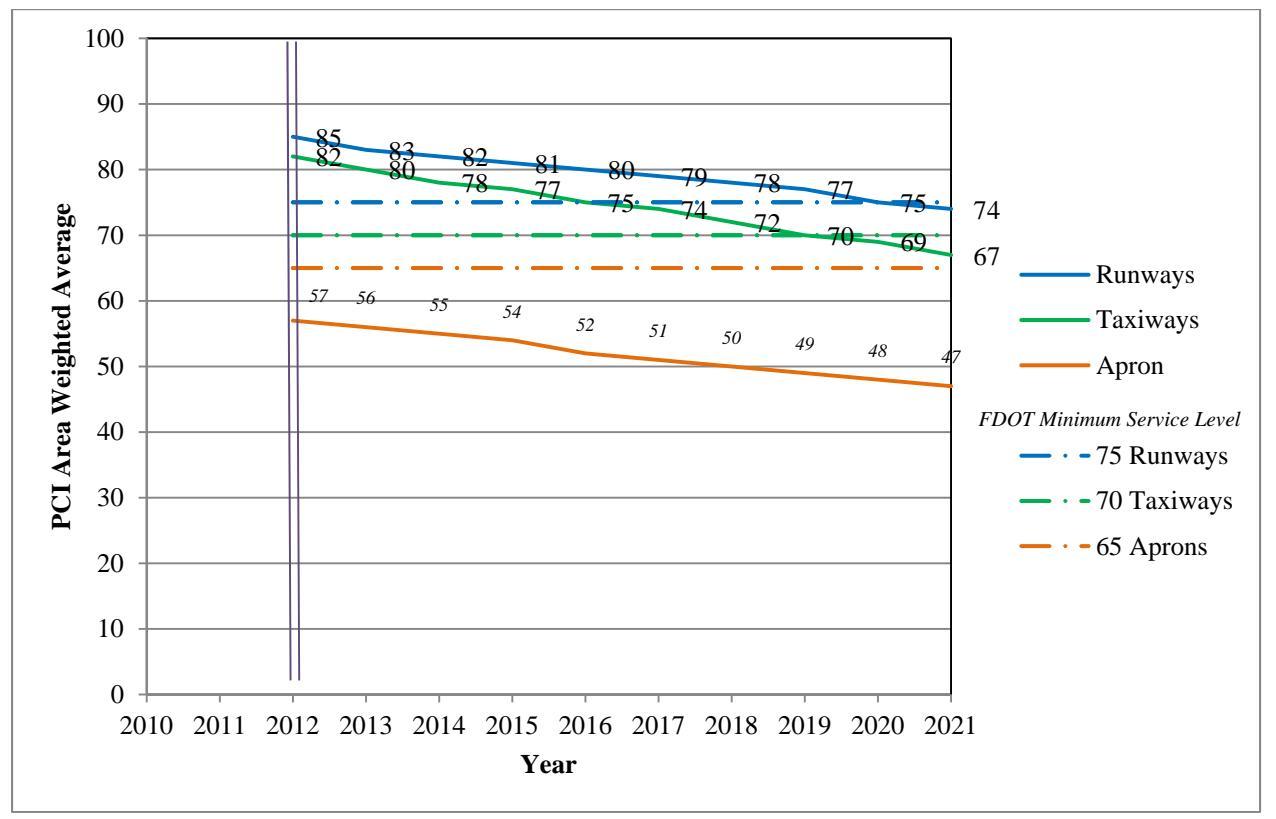
Figure 4-1: Predicted PCI by Pavement Use

Performance prediction models or deterioration curves for PCI were used to develop a condition forecast. The performance models were developed for combinations of variables such as pavement use (runway, taxiway or apron), surface type (AC or PCC) and airport category (GA, RL, or PR). Figure 4-1 illustrates the predicted performance of pavements at Pensacola Gulf Coast Regional Airport based on current condition, age since last construction and the deterioration model appropriate for the type of pavement. The figure presents the forecast for each pavement use and displays the FDOT minimum service level for Primary / Part 139 (PR) airports.

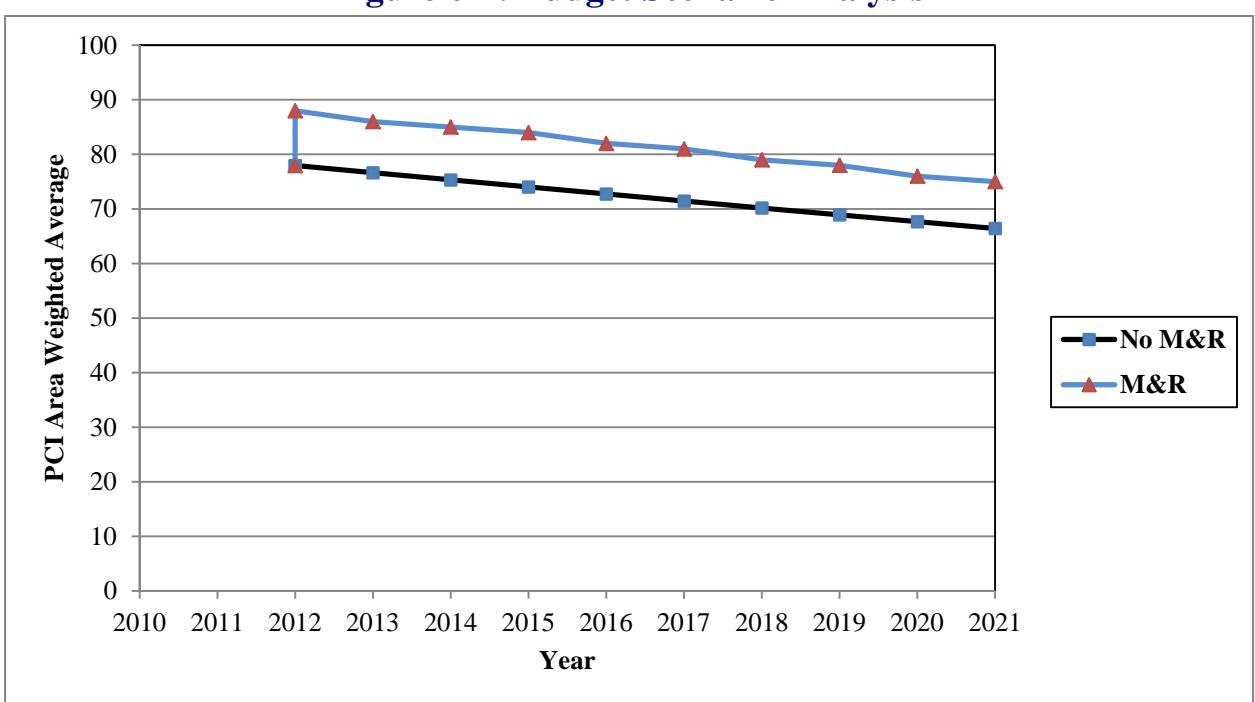
Figure 6-1: Budget Scenario Analysis

The 10 year forecast results are shown in Figure 6-1, illustrating the effect on pavement condition (PCI) of doing no maintenance versus having unlimited funds and performing all M&R actions based on the policies.

The following network level observations can be made from the figure above:

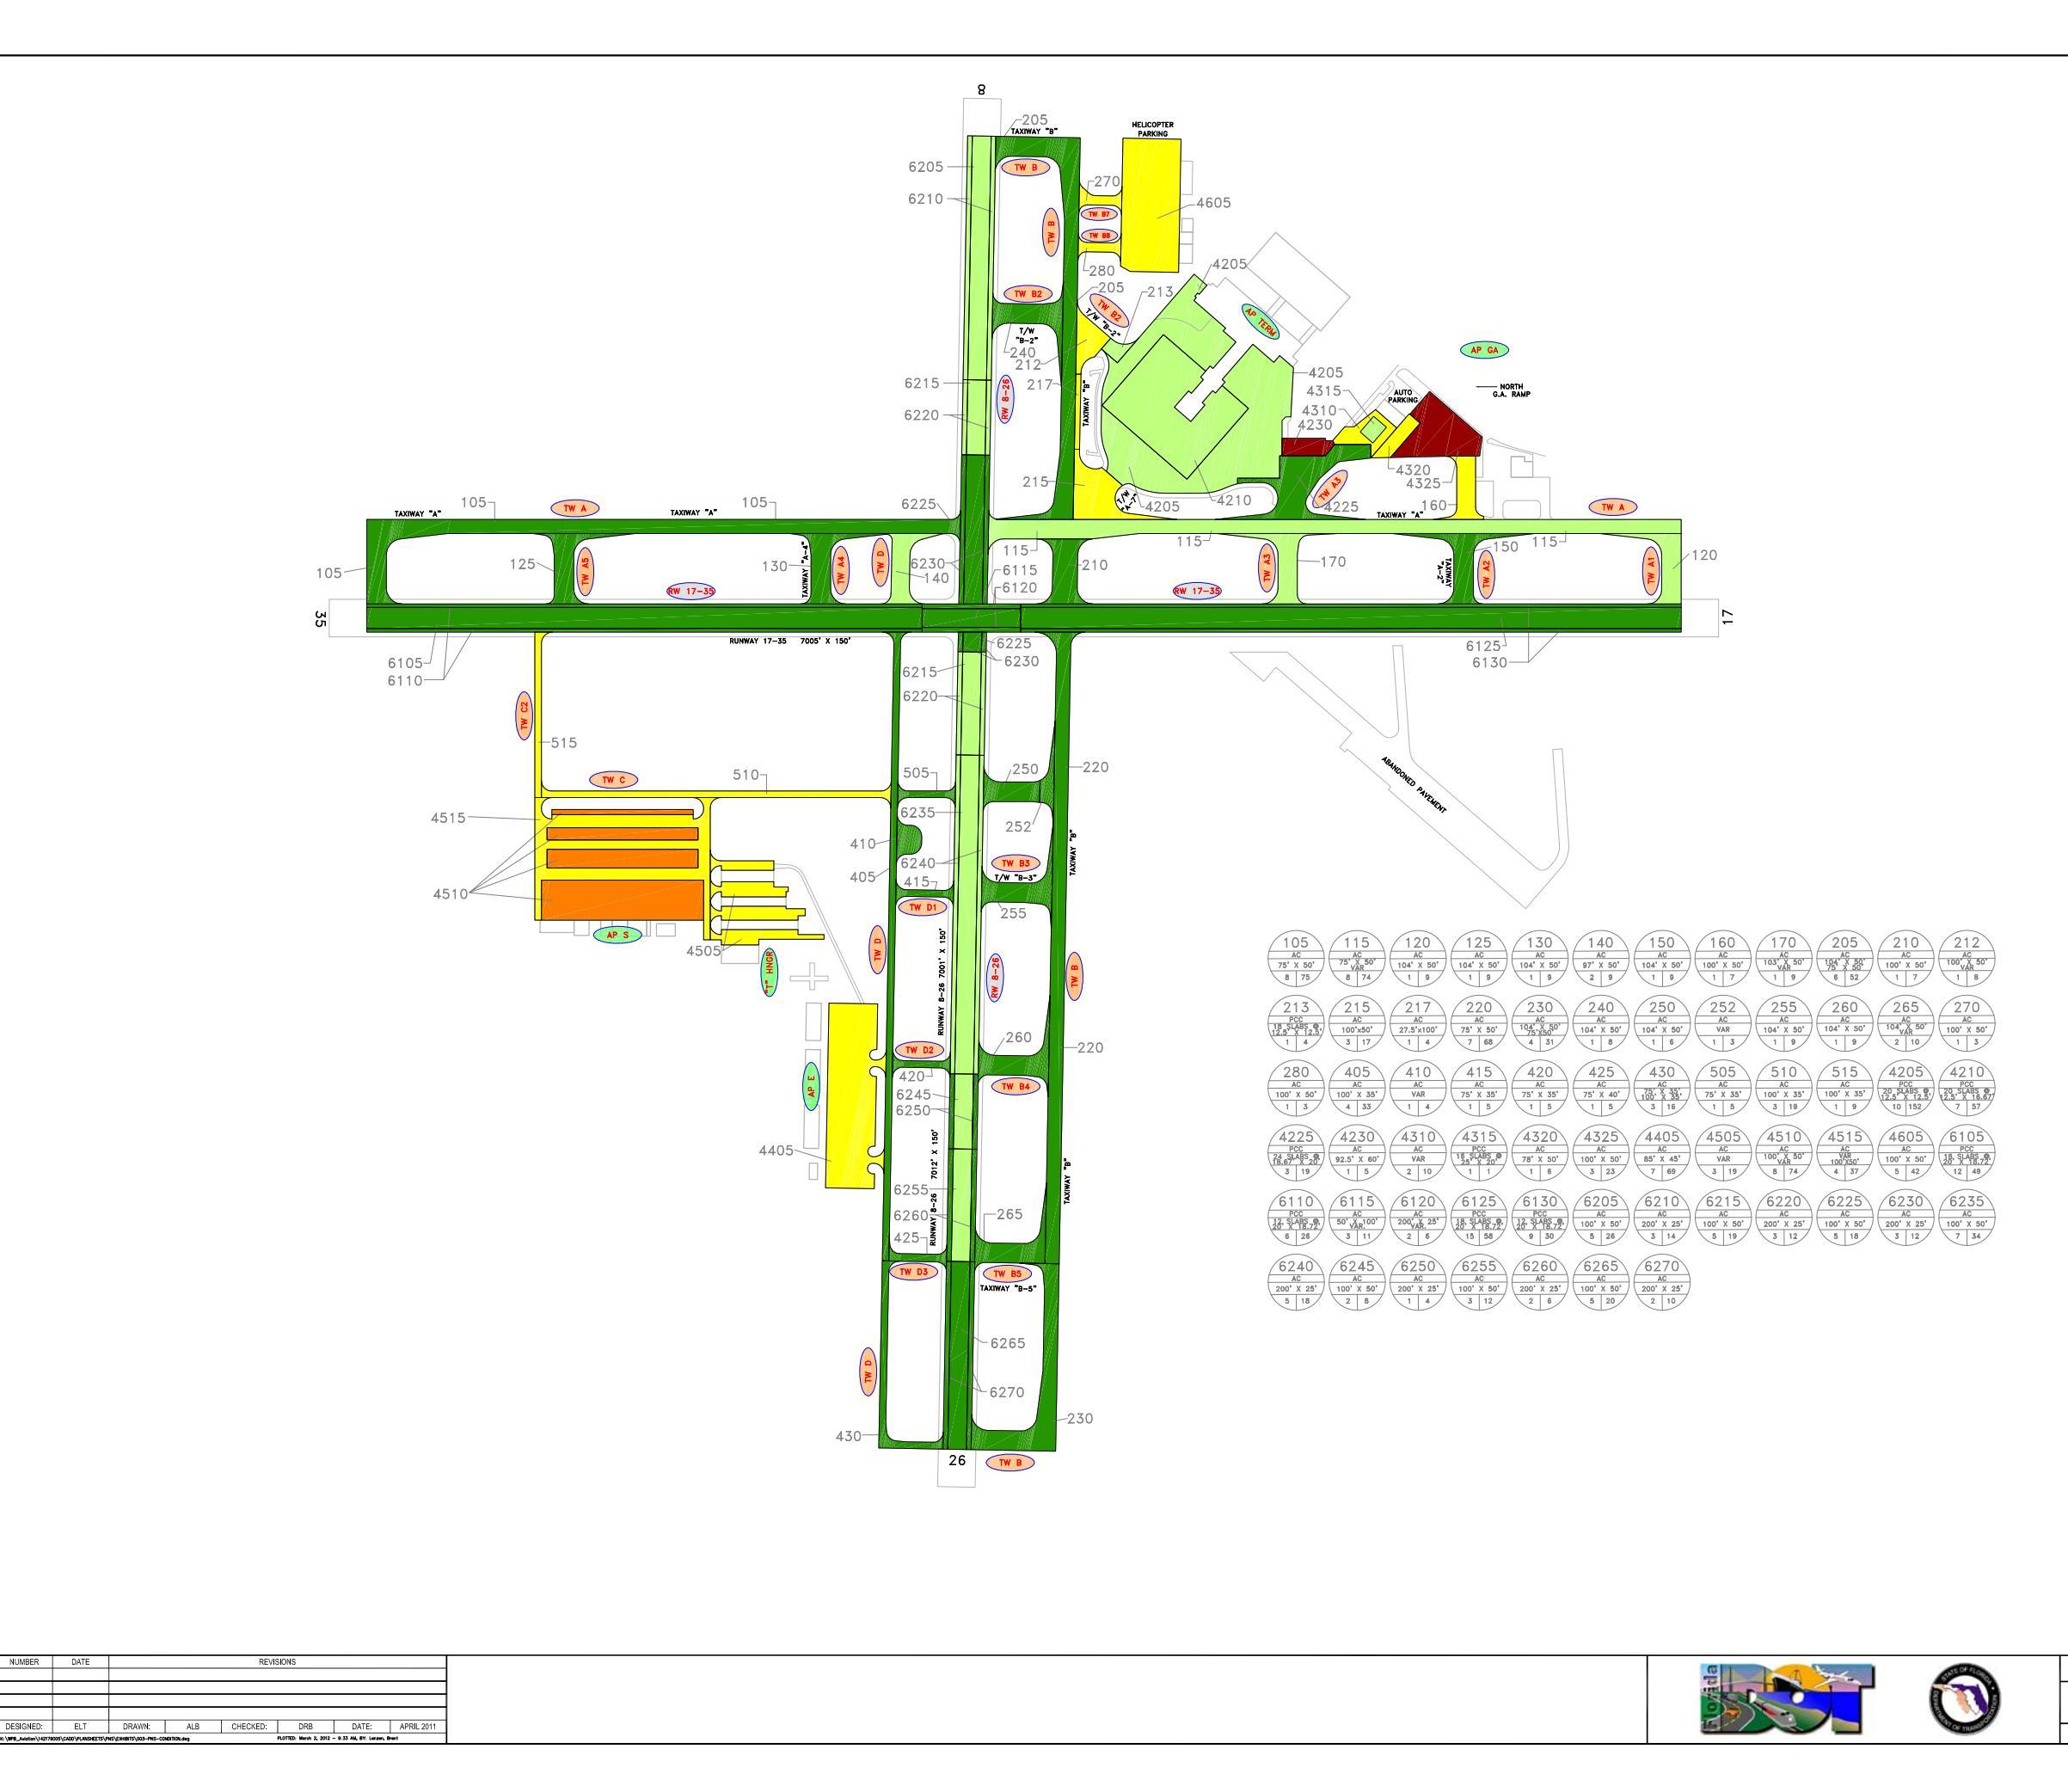
2012 CONDITION MAP PENSACOLA REGIONAL AIRPORT ESCAMBIA COUNTY, FLORIDA FLORIDA DEPARTMENT OF TRANSPORTATION - AVIATION OFFICE

Appendix B contains a table and a Condition Map which depicts the PCI results by Section, and Appendix C contains a table of PCI results by Branch. Appendix I includes detailed distress data generated by MicroPAVER for each inspected sample unit.

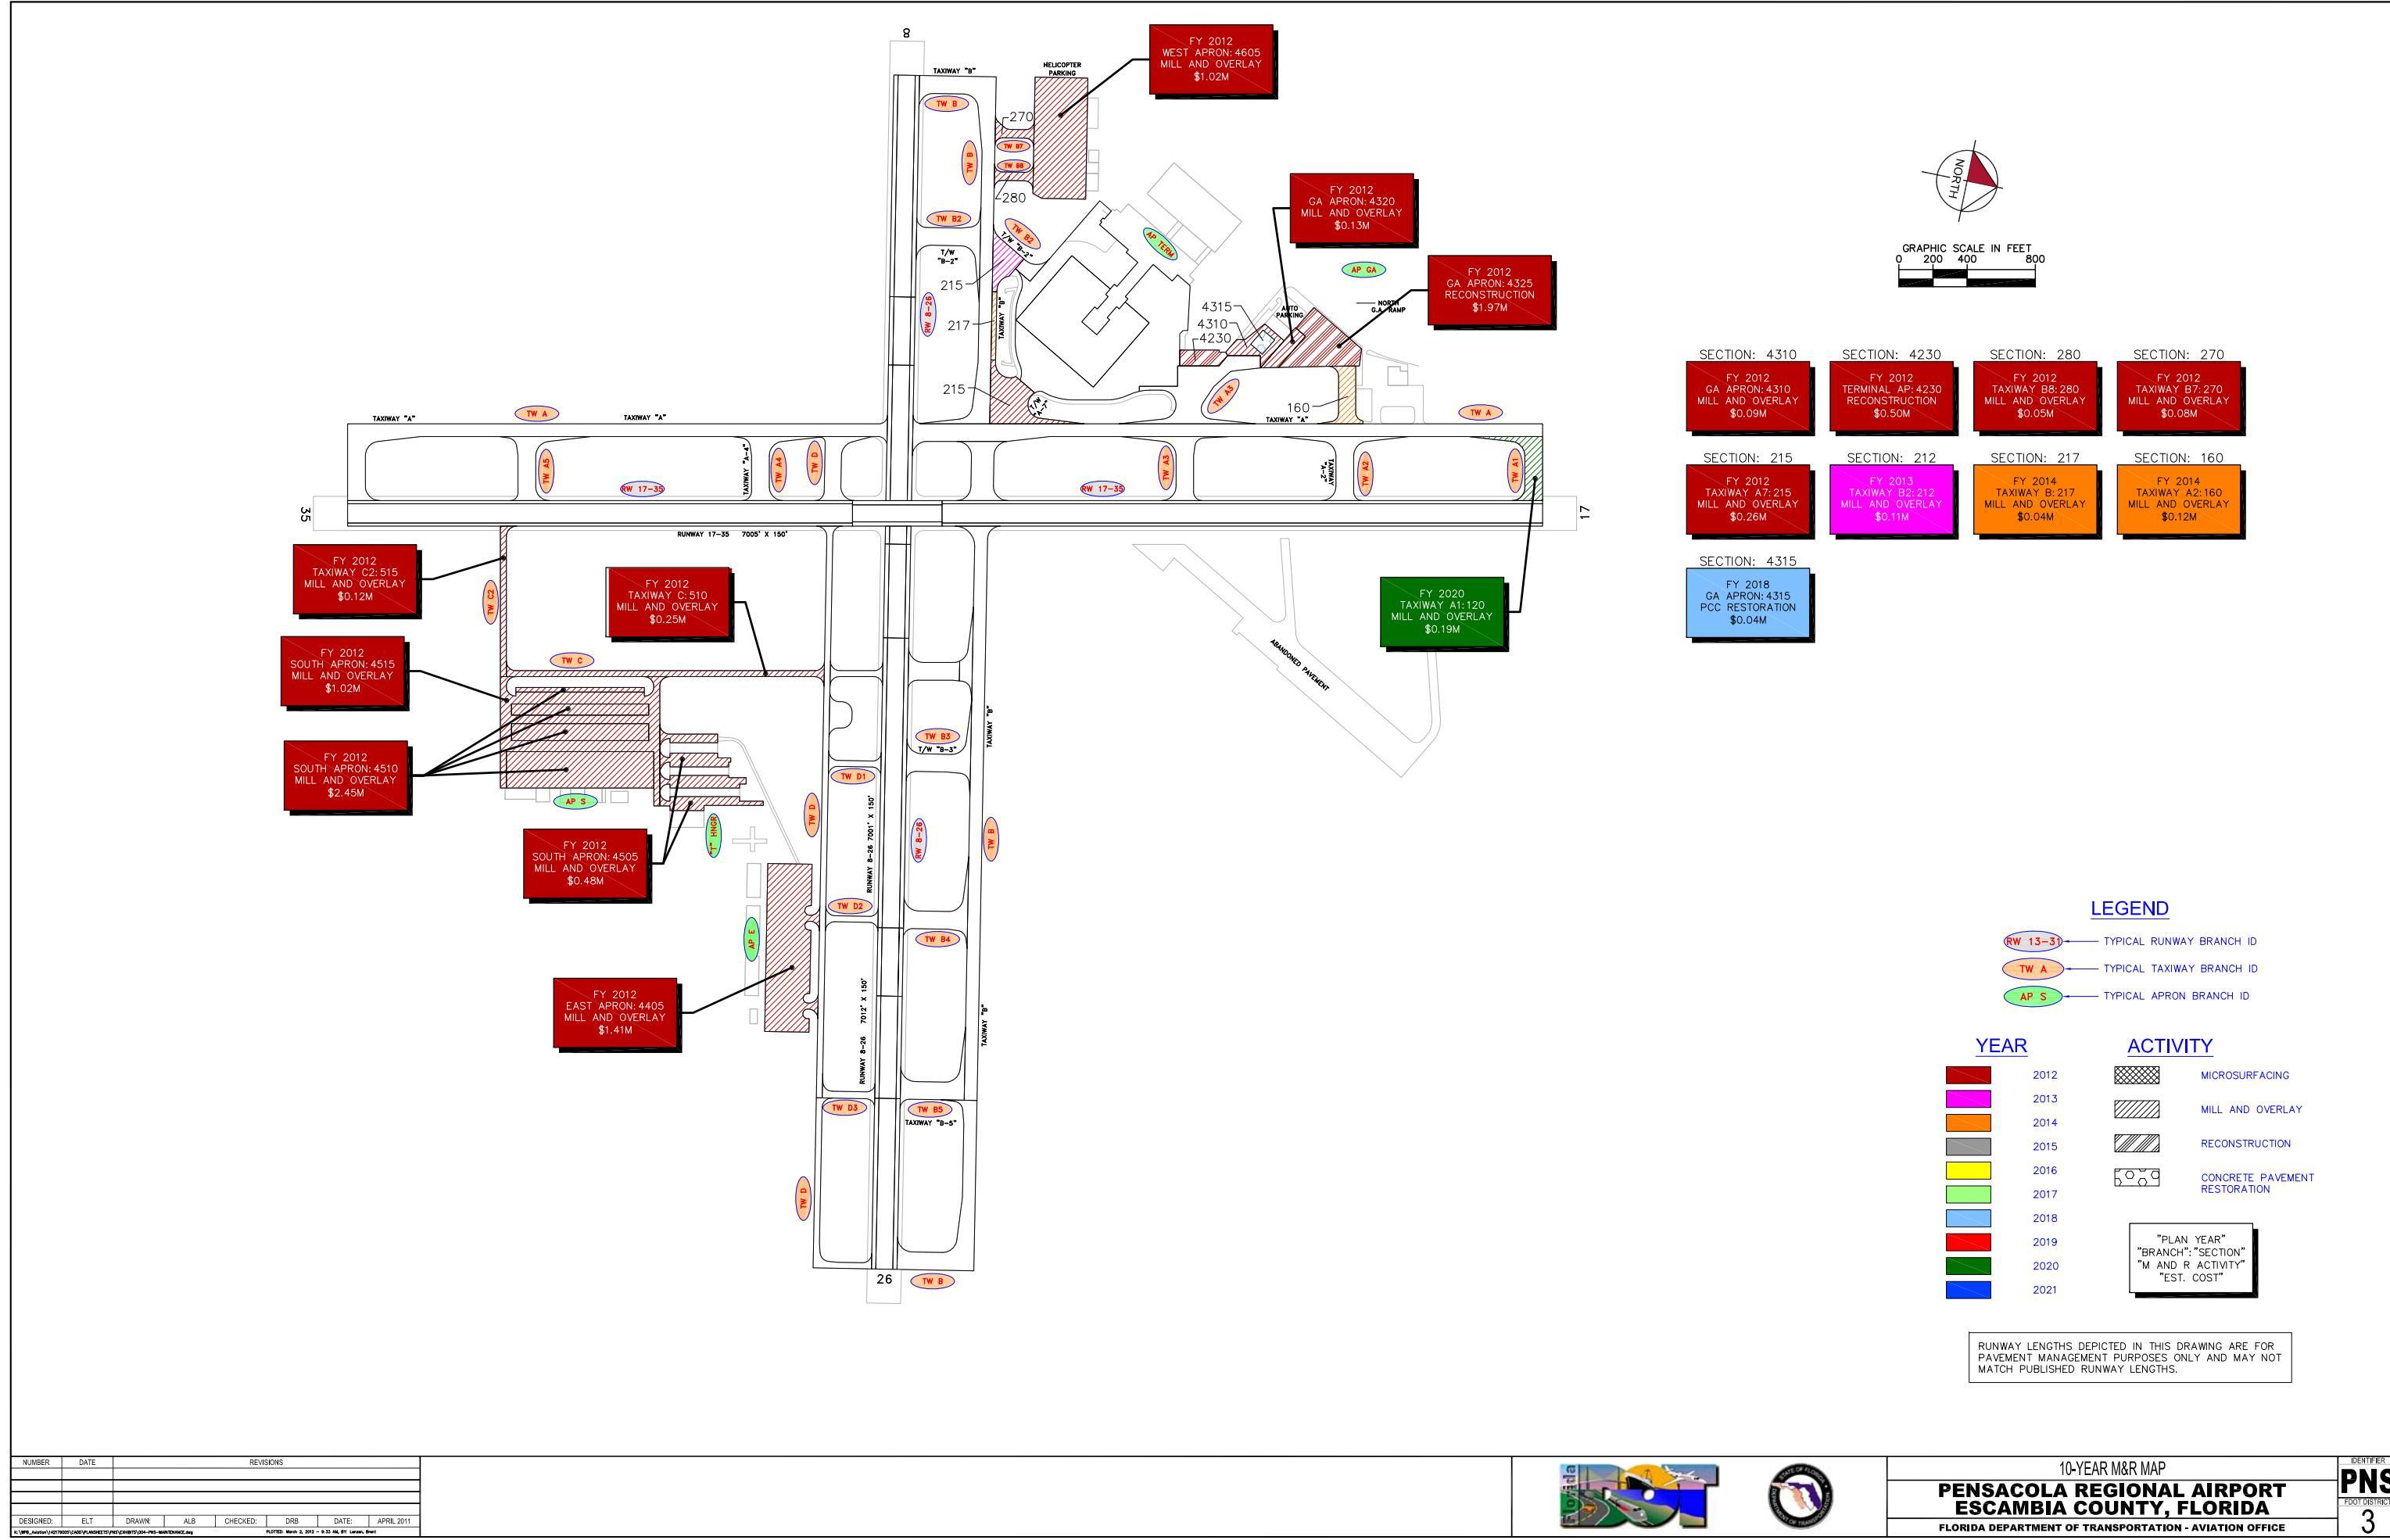
10-YEAR M&R MAP	
PENSACOLA REGIONAL AIRPORT ESCAMBIA COUNTY, FLORIDA	FDOT DISTRIC
FLORIDA DEPARTMENT OF TRANSPORTATION - AVIATION OFFICE	3

The implementation of the 10-Year Major M&R Plan is expected to provide an improvement in the overall condition of the airfield pavement, where the area-weighted PCI would only decrease from 79 in 2011 to 75 in 2021. Appendix F lists the Major M&R for the 10-Year program. Appendix G graphically depicts the program activity.

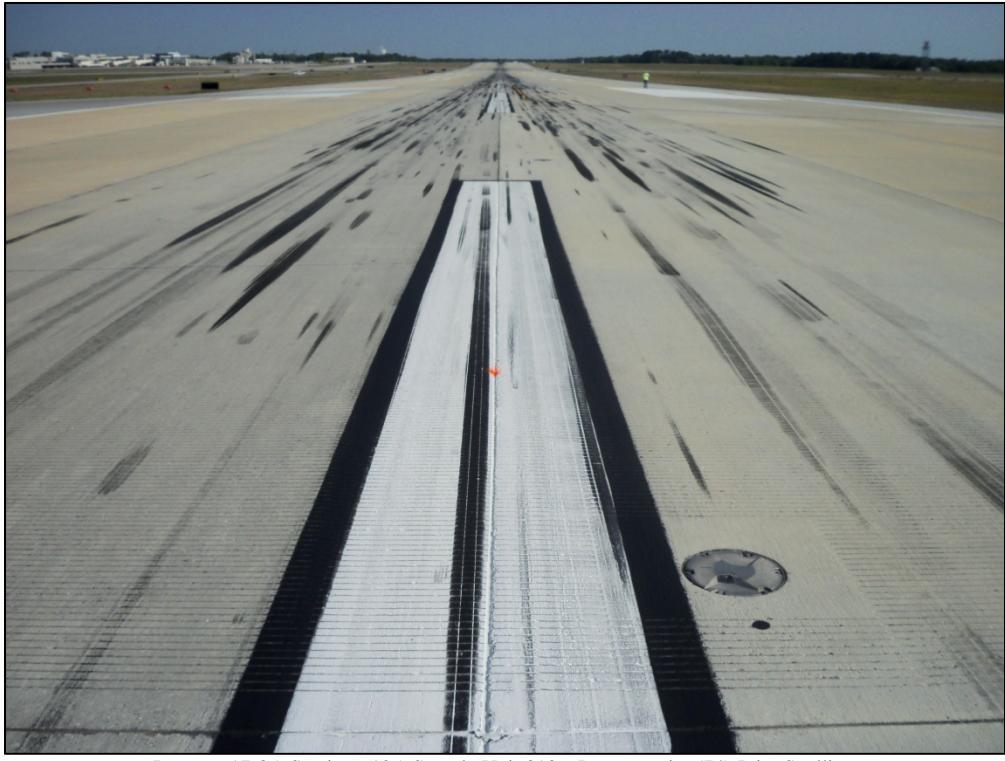
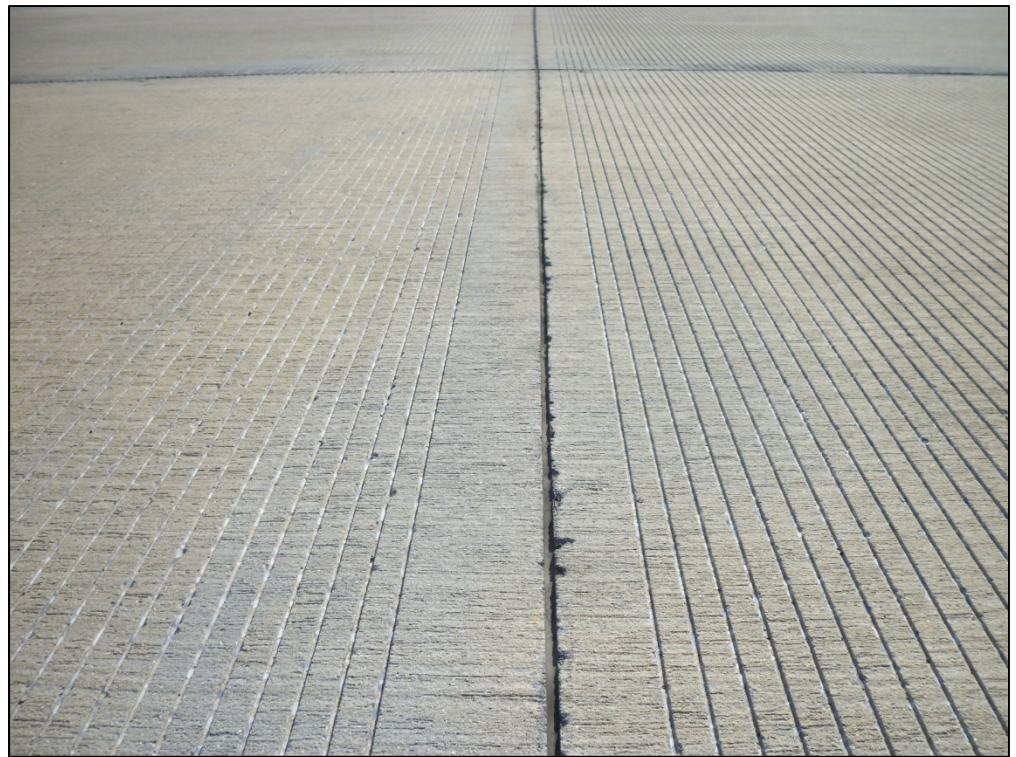
Runway 17-35 exhibited low severity patching, joint and corner spalling distresses. The runway was recently reconstructed and this was evident in the good overall condition of the Portland Cement Concrete pavement.

Runway 17-35, Section 6105, Sample Unit 313 – Low severity (74) Joint Spalling

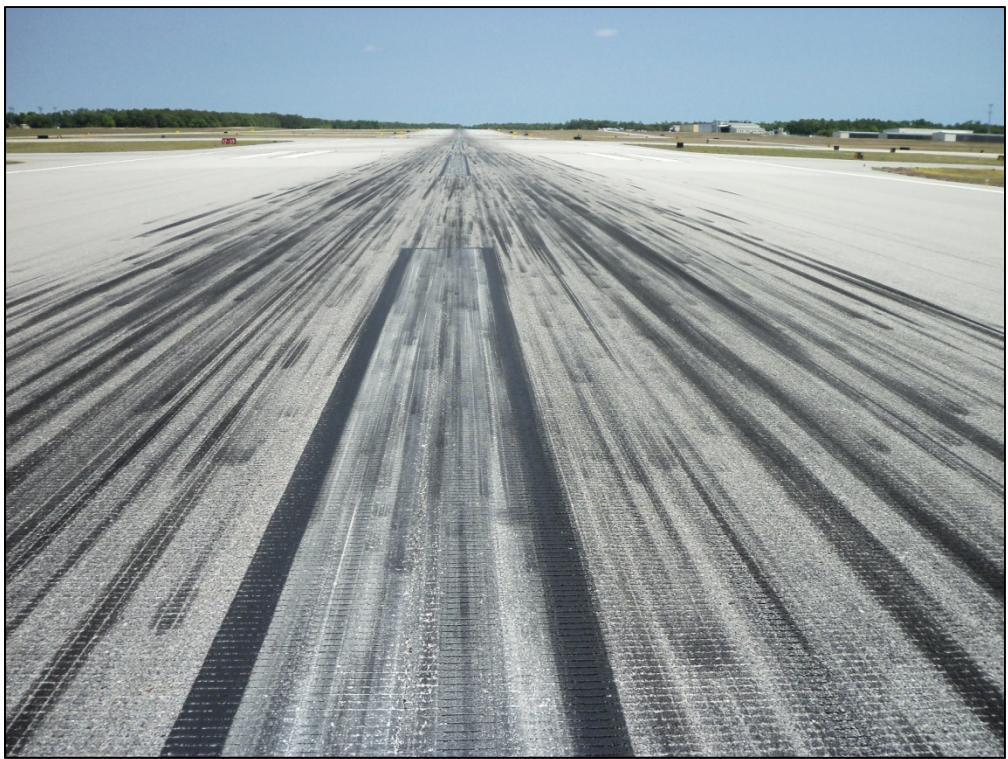
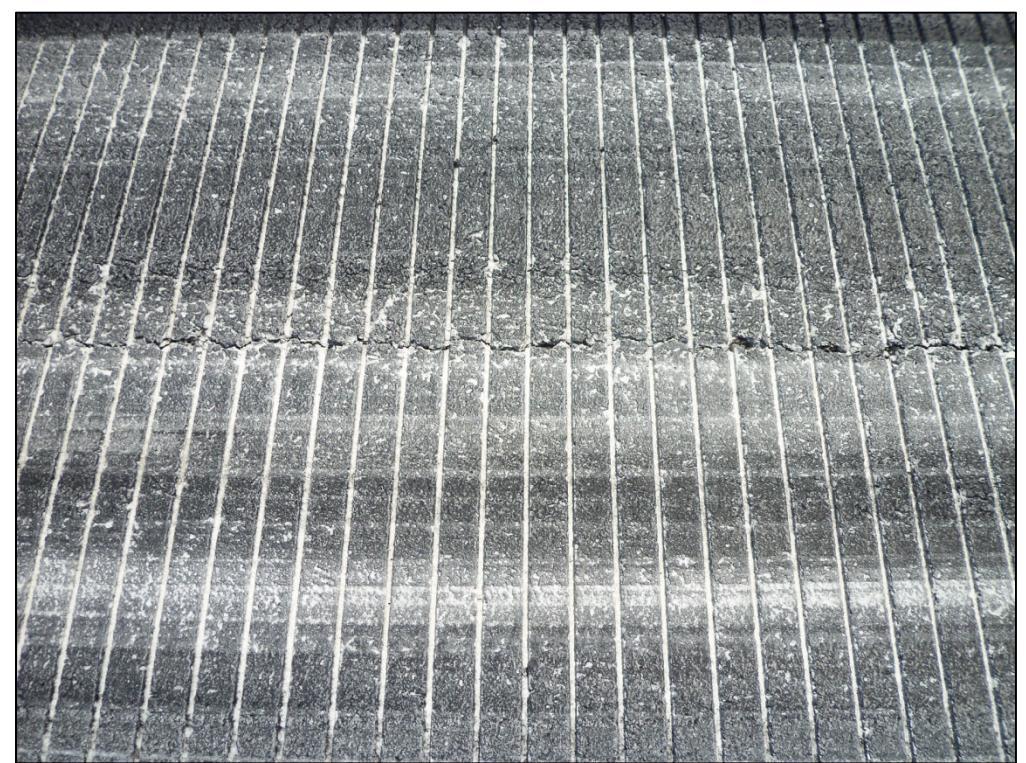
Runway 8-26 exhibited low severity longitudinal and transverse cracking along with low severity weathering and raveling. These distresses were observed in low quantities due to the good overall condition of the runway pavement.

Runway 8-26, Section 6215, Sample Unit 336 – Low severity (48) Longitudinal and Transverse Cracking, low severity (52) Weathering and Raveling

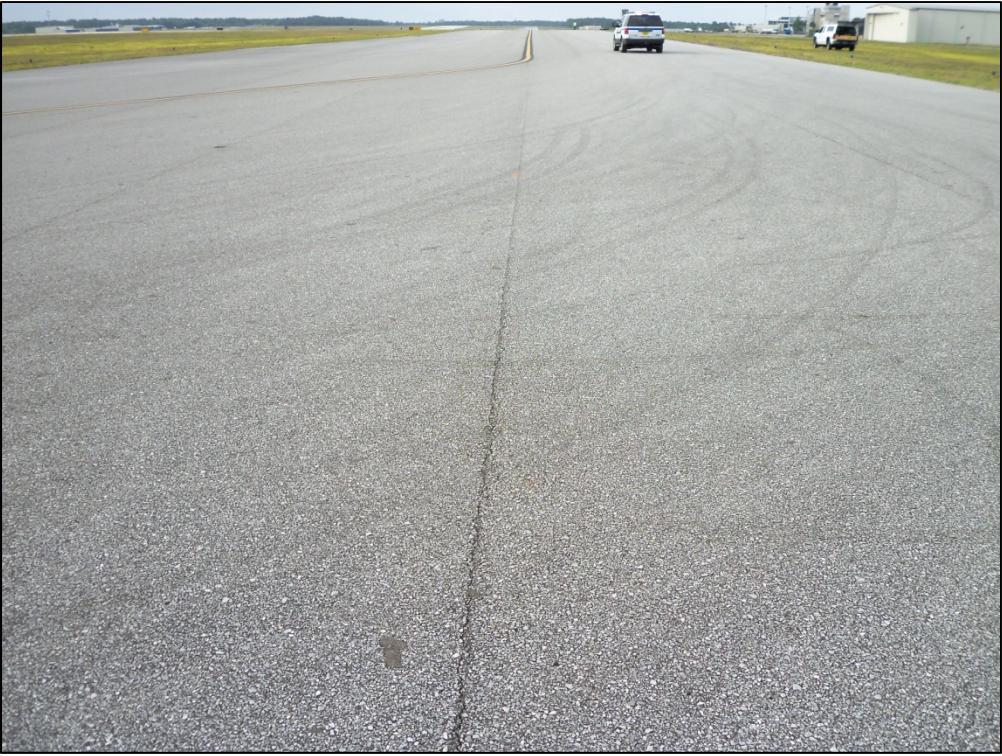
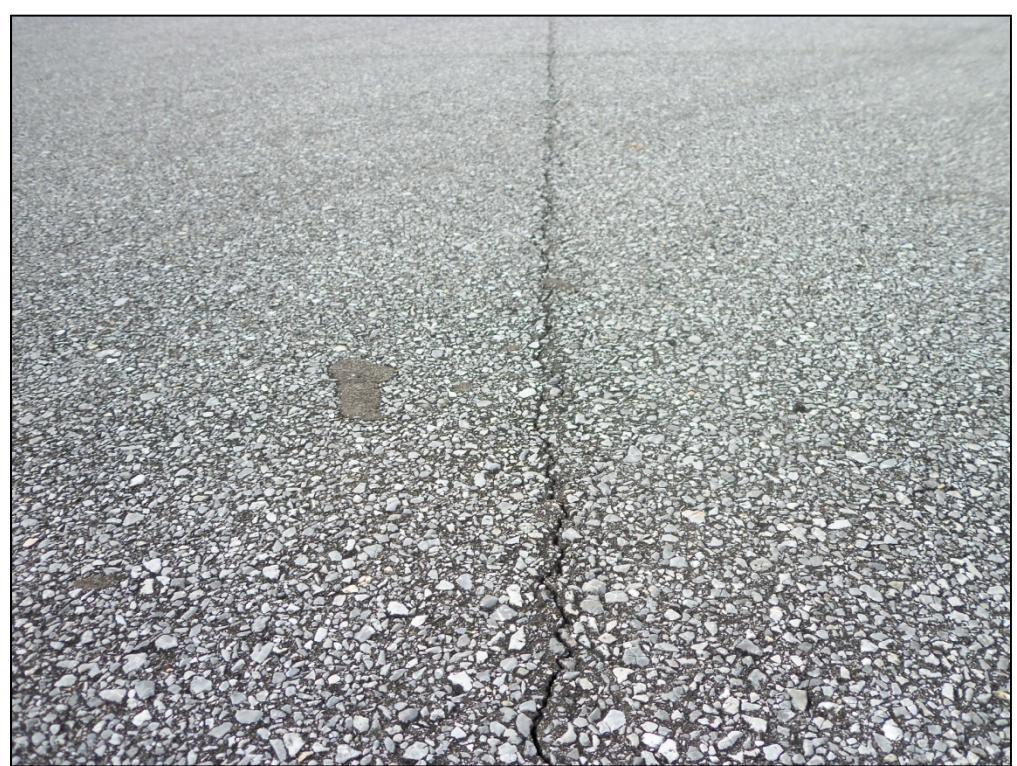
The taxiways and taxiway connectors exhibited very similar distresses to Runway 8-26, with low quantities of low severity longitudinal and transverse cracking along with low severity weathering and raveling.

Taxiway Alpha, Section 115, Sample Unit 172 – Low severity (48) Longitudinal and Transverse Cracking, low severity (52) Weathering and Raveling

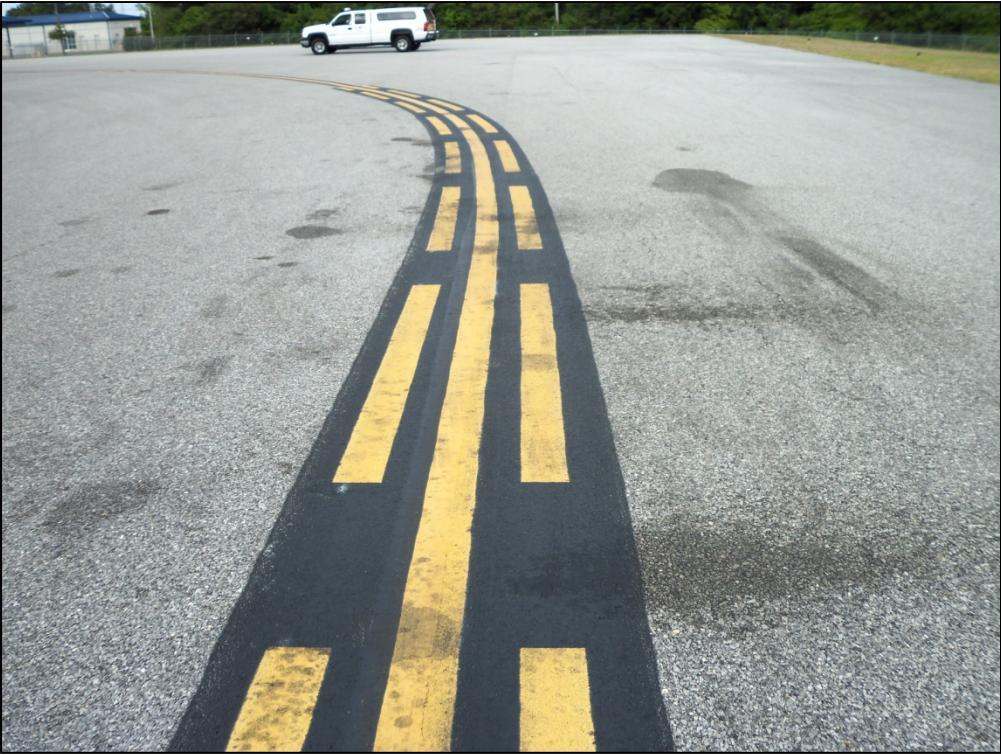
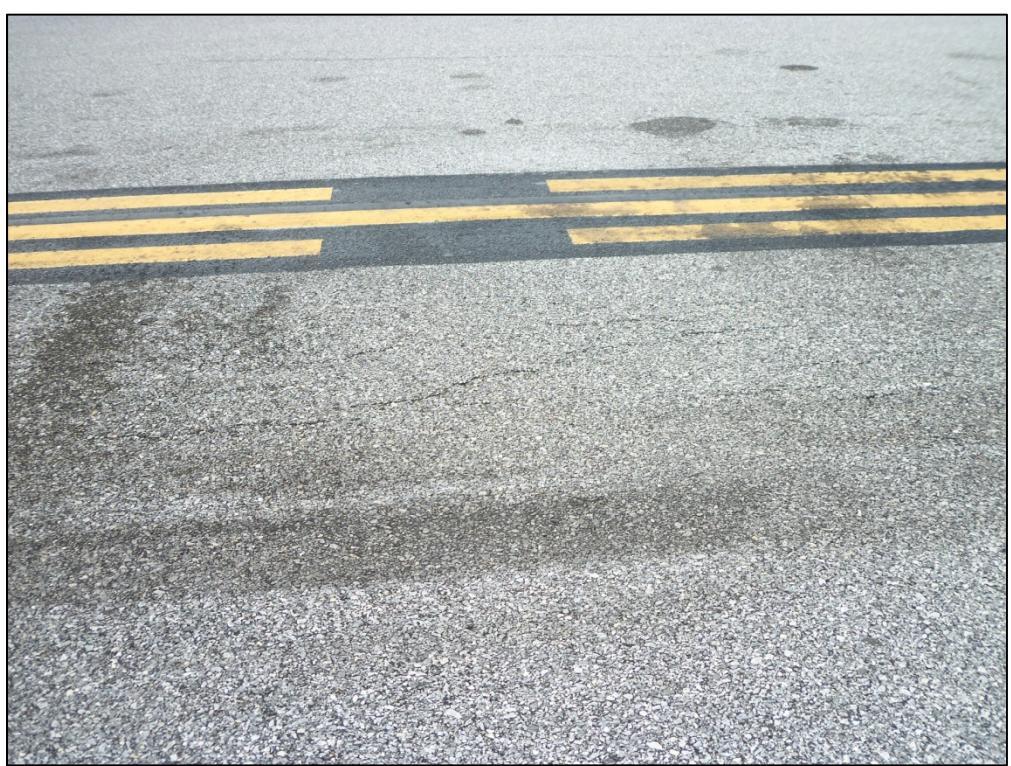
Taxiway Connector A1, Section 120, Sample Unit 102 – Low severity (43) Block Cracking, low severity (48) Longitudinal and Transverse Cracking, (49) Oil Spillage, low severity (52) Weathering and Raveling

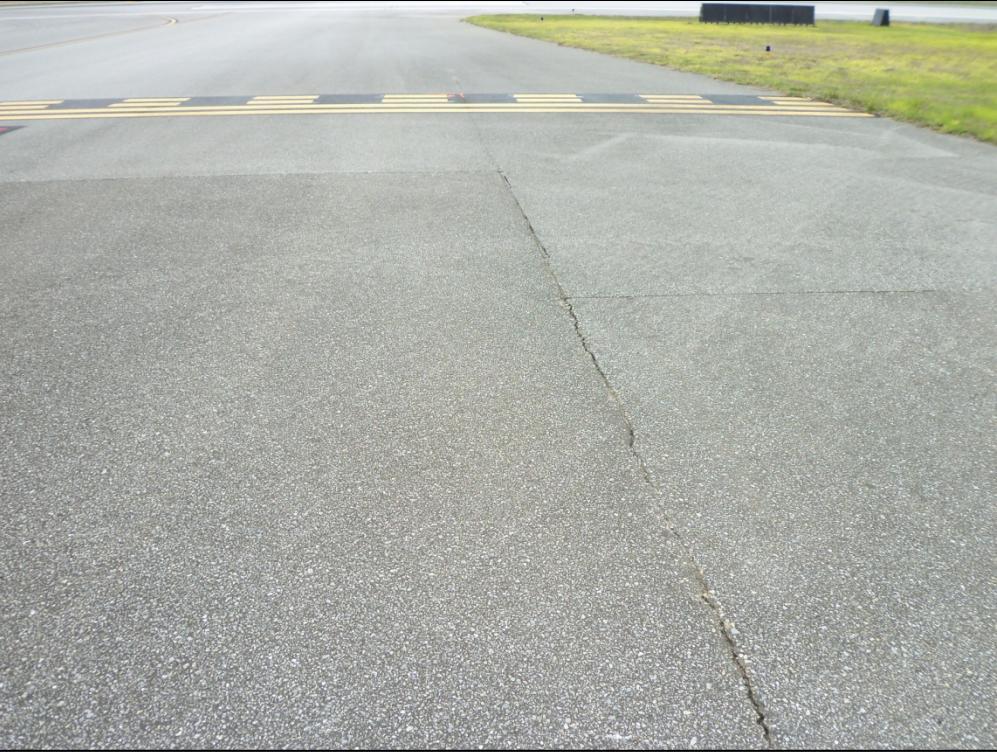
Taxiway Connector A1, Section 120, Sample Unit 102 – Low and medium severity (48) Longitudinal and Transverse Cracking, low severity (52) Weathering and Raveling

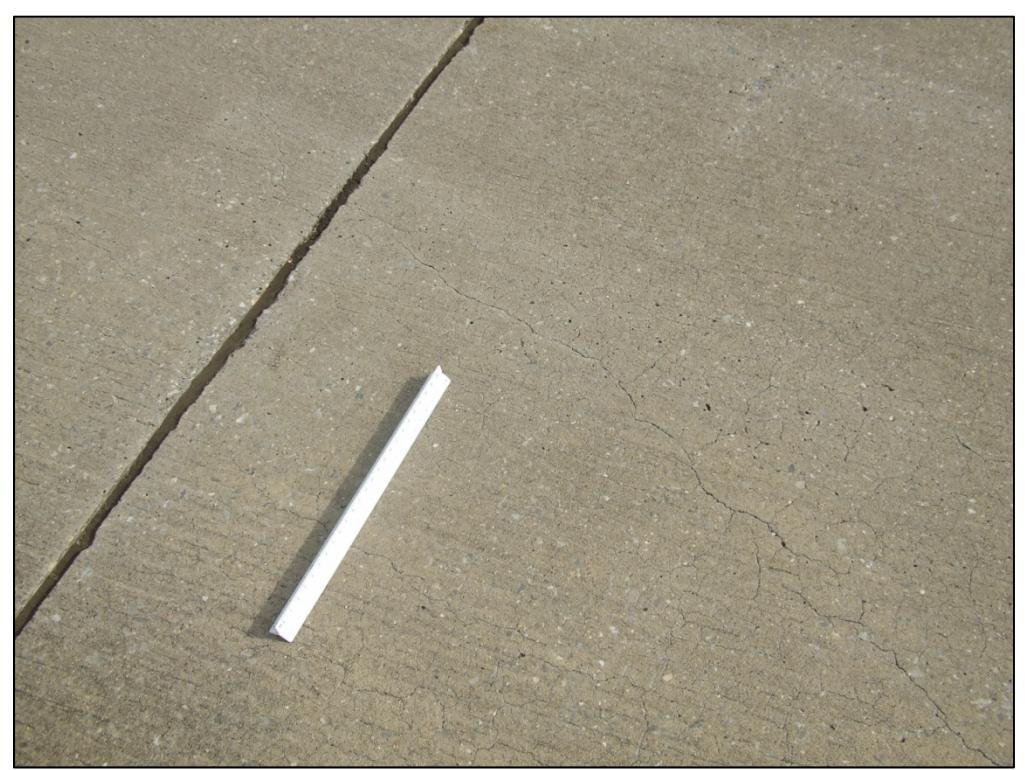
The main terminal apron which is constructed of Portland Cement Concrete exhibited distresses such as longitudinal, transverse and diagonal cracking, joint seal damage, patching, map cracking, shrinkage cracking, and joint spalling. These distresses varied from mostly low and medium severities. The other Asphalt Concrete pavement aprons throughout the airport exhibited distresses such as joint reflection cracking, longitudinal and transverse cracking, patching, weathering and raveling, and swelling.

Terminal Apron, Section 4205, Sample Unit 325 - Low severity (70) Map Cracking, (73) Shrinkage Crack

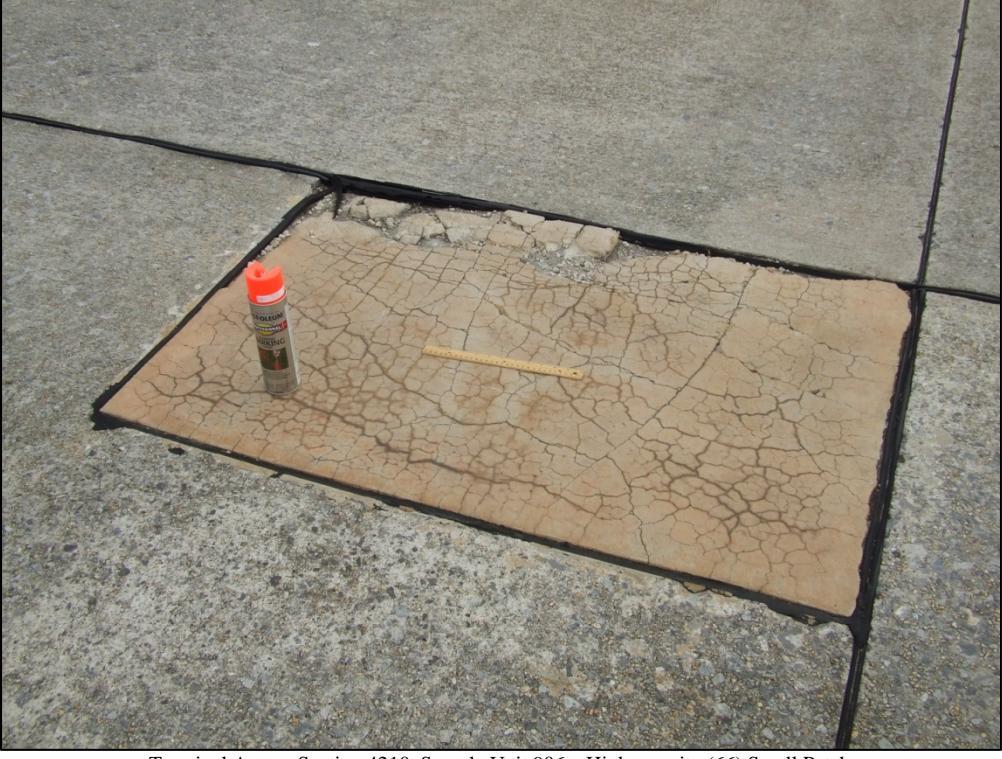
Terminal Apron, Section 4210, Sample Unit 906 – High severity (66) Small Patch
