STATE OF FLORIDA DEPARTMENT OF TRANSPORTATION AVIATION OFFICE

Statewide Airfield Pavement Management Program

Pensacola Gulf Coast Regional Airport– PNS (Primary Airport) Pensacola, Florida (District 3)

March 2012

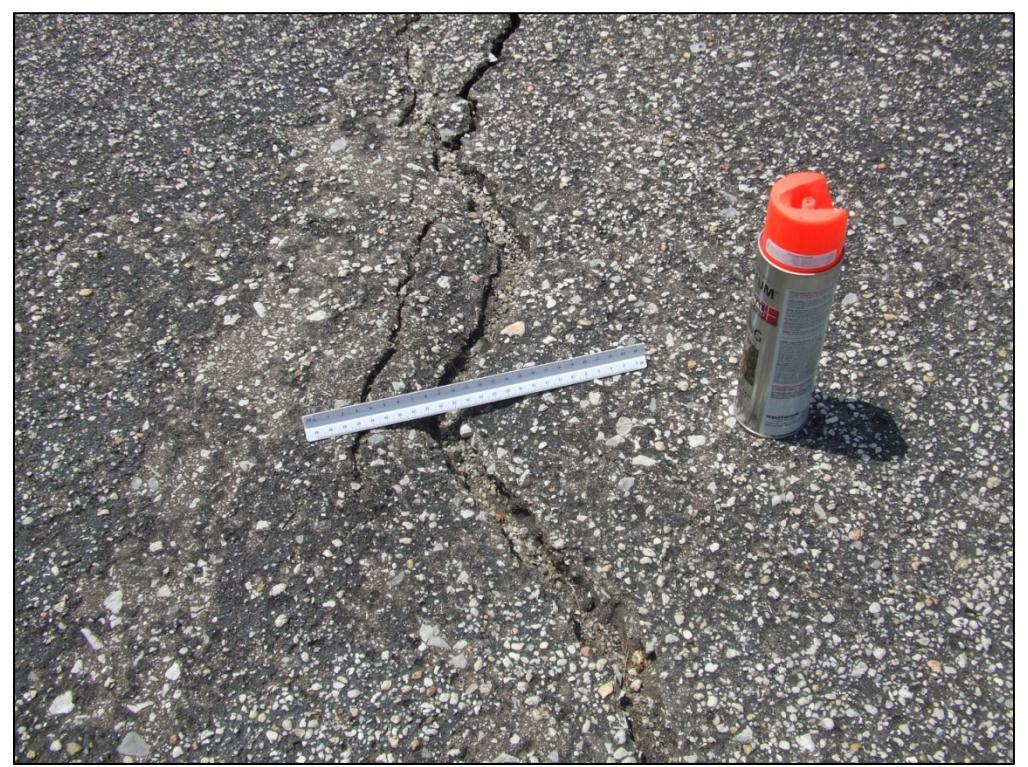
Apron, Section 4325, Sample Unit 454 – High severity (48) Longitudinal and Transverse Cracking

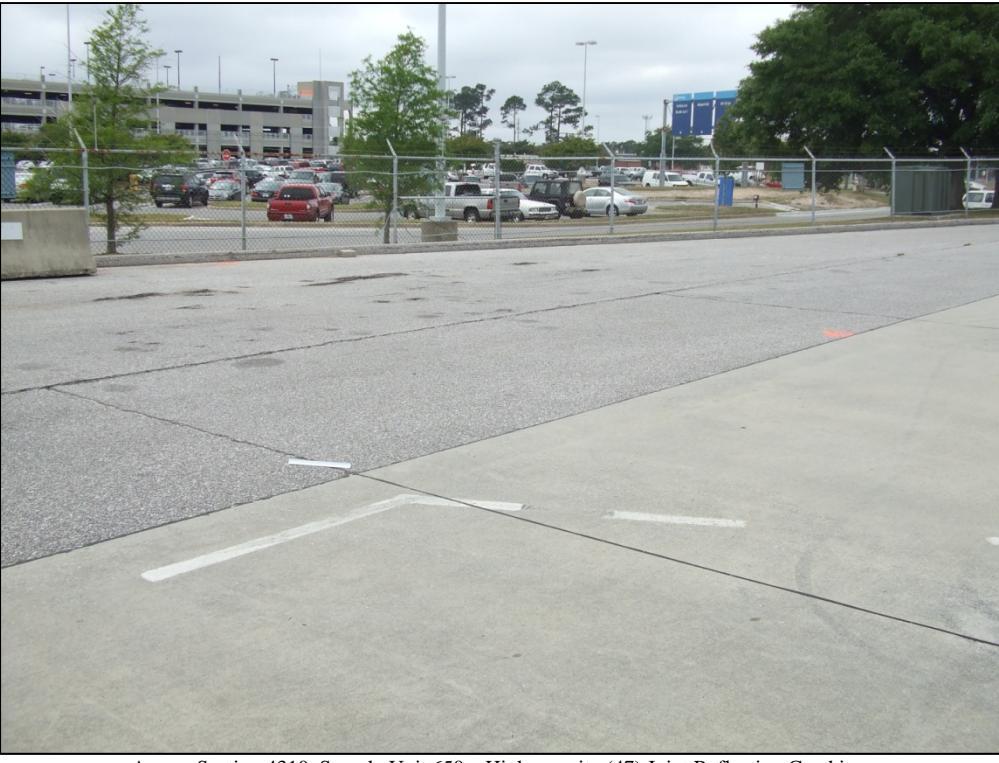
Apron, Section 4310, Sample Unit 650 - High severity (47) Joint Reflection Cracking

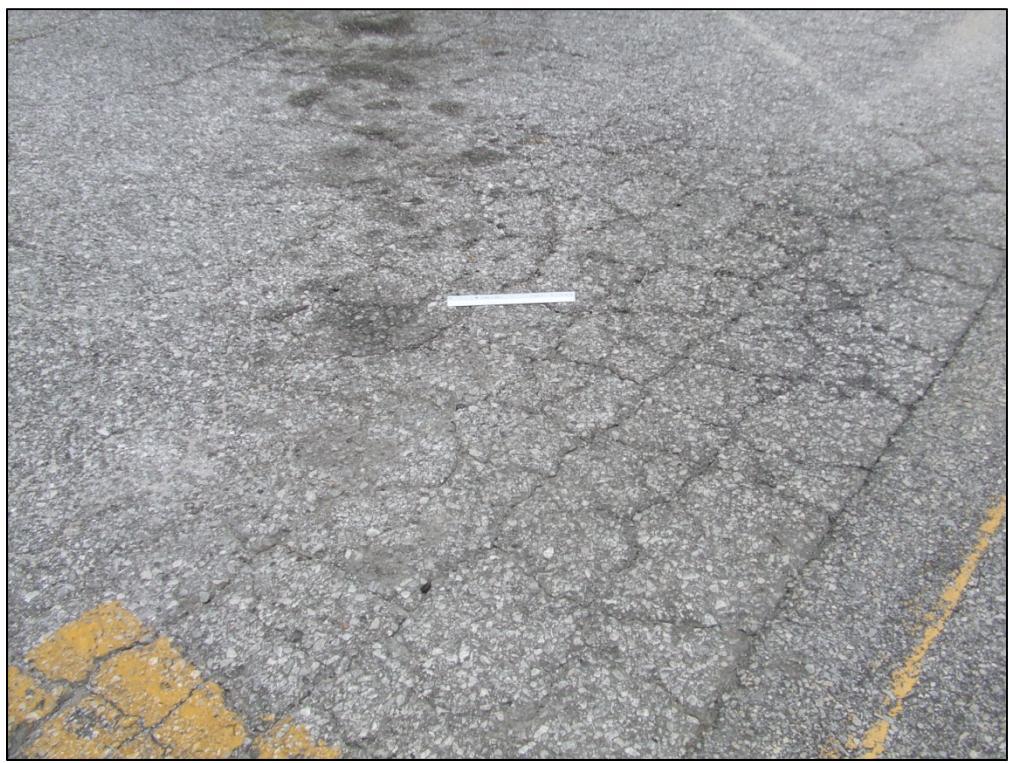
Apron, Section 325, Sample Unit 101 – Medium severity (43) Block Cracking

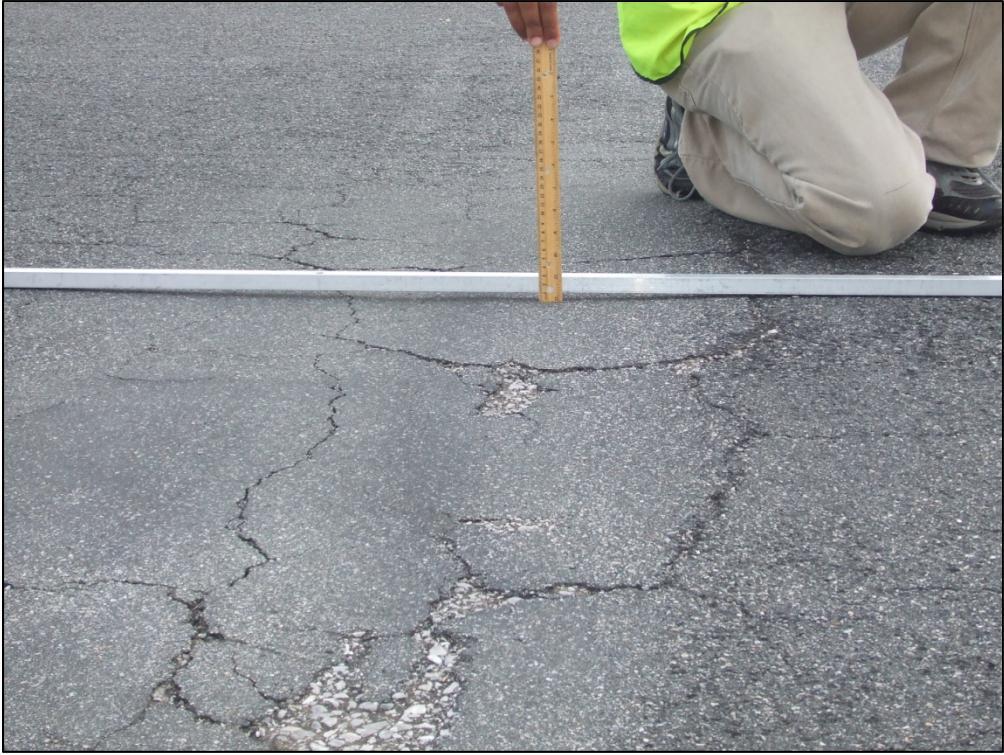
Apron, Section 4510, Sample Unit 311 – Low severity (45) Depression

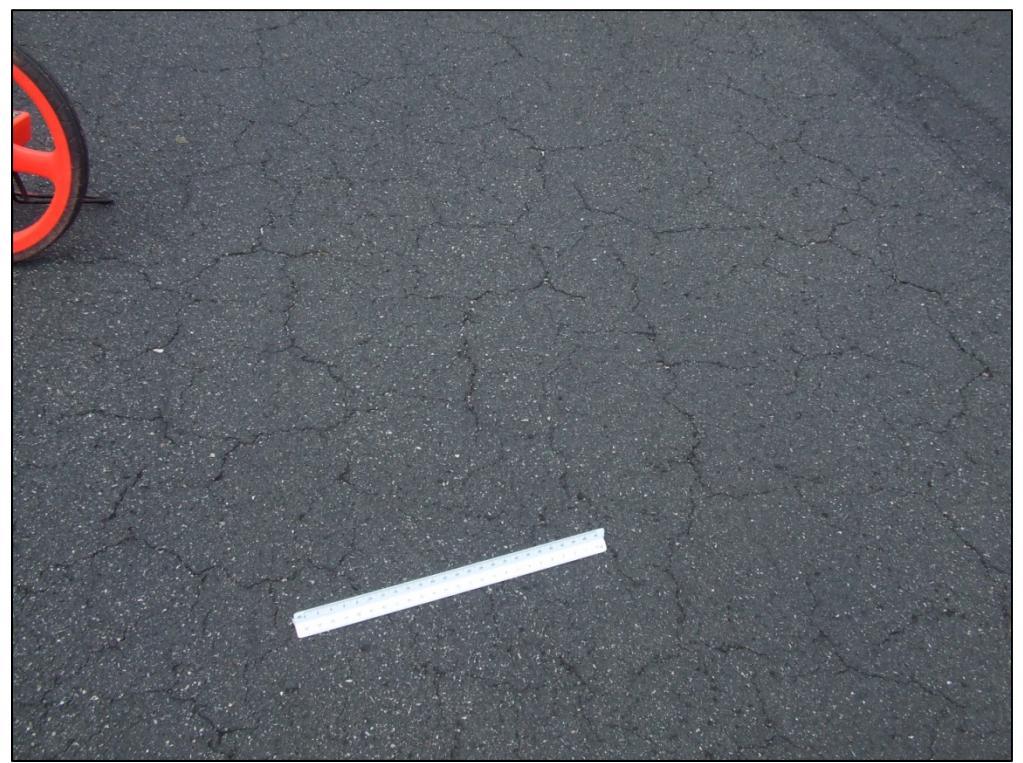
Apron, Section 4405, Sample Unit 311 - Low severity (52) Weathering and Raveling
