FLORIDA DEPARTMENT OF TRANSPORTATION
AVIATION AND SPACEPORTS OFFICE

Statewide Airfield Pavement Management Program

**Airport Pavement
Evaluation Report
September 2017**

**George T. Lewis
Airport (CDK)**
General Aviation Airport
District 2

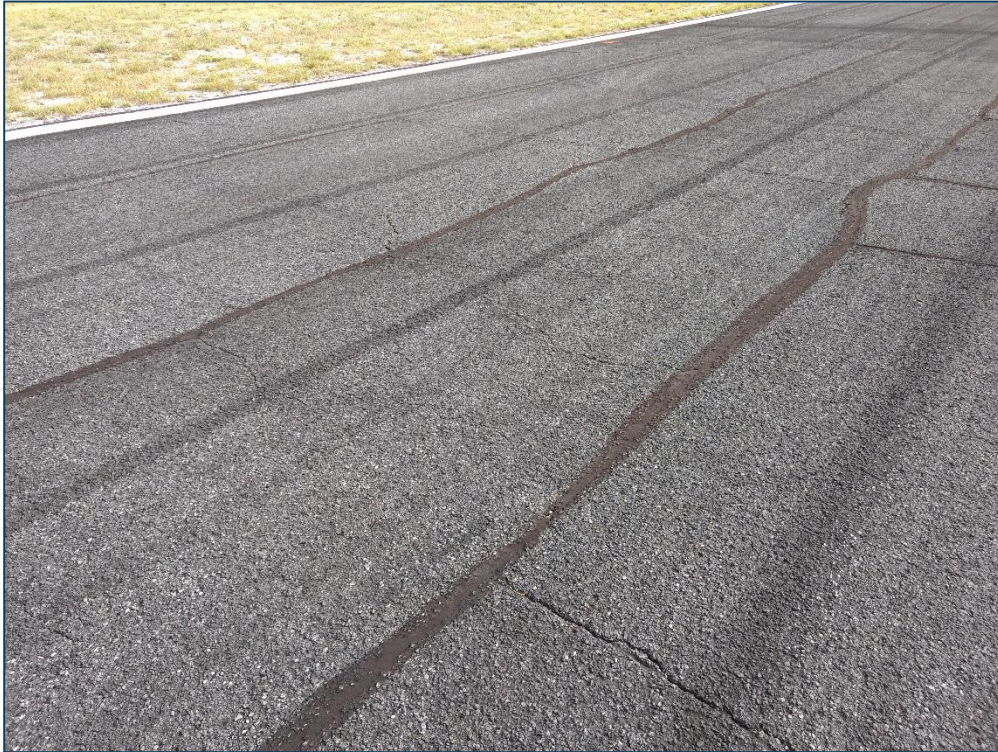
Runway 5-23, Section 6105, Sample Unit 115 - Low Severity (43) Block Cracking, Medium Severity (52) Raveling

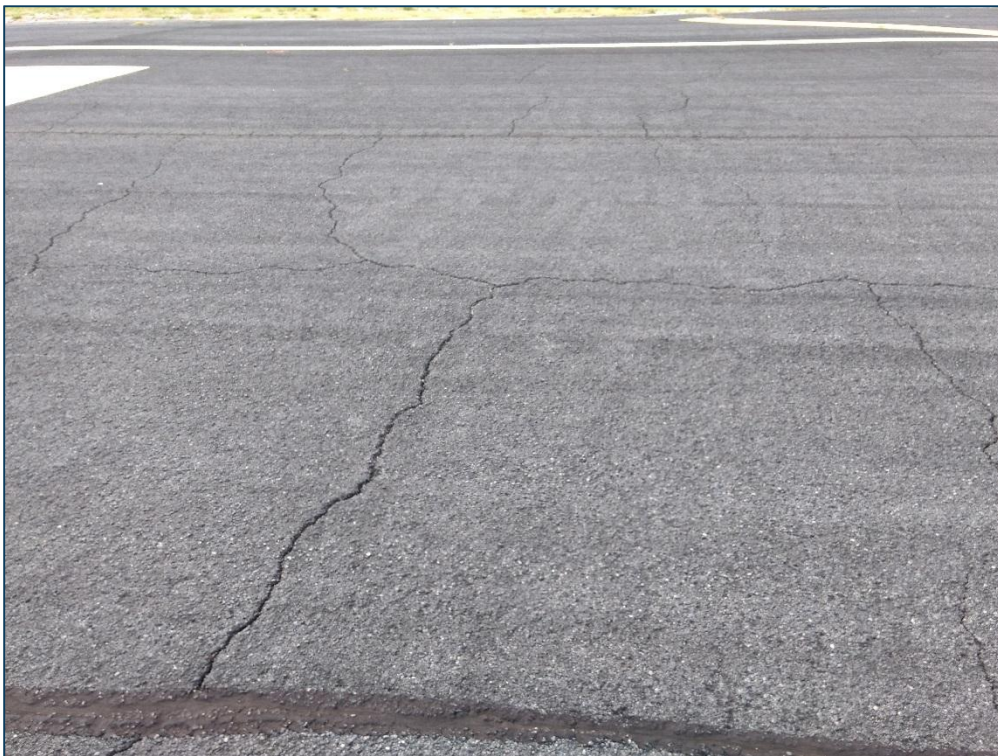
Runway 5-23, Section 6105, Sample Unit 135 - Low Severity (43) Block Cracking, Medium Severity (43) Block Cracking, Medium Severity (52) Raveling

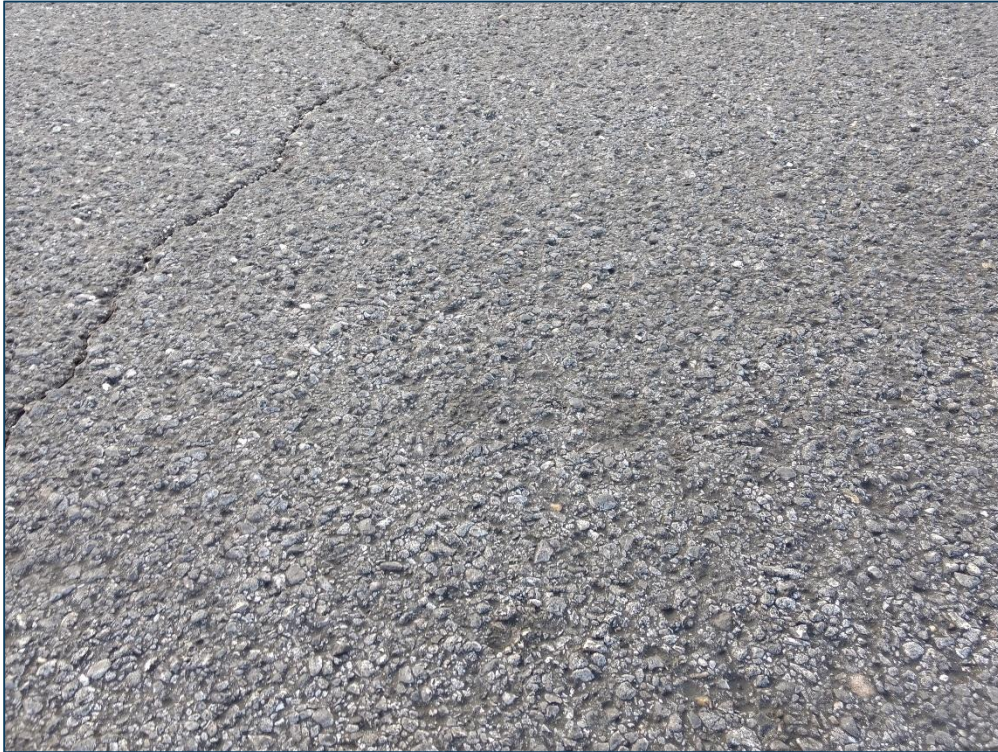
Runway 5-23, Section 6105, Sample Unit 143 - Low Severity (43) Block Cracking, Medium Severity (52) Raveling

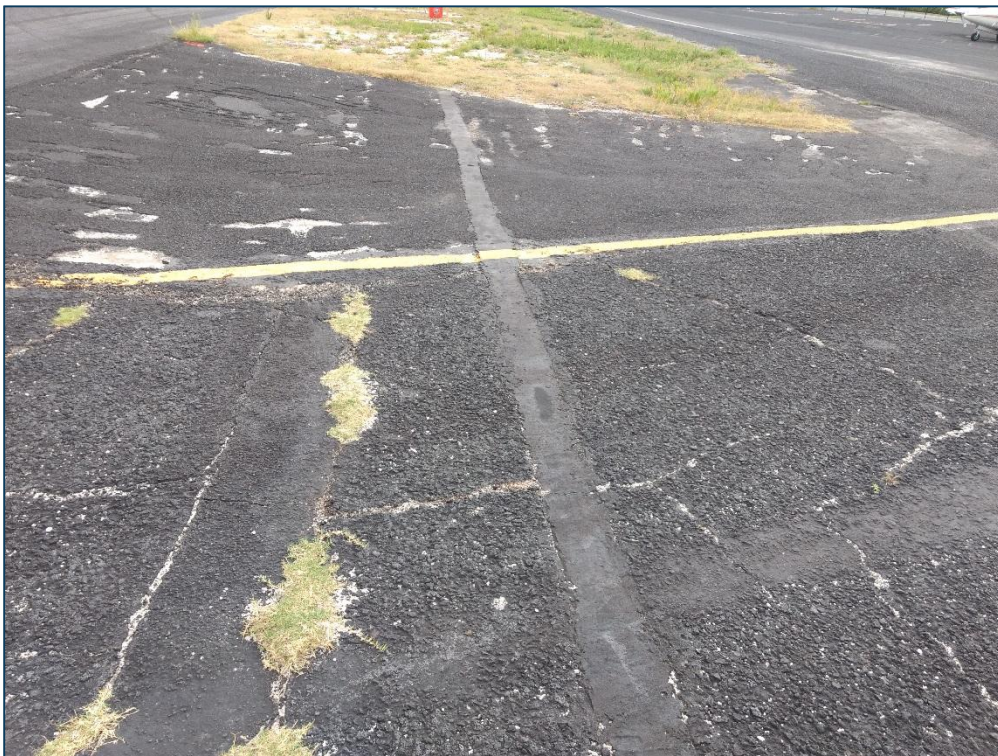
Taxiway A, Section 105, Sample Unit 100 - Medium Severity (43) Block Cracking, Low Severity (50) Patching, Medium Severity (50) Patching, Medium Severity (52) Raveling, High Severity (52) Raveling

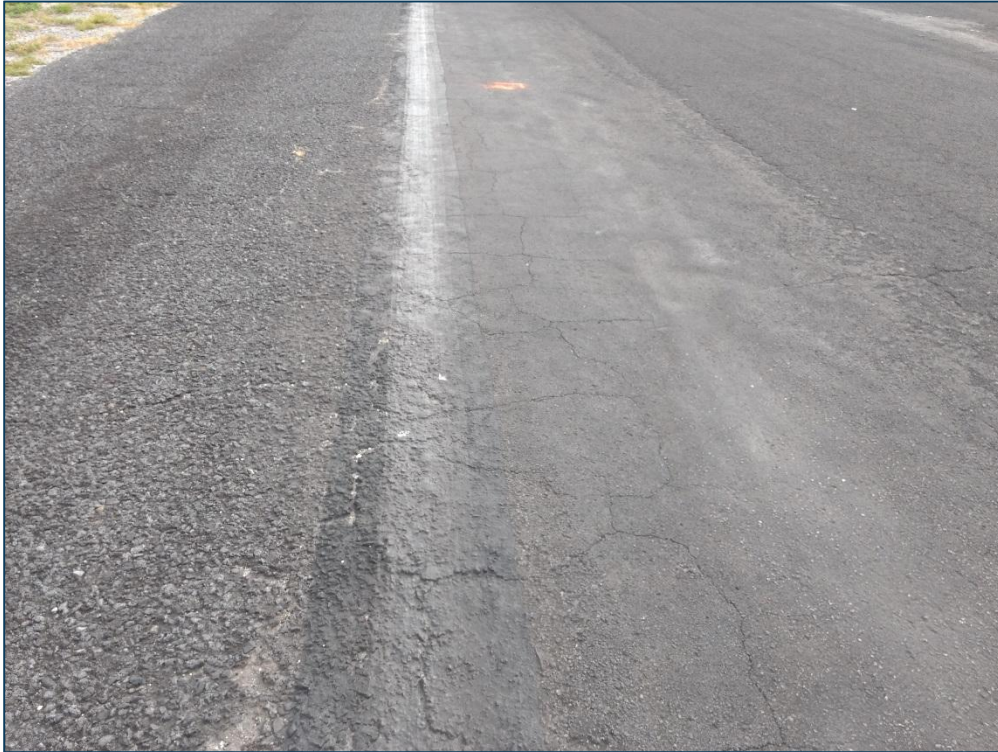
Taxiway A, Section 105, Sample Unit 100 - Medium Severity (43) Block Cracking, Medium Severity (52) Raveling

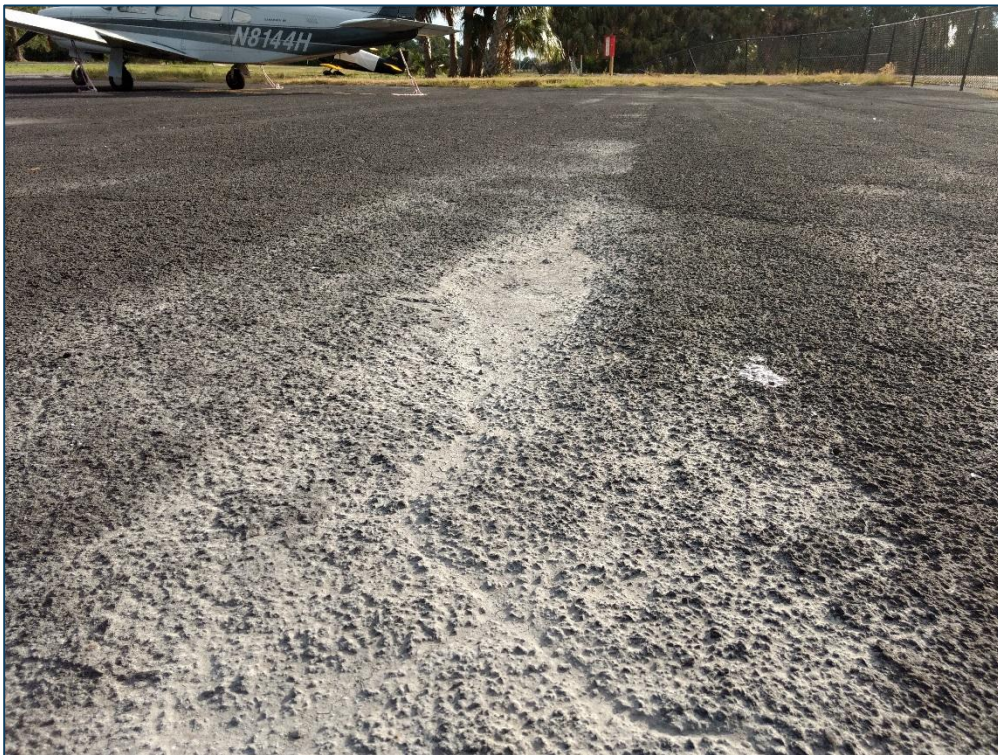
Apron, Section 4105, Sample Unit 100 - Low Severity (43) Block Cracking, Low Severity (45) Depression, Medium Severity (52) Raveling
