FLORIDA DEPARTMENT OF TRANSPORTATION
AVIATION AND SPACEPORTS OFFICE

Statewide Airfield Pavement Management Program

**Airport Pavement
Evaluation Report
September 2017**

**Destin Executive
Airport (DTS)**
General Aviation Airport
District 3

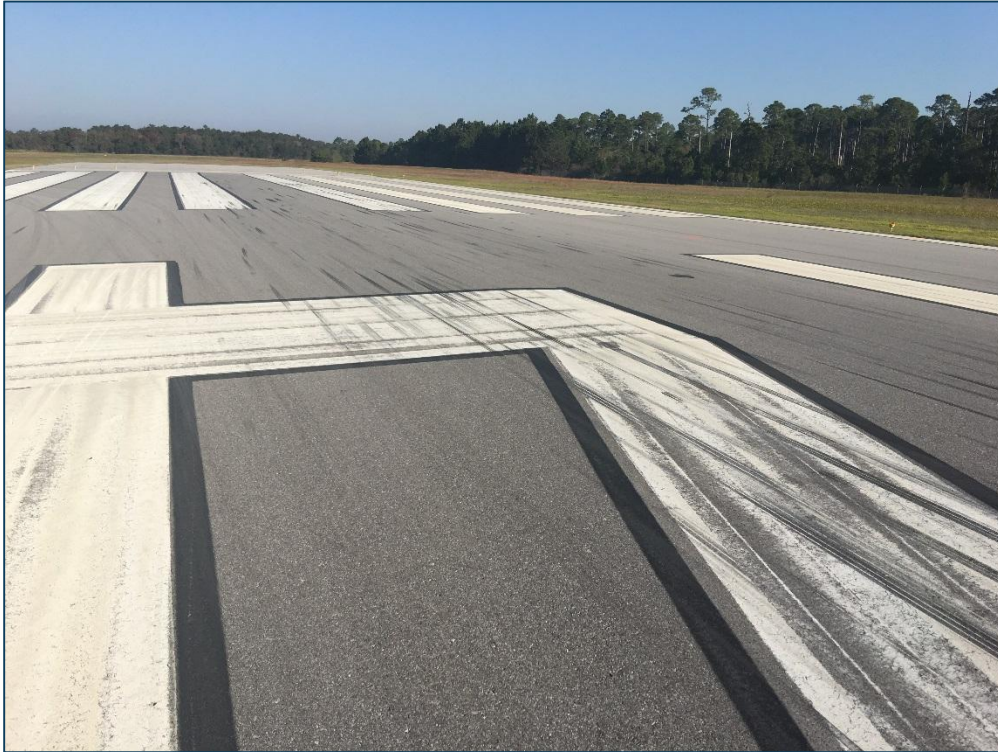
Runway 14-32, Section 6115, Sample Unit 302 – Low Severity (57) Weathering

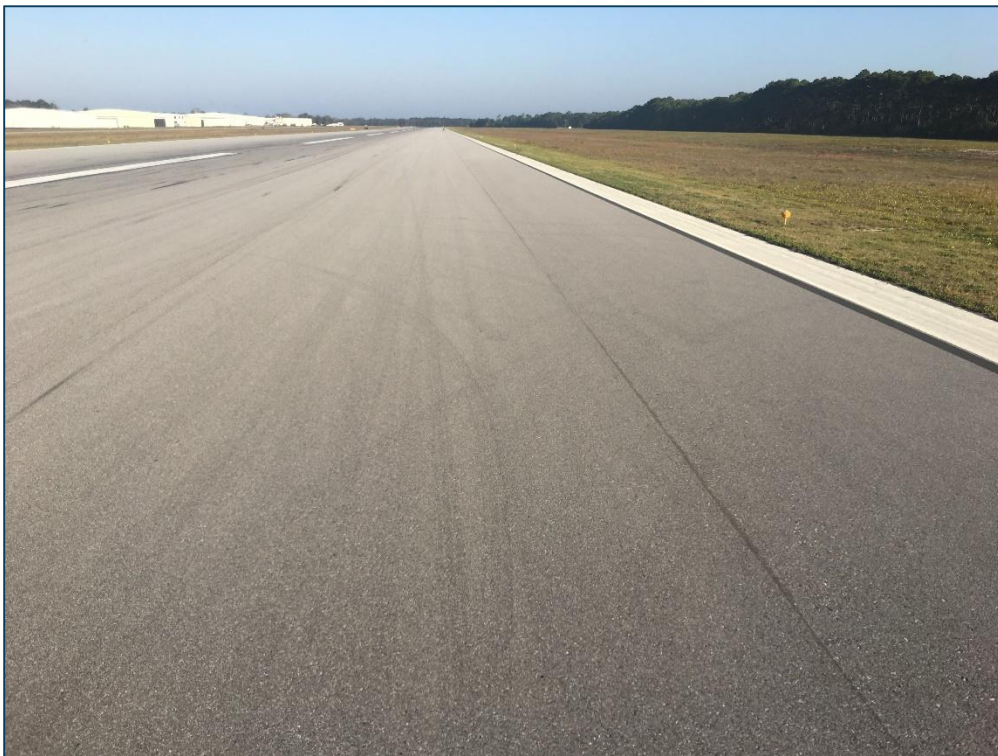
Runway 14-32, Section 6110, Sample Unit 168 – Low Severity (57) Weathering

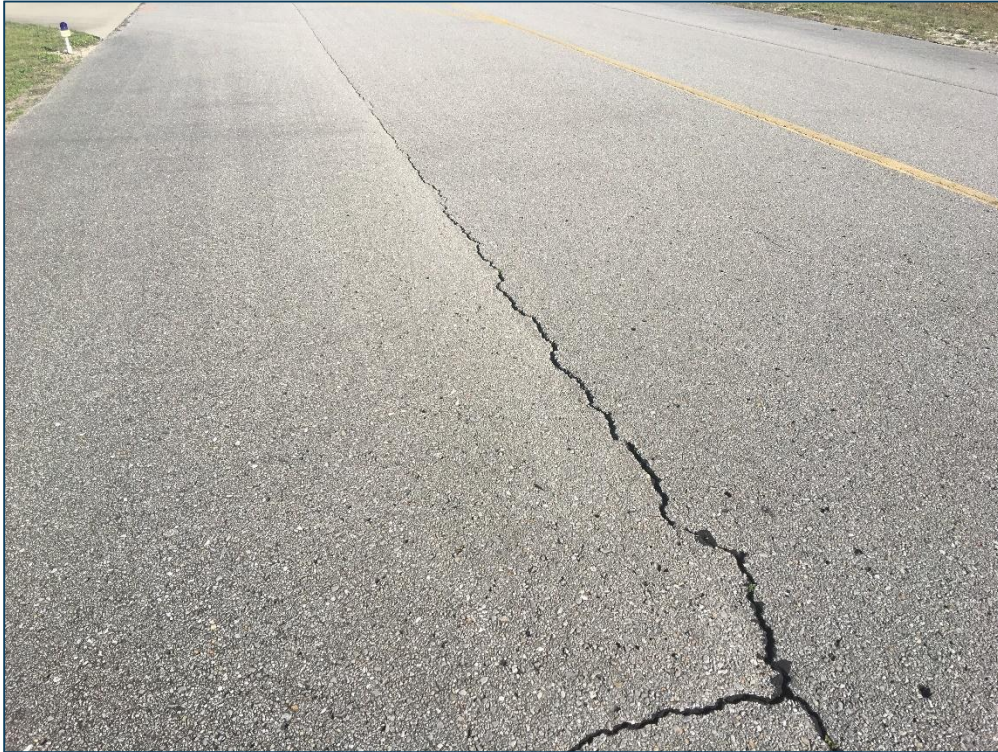
Taxiway A1, Section 105, Sample Unit 108 – Low and Medium Severity (48) Longitudinal and Transverse Cracking, Low Severity (52) Raveling, Medium Severity (52) Raveling

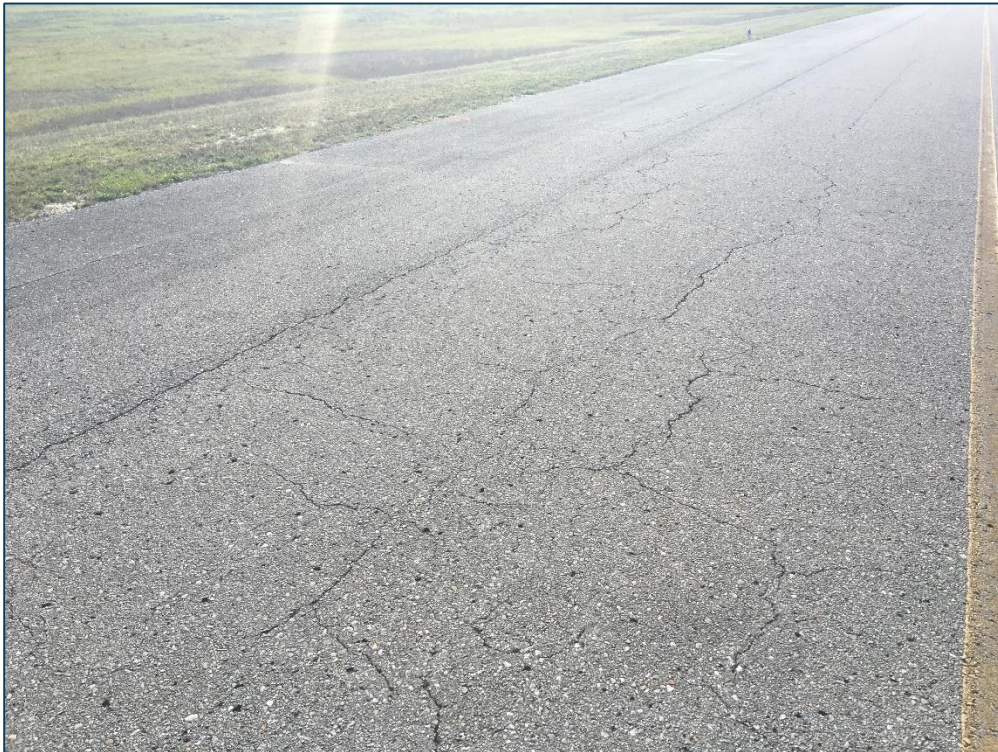
Taxiway A, Section 115, Sample Unit 127 – Low Severity (43) Block Cracking, Low Severity (48) Longitudinal and Transverse Cracking, Medium Severity (52) Raveling, Low Severity (56) Swelling

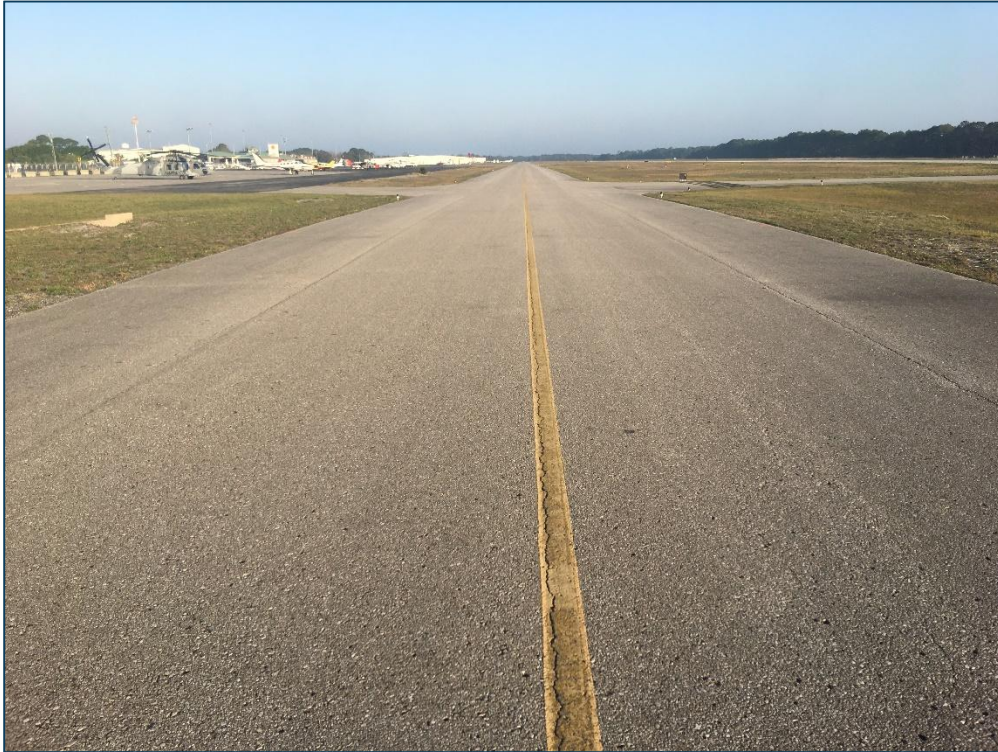
Taxiway A, Section 135, Sample Unit 146 – Low Severity (48) Longitudinal and Transverse Cracking, Low Severity (52) Raveling, Medium Severity (52) Raveling

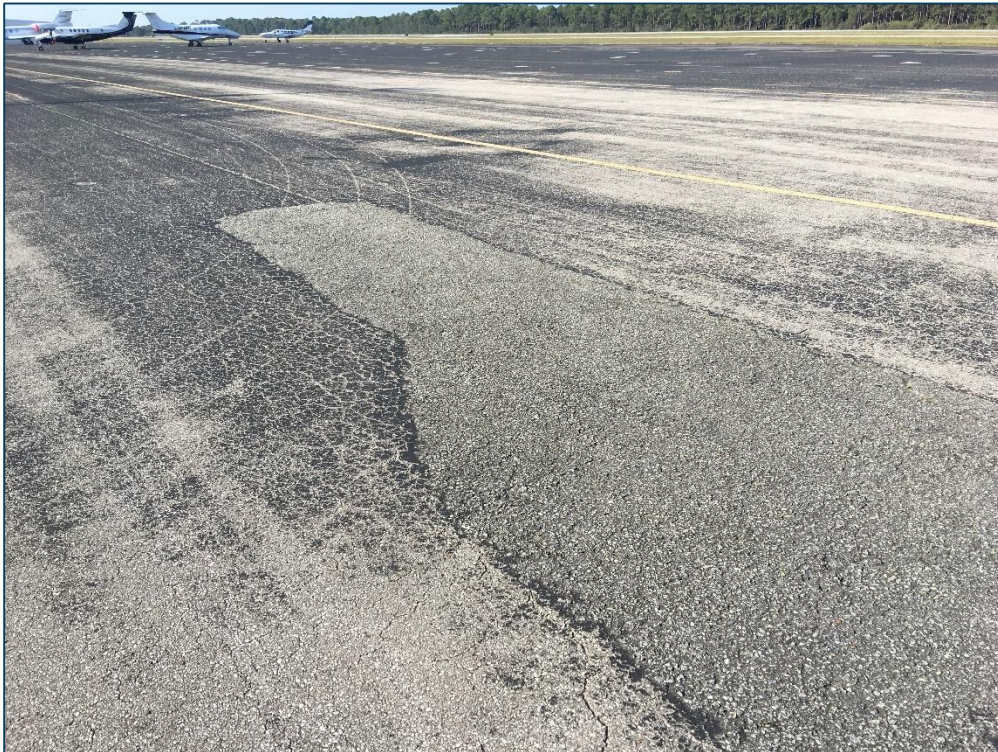
Apron, Section 4125, Sample Unit 709 – Low and Medium Severity (48) Longitudinal and Transverse Cracking, Medium Severity (50) Patching, Medium Severity (52) Raveling

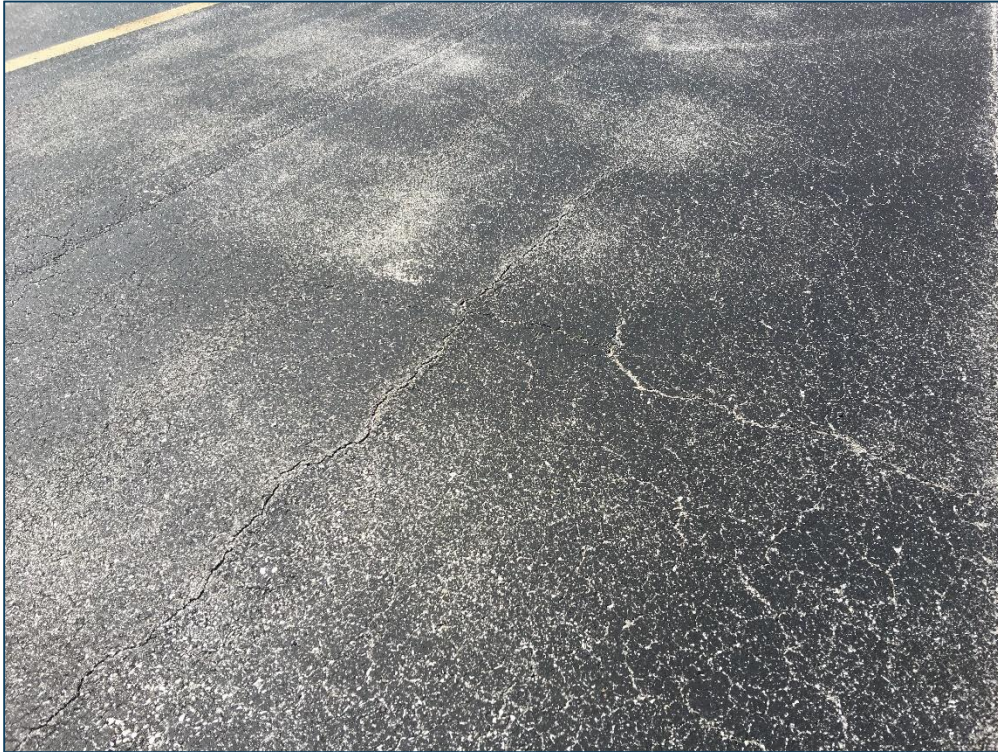
Apron, Section 4120, Sample Unit 84 – Low Severity (48) Longitudinal and Transverse Cracking, Low Severity (52) Raveling, Medium Severity (52) Raveling

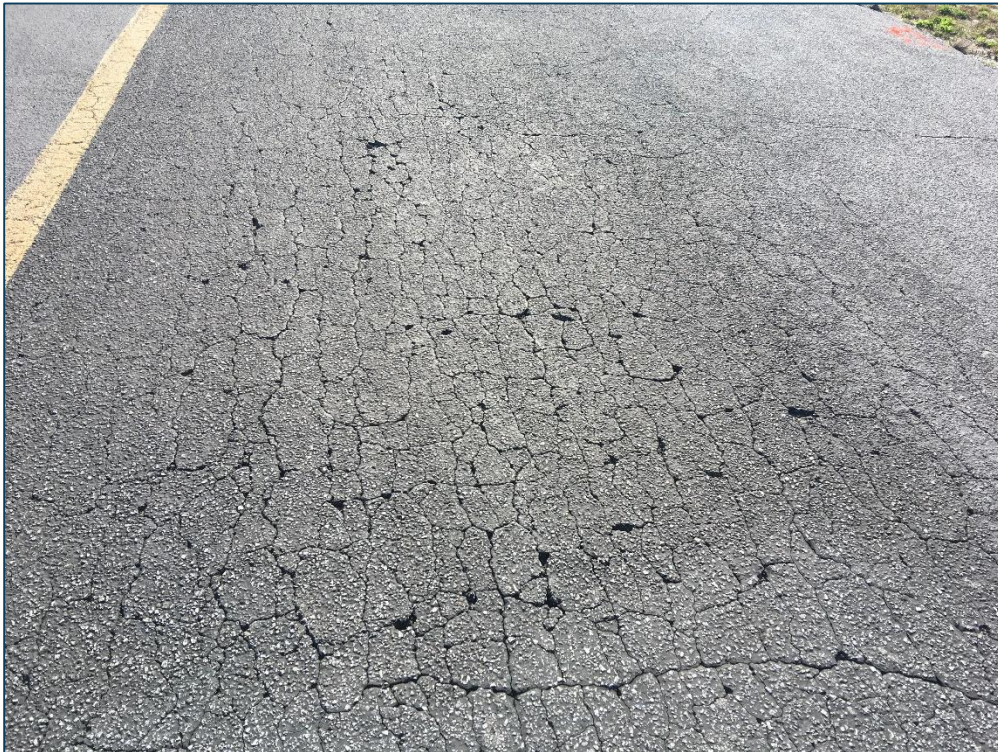
Taxiway Connector, Section 209, Sample Unit 201 – Medium Severity (41) Alligator Cracking, Low Severity (48) Longitudinal and Transverse Cracking, Low Severity (52) Raveling
