Statewide Airfield Pavement Management Program

Airport Pavement
Evaluation Report
September 2017

**Carrabelle-Thompson
Airport (X13)**
General Aviation Airport
District 3

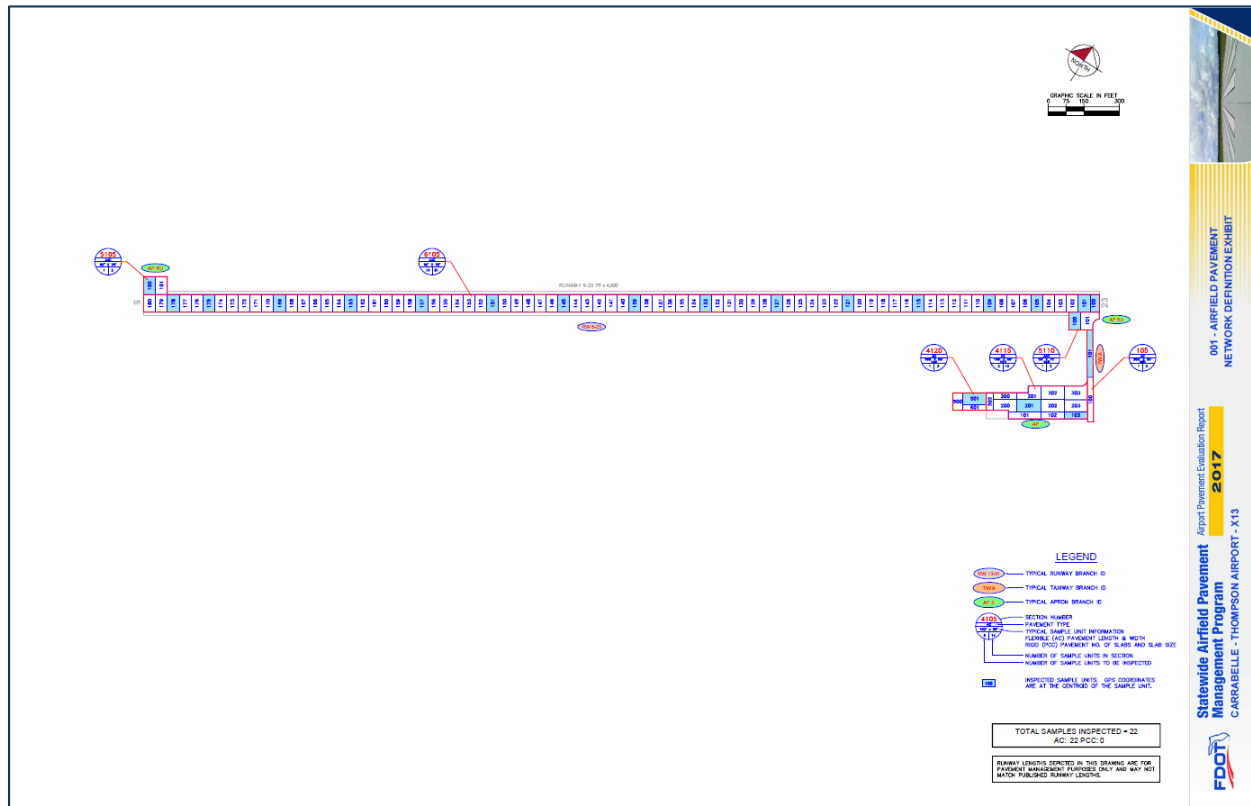
Figure 3.1.1-1 2017 Airfield Pavement Network Definition Exhibit

The Airfield Pavement Network Definition Exhibit provides details to the PCI Survey inspection efforts. The exhibit identifies the pavement facilities, surface type, section definition, and sample unit delineation.

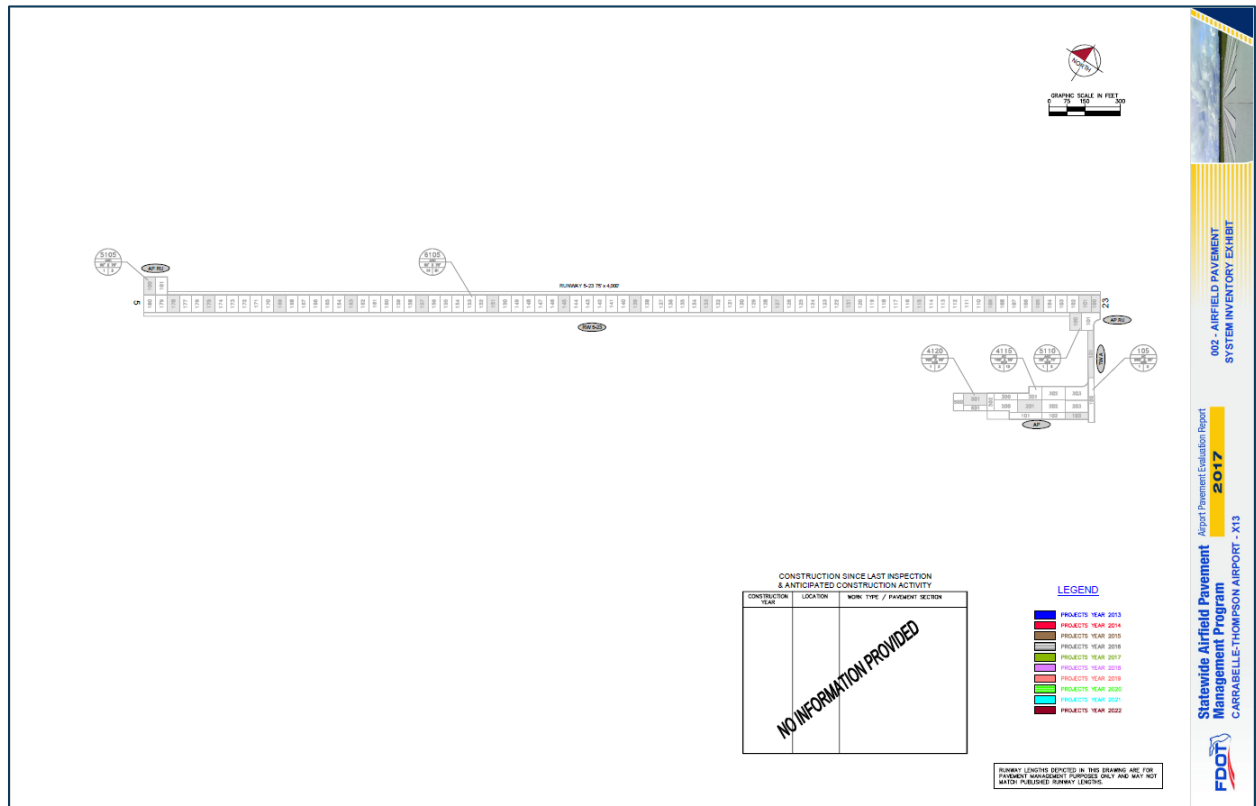
Figure 3.1.1-2 2017 Airfield Pavement System Inventory Exhibit

The Airfield Pavement System Inventory Exhibit provides details to the work history updates communicated by the Airport. The Exhibit provides the approximate limits of recent and/or anticipated construction on the airfield pavement facilities. The limits are based on documentation provided by the Airport and, if constructed, observed in the field.

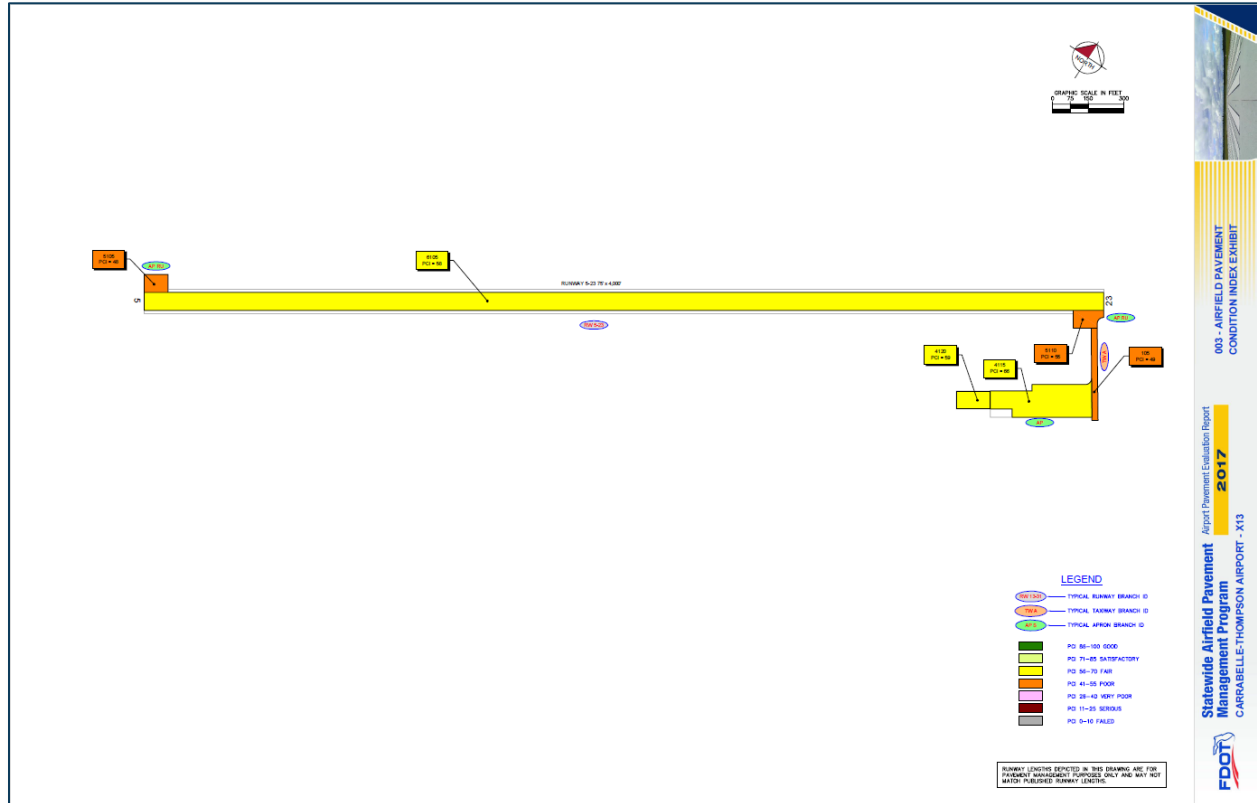
Figure 4.1.3 2017 Airfield Pavement Condition Index Exhibit

Figure 4.1.3 is an inset view of the 2017 Airfield Pavement Condition Index Exhibit that visually represents the results of the latest PCI Survey inspection. A large format exhibit is located in **Appendix C Technical Exhibits**.

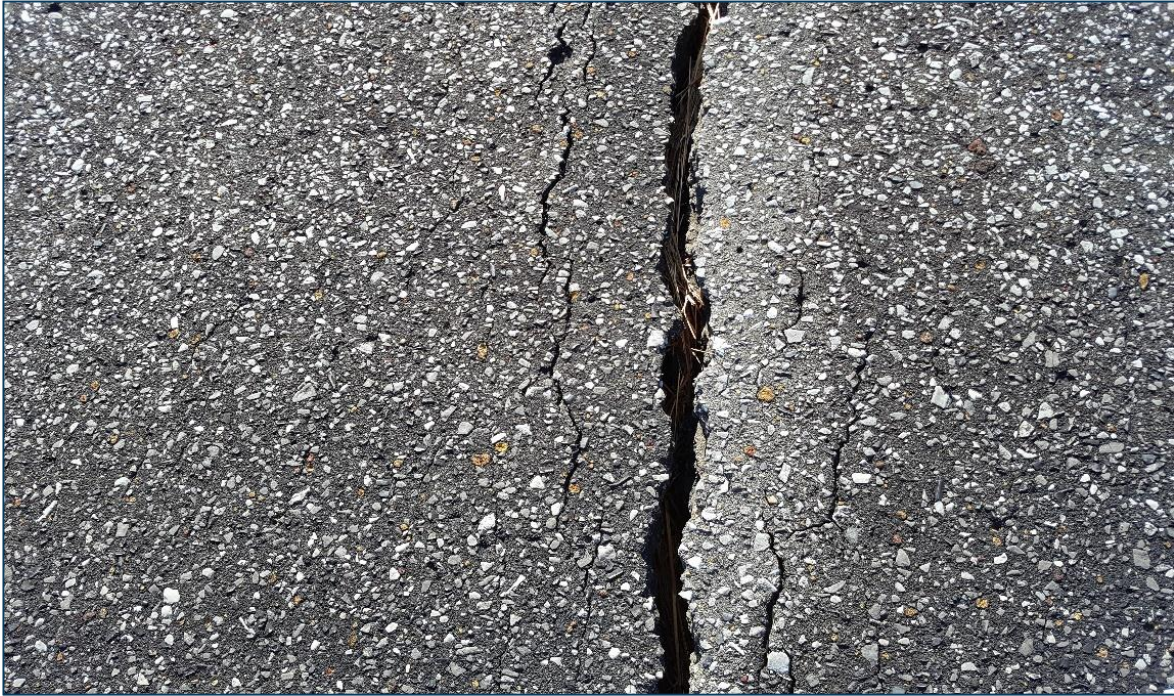
Runway 5-23, Section 6105, Sample Unit 115 – Low and Medium Severity (48) Longitudinal and Transverse Cracking, Low Severity (56) Swelling, Low Severity (52) Raveling

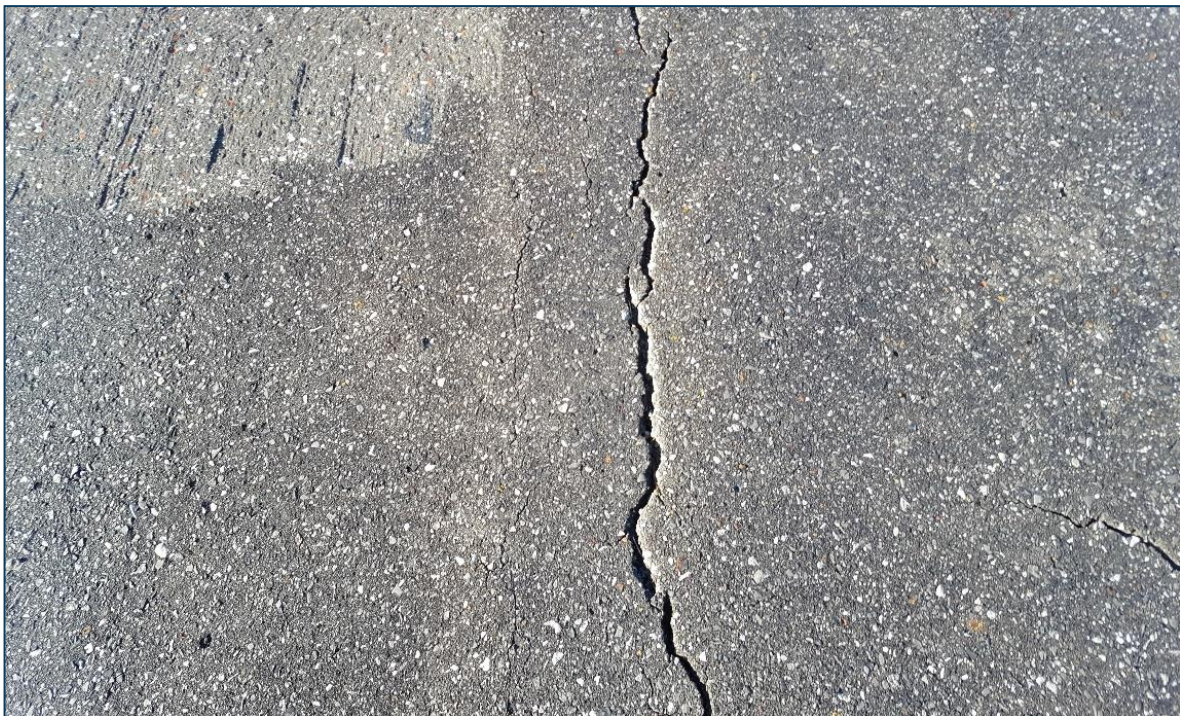
Runway 5-23, Section 6105, Sample Unit 100 – Low and Medium Severity (48) Longitudinal and Transverse Cracking, Low Severity (52) Raveling, Medium Severity (52) Raveling, Low Severity (56) Swelling

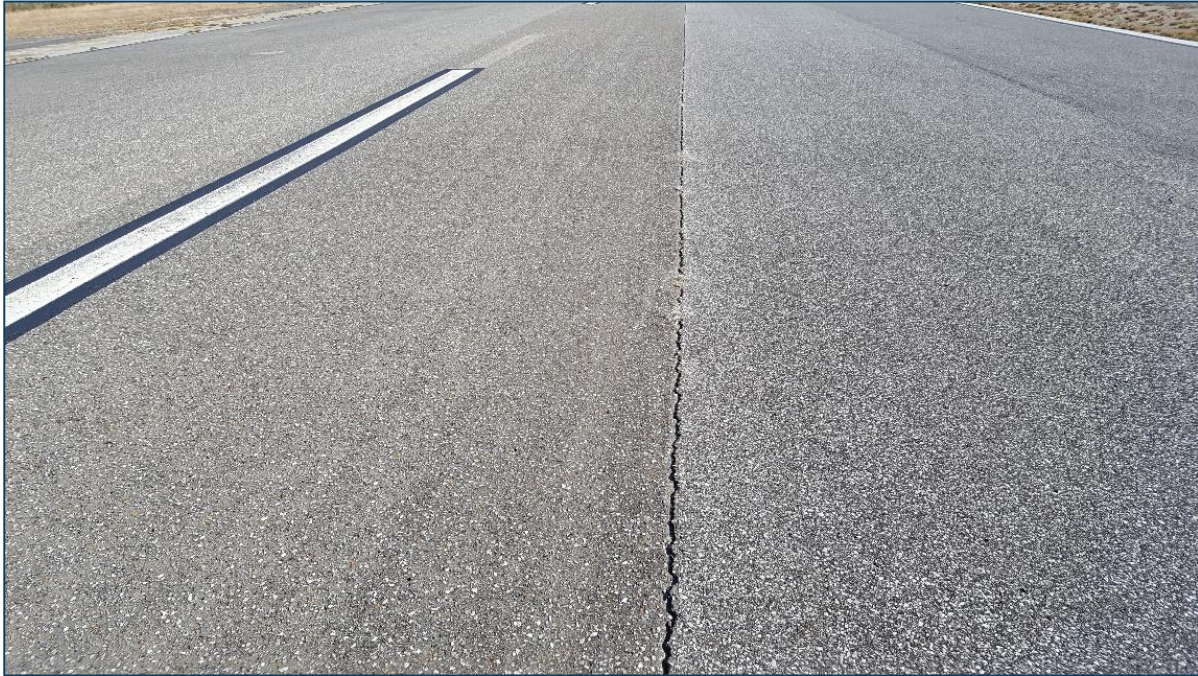
Runway 5-23, Section 6105, Sample Unit 145 – Low and Medium Severity (48) Longitudinal and Transverse Cracking, Low Severity (52) Raveling, Medium Severity (52) Raveling

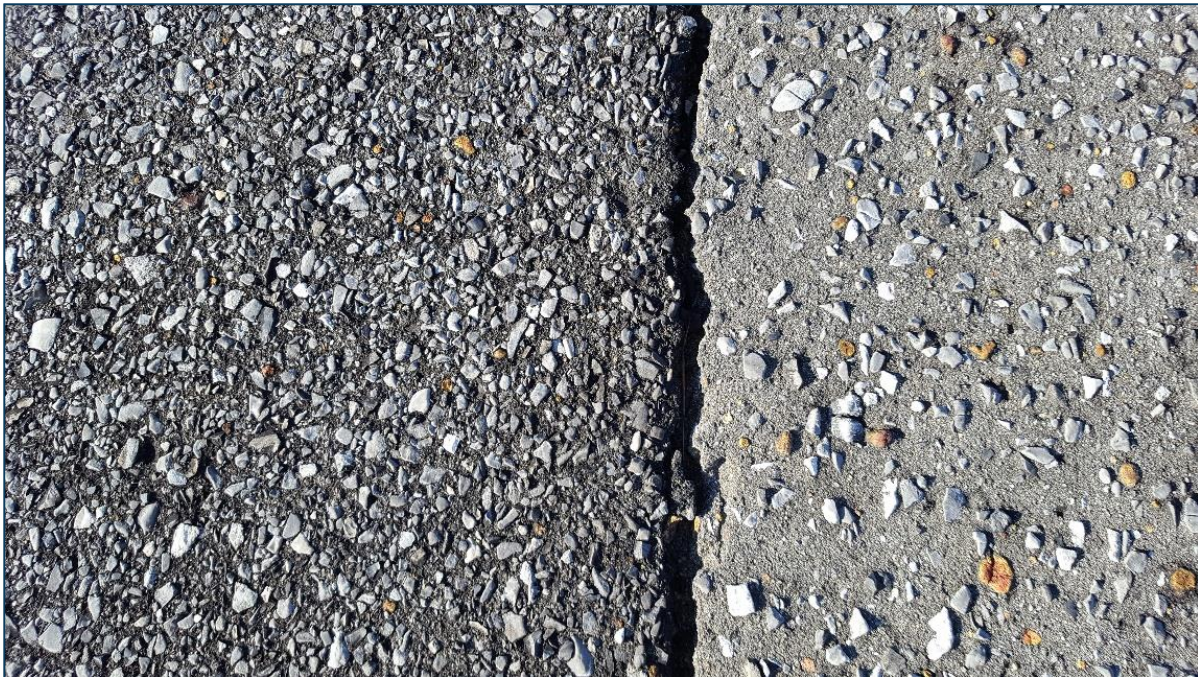
Runway 5-23, Section 6105, Sample Unit 101 – Medium Severity (48) Longitudinal and Transverse Cracking, Low Severity (52) Raveling, Medium Severity (52) Raveling

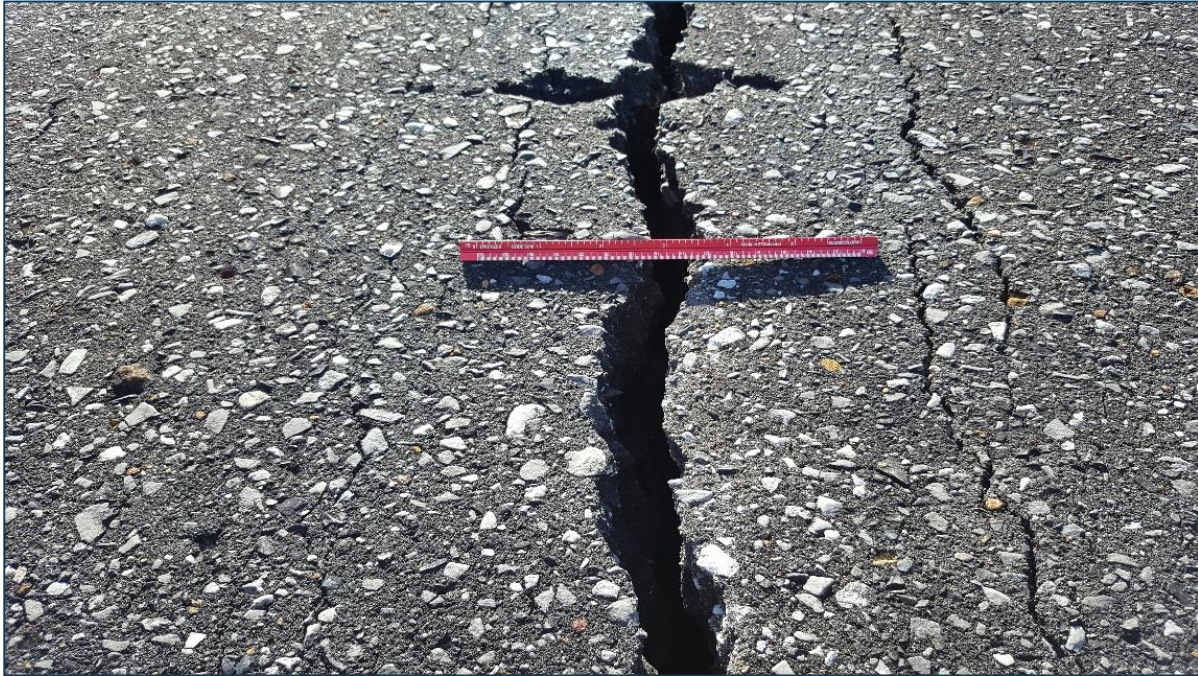
Runway 5-23, Section 6105, Sample Unit 105 – Low and Medium Severity (48) Longitudinal and Transverse Cracking, Low Severity (52) Raveling

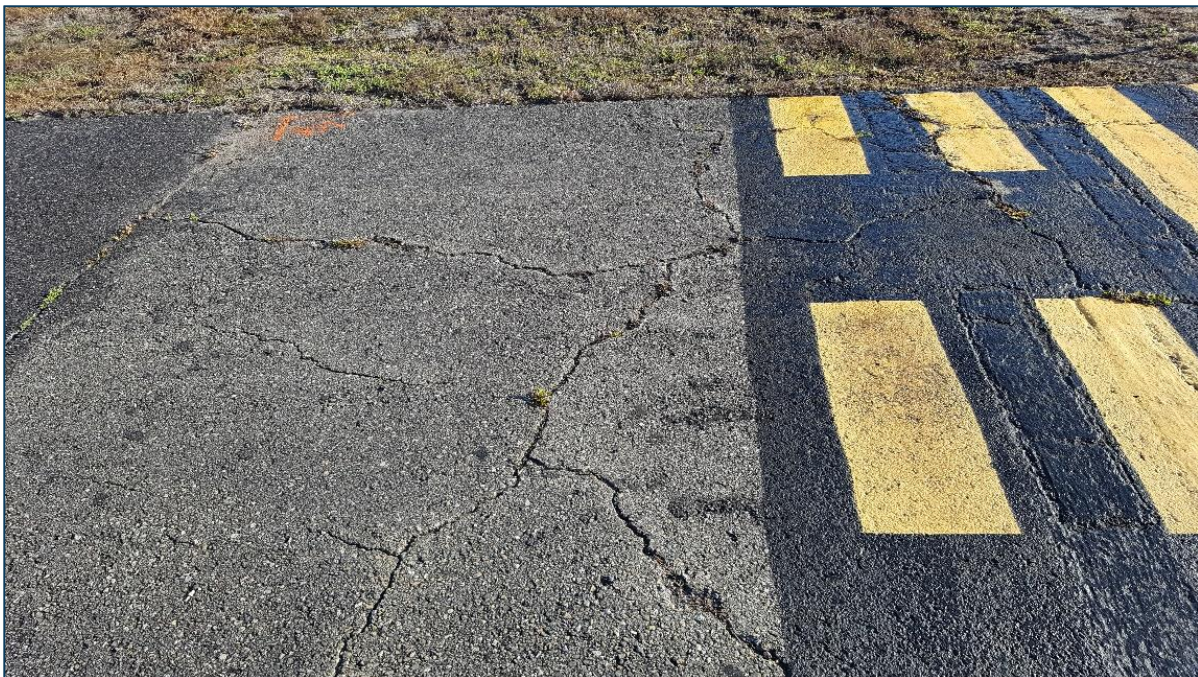
Taxiway A, Section 105, Sample Unit 101 – Low Severity (43) Block Cracking, Low and Medium Severity (48) Longitudinal and Transverse Cracking, Low Severity (52) Raveling, Low Severity (57) Weathering

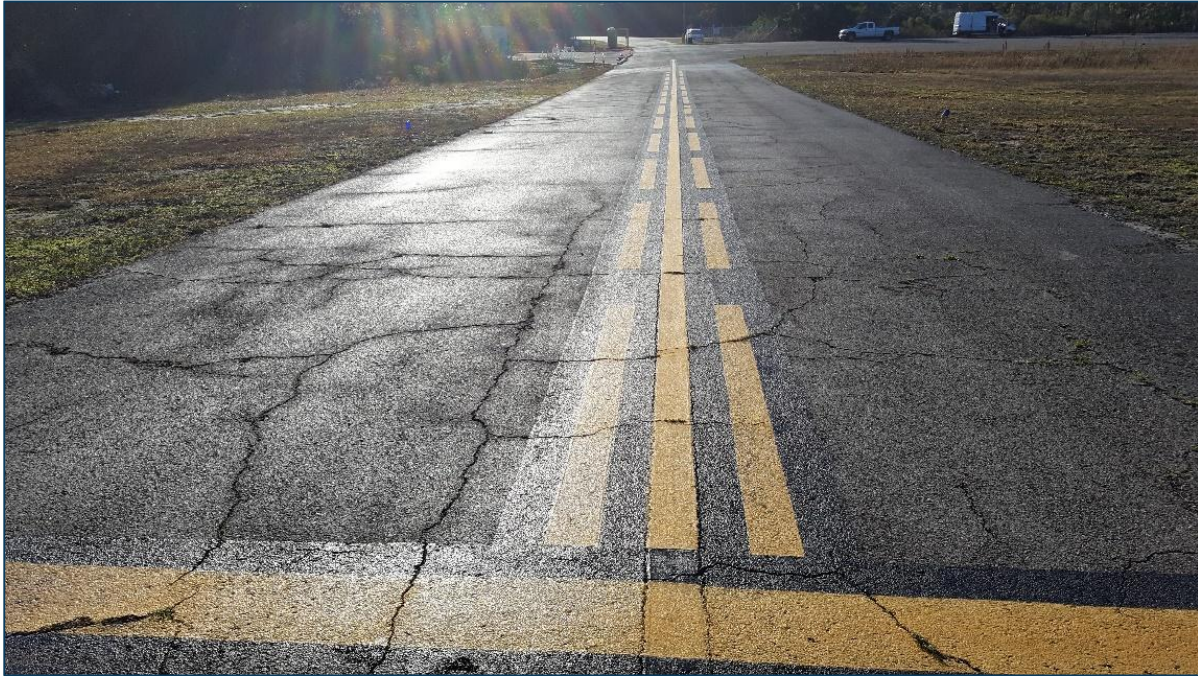
Taxiway A, Section 105, Sample Unit 101 – Low Severity (43) Block Cracking, Low and Medium Severity (48) Longitudinal and Transverse Cracking, Low Severity (52) Raveling, Low Severity (57) Weathering

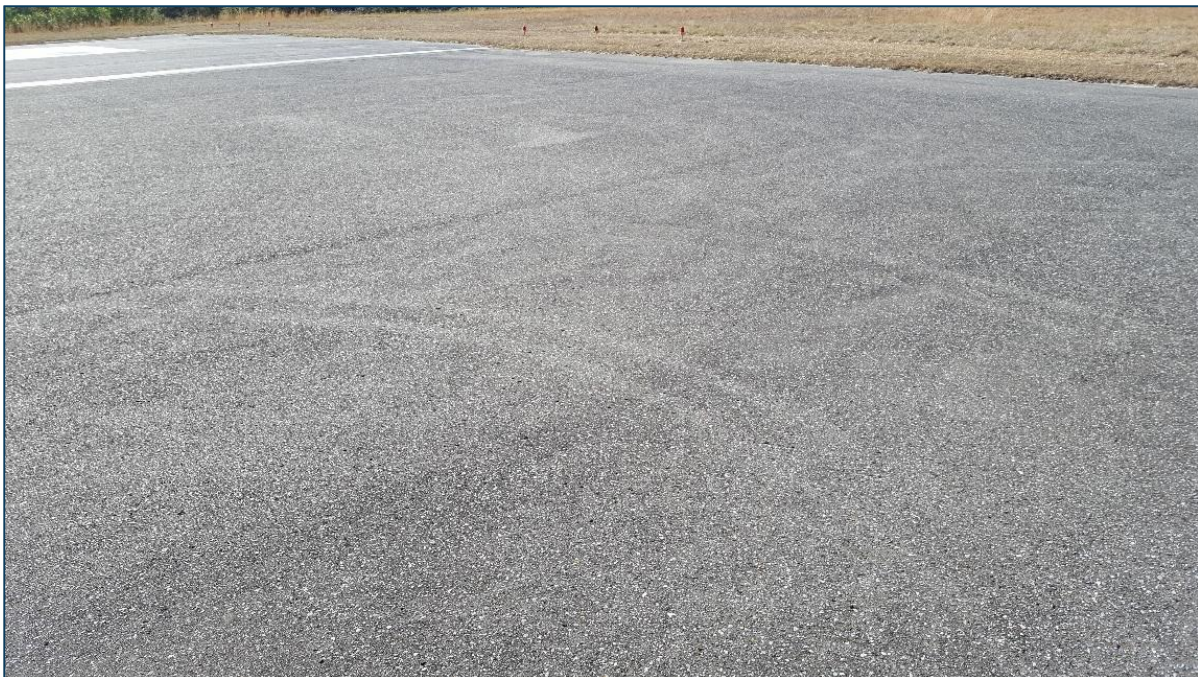
Apron AP RU, Section 5105, Sample Unit 100 – Low Severity (45) Depression, Low Severity (48) Longitudinal and Transverse Cracking, Low Severity (52) Raveling, Medium Severity (52) Raveling

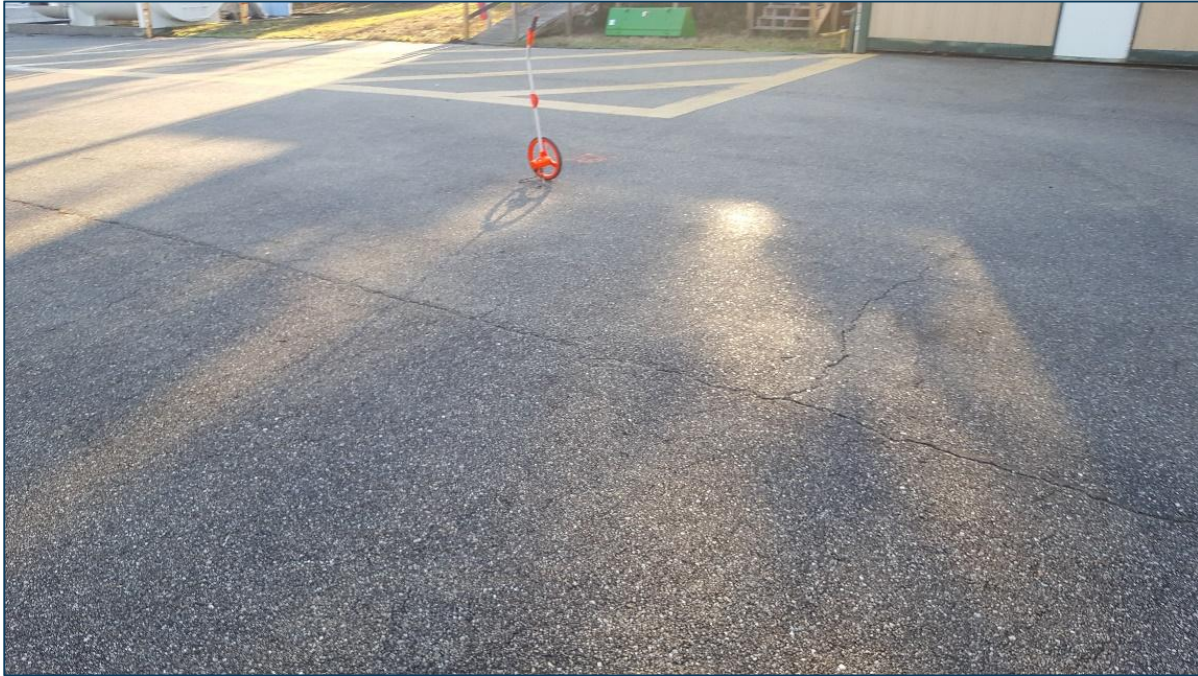
Apron AP, Section 4120, Sample Unit 501 – Low and Medium Severity (48) Longitudinal and Transverse Cracking, Low Severity (52) Raveling

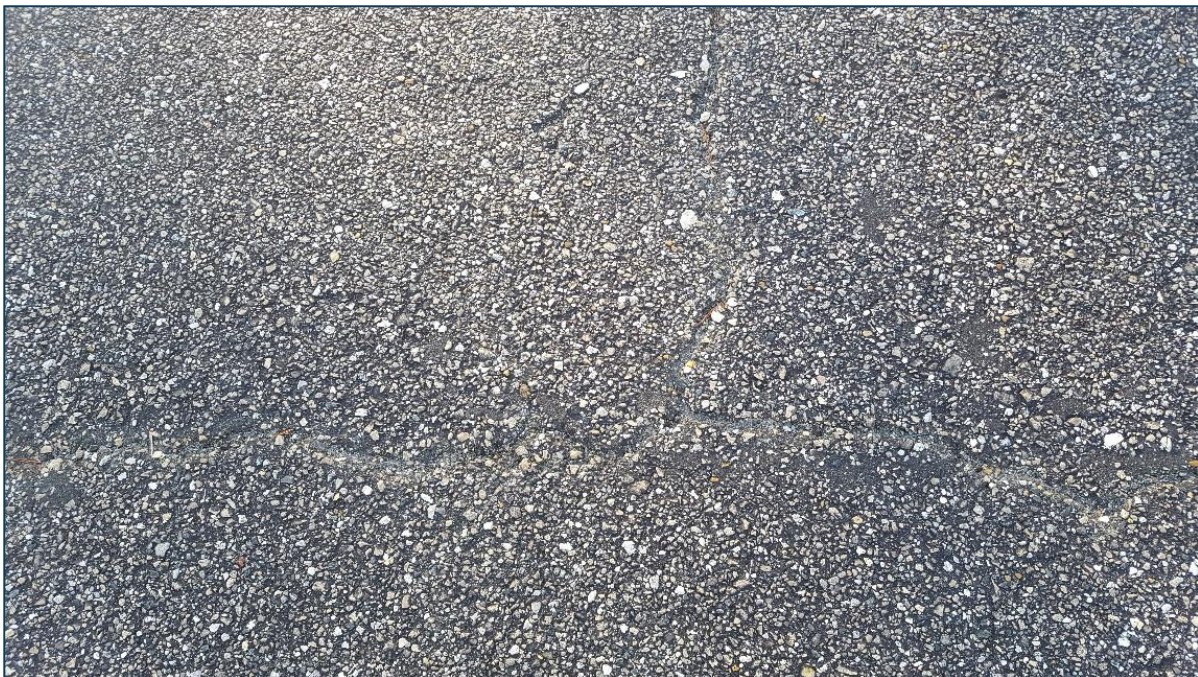
Apron AP, Section 4120, Sample Unit 501 – Low and Medium Severity (48) Longitudinal and Transverse Cracking, Low Severity (52) Raveling, Medium Severity (52) Raveling
