Statewide Airfield Pavement Management Program

**Airport Pavement
Evaluation Report
September 2017**

**Umatilla Municipal
Airport (X23)**
General Aviation Airport
District 5

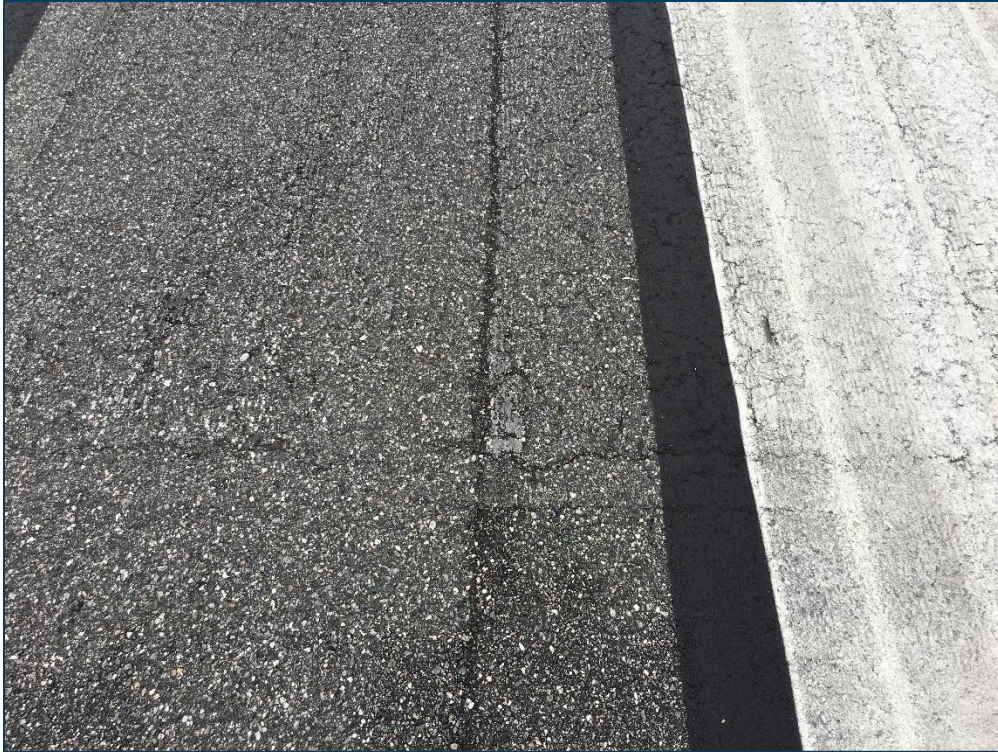
Runway 01-19, Section 6105, Sample Unit 202 – Low Severity (48) Longitudinal and Transverse Cracking, Low Severity (52) Raveling, Low Severity (57) Weathering

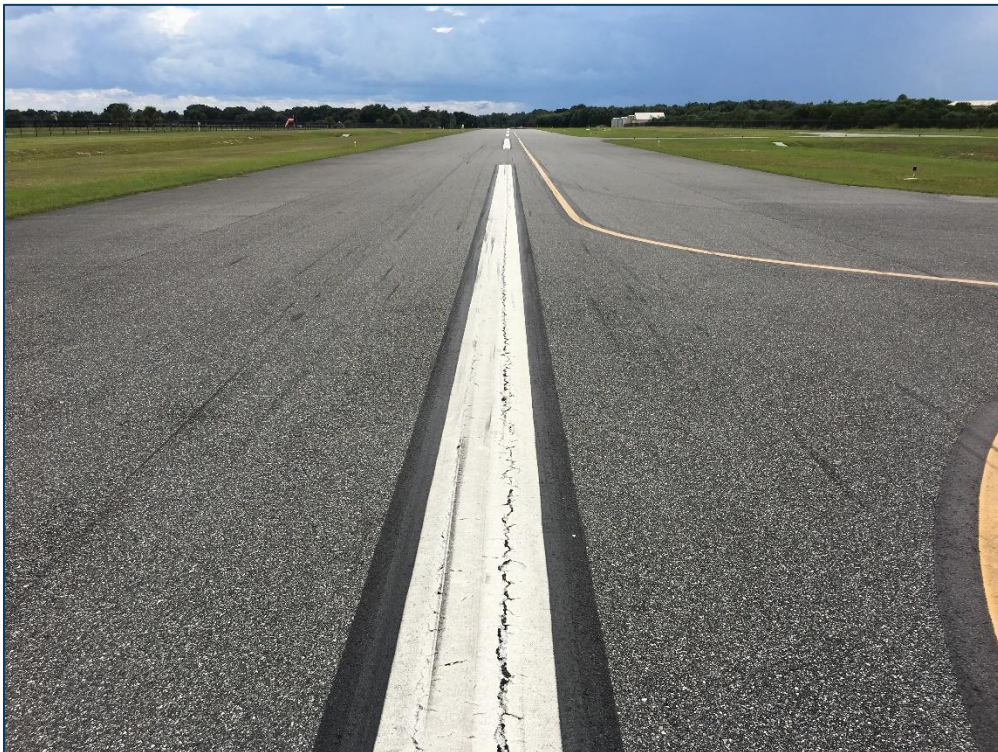
Runway 01-19, Section 6105, Sample Unit 217 – Low Severity (48) Longitudinal and Transverse Cracking, Low Severity (52) Raveling, Low Severity (57) Weathering

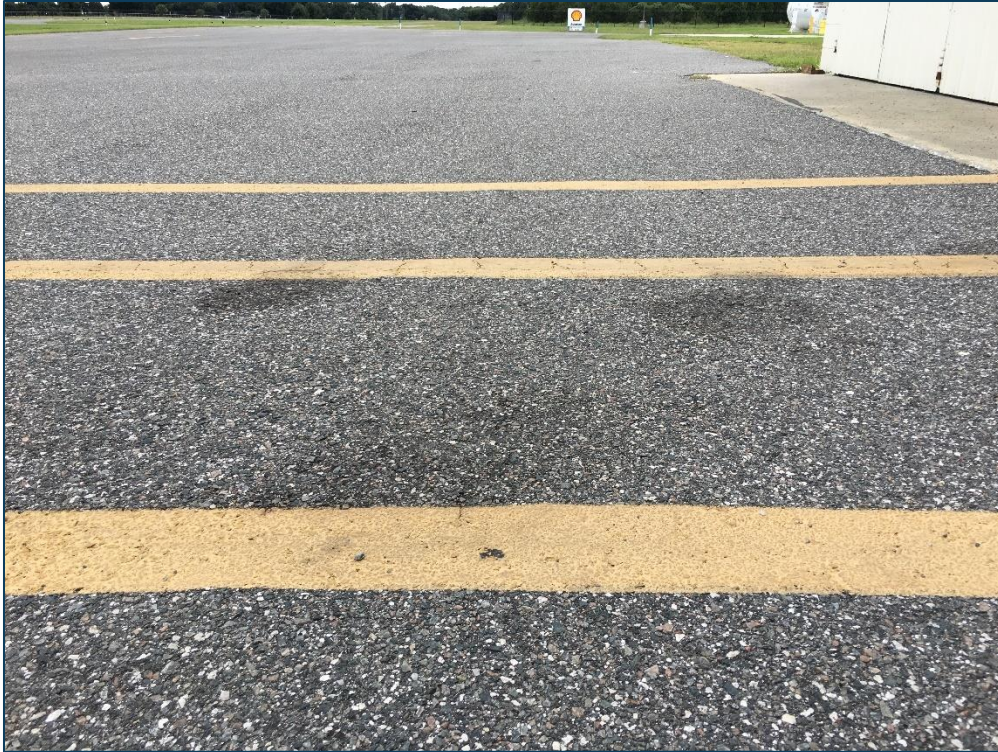
Taxiway AP, Section 110, Sample Unit 204 – Low Severity (56) Swelling, Low Severity (52) Raveling, Low Severity (57) Weathering

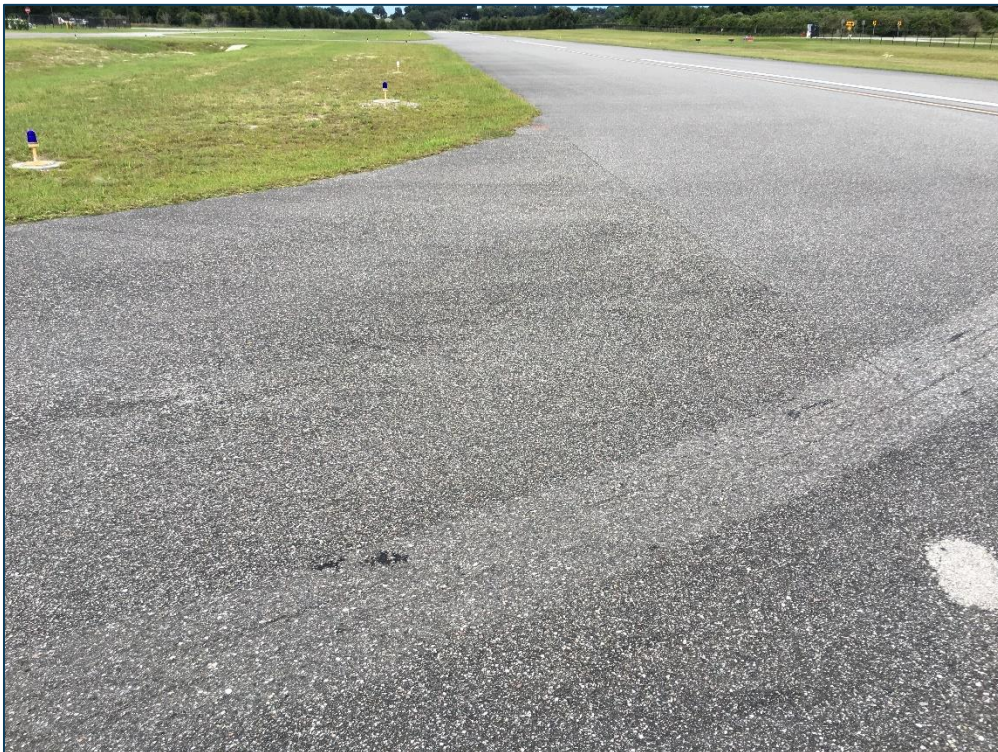
Taxiway AP, Section 110, Sample Unit 100 – Low Severity (52) Raveling, Low Severity (57) Weathering

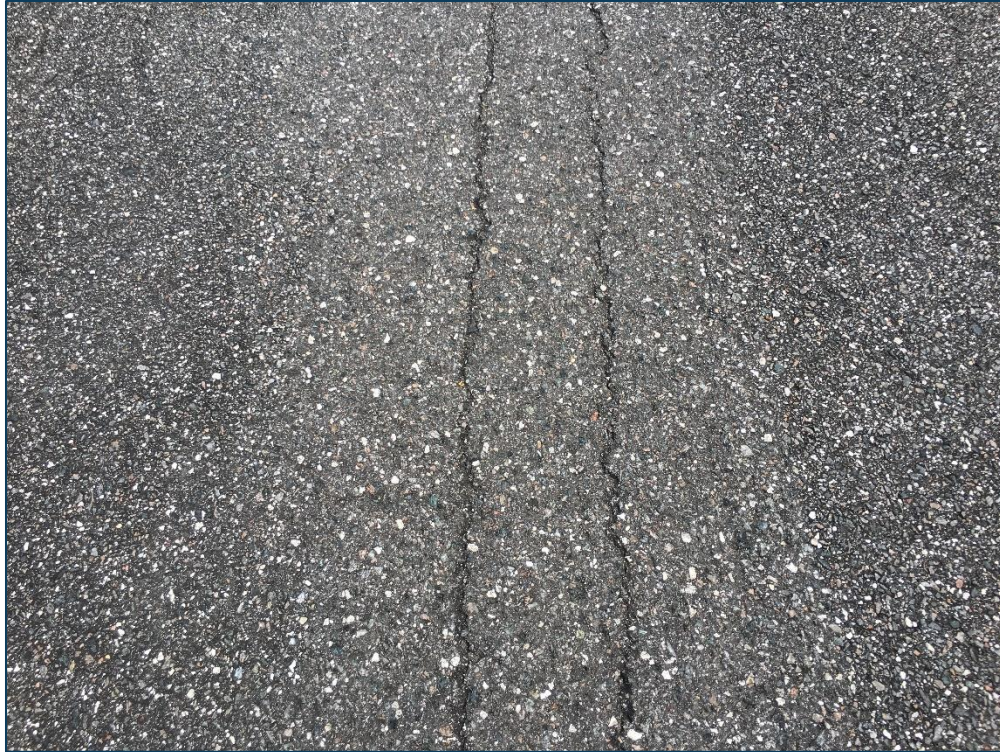
Taxiway AP, Section 110, Sample Unit 100 – Low Severity (48) Longitudinal and Transverse Cracking, Low Severity (52) Raveling, Low Severity (57) Weathering

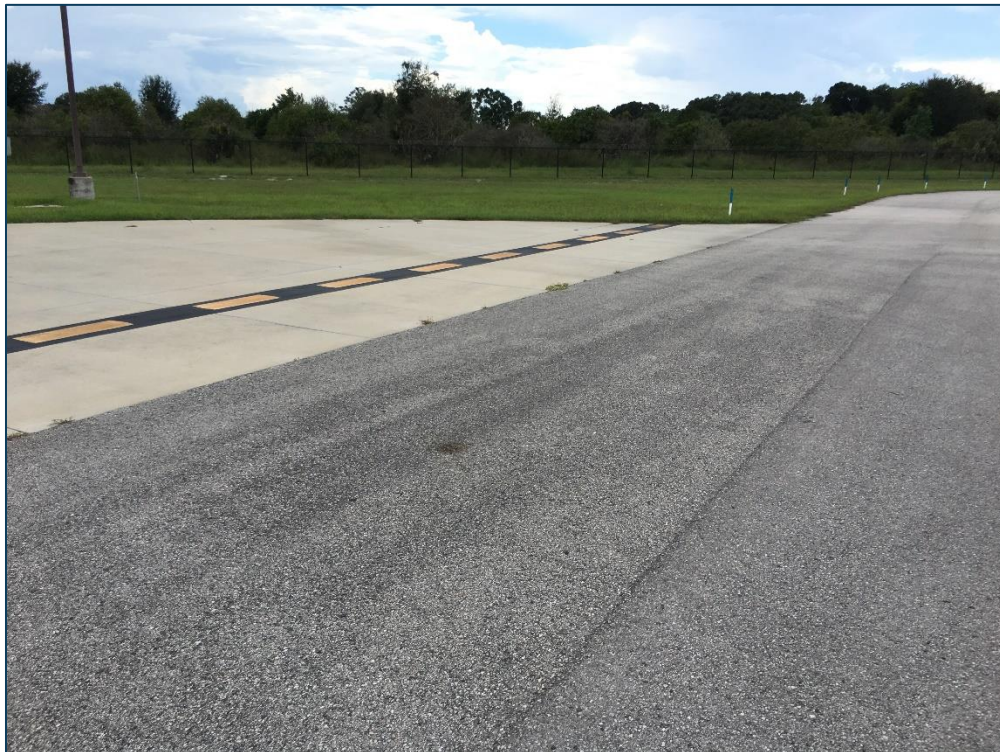
Taxilane To Hangar, Section 110, Sample Unit 301 – Low Severity (48) Longitudinal and Transverse Cracking, Low Severity (52) Raveling, Low Severity (57) Weathering

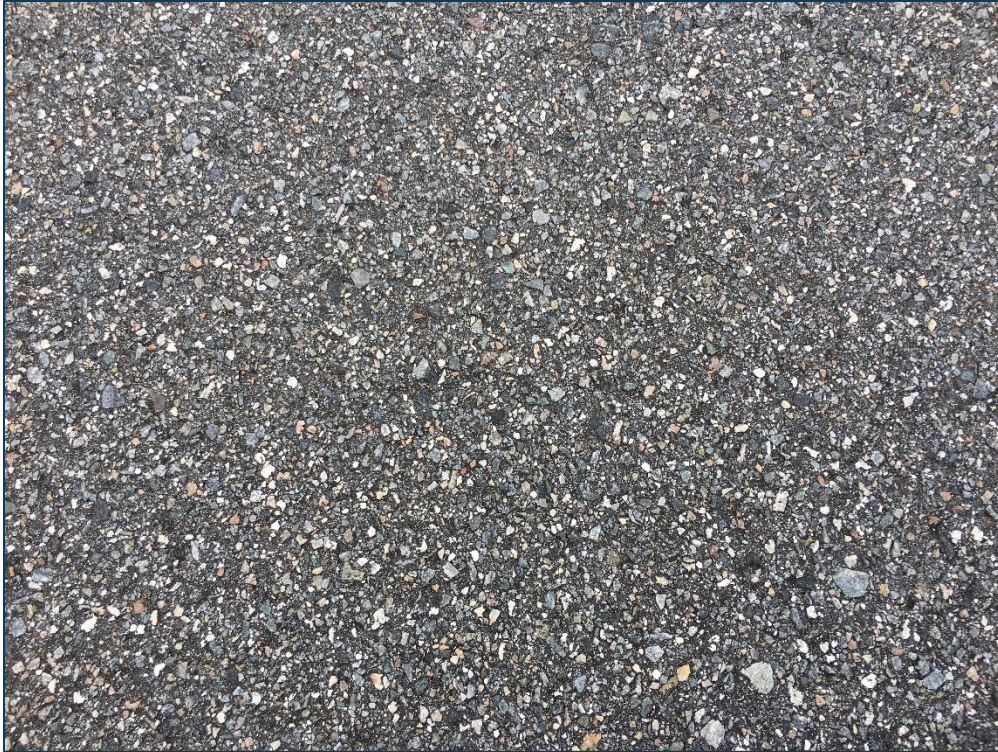
Taxilane To Hangar, Section 4115, Sample Unit 501 – Low Severity (57) Weathering, Medium Severity (57) Weathering

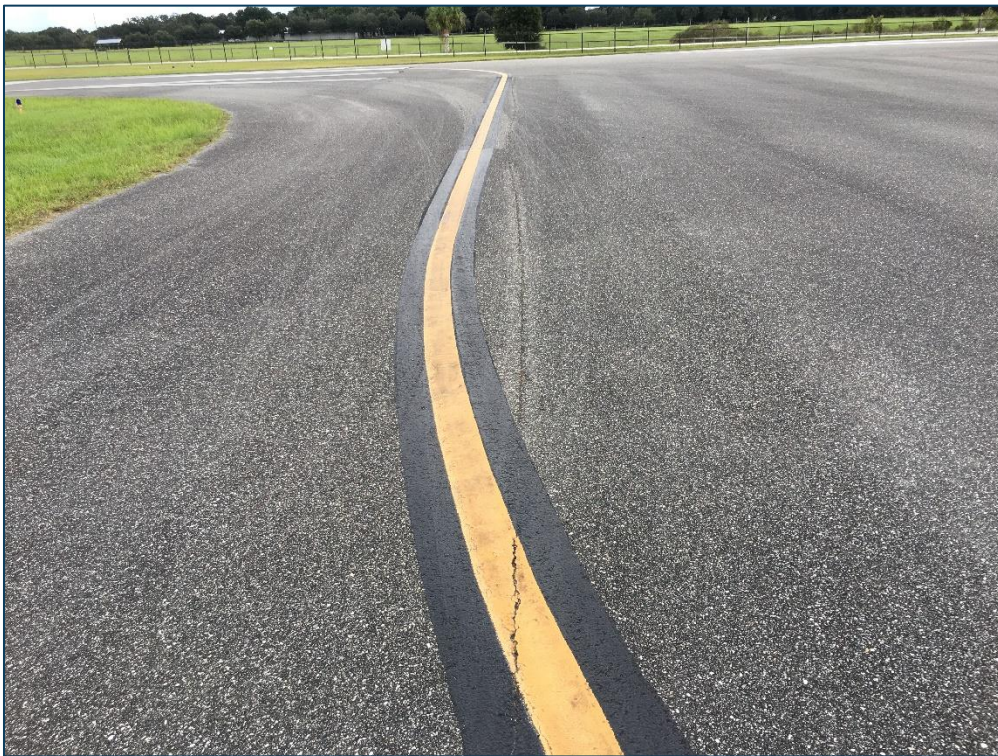
Taxilane To Hangar, Section 4205, Sample Unit 102 – Low Severity (48) Longitudinal and Transverse Cracking, Low Severity (52) Raveling, Low Severity (57) Weathering

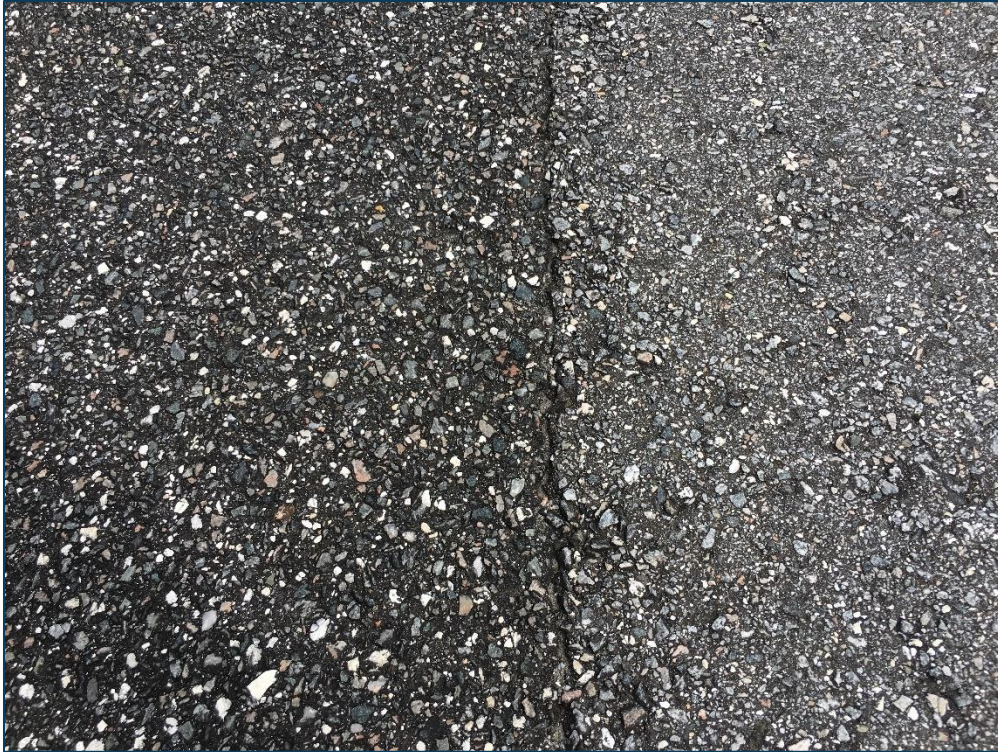
Run-Up Apron, Section 5105, Sample Unit 100 – Low Severity (57) Weathering, Low Severity (52) Raveling, Low Severity (48) Longitudinal and Transverse Cracking
