Statewide Airfield Pavement Management Program

**Airport Pavement
Evaluation Report
September 2017**

Tri-County Airport (1J0)
General Aviation Airport
District 3

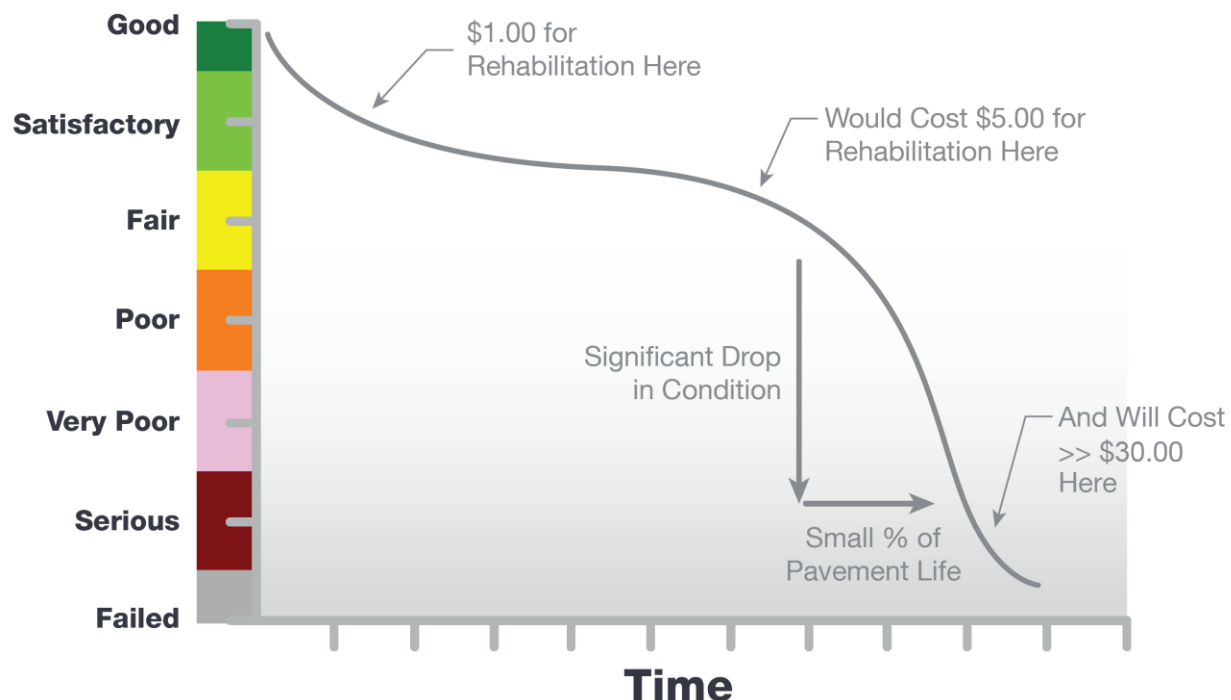
Figure 1.7-1 Typical Pavement Condition Life Cycle

**Figure is for conceptual purposes only – unit costs are not specific to airfield pavements (AC vs PCC).*

Pavement maintenance, repair, and major rehabilitation would be quite anticipatory if all pavements behaved as depicted in **Figures 1.7-1 and 1.7-2**, however pavement condition performance vary significantly based on several factors. Factors that contribute to a pavement section's condition and deterioration performance may include: functional design life, material type, material construction quality, climatic conditions, aircraft loading type and frequency, non-aircraft loading type and frequency, maintenance history, subgrade conditions, and other infrastructure in the vicinity. The list of factors is not all-inclusive of all factors that may contribute to a pavement's life cycle, it is intended to clarify that unique conditions certainly will affect a pavement's deterioration.

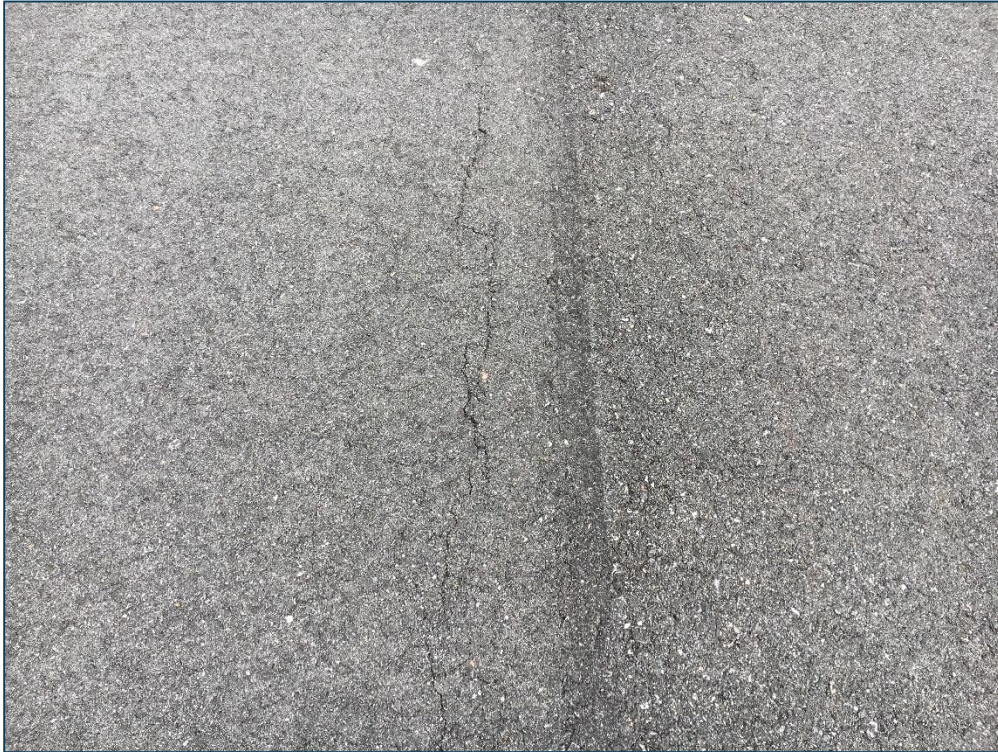
Runway 1-19, Section 6115, Sample Unit 182 – Low Severity (48) Longitudinal and Transverse Cracking, Low Severity (57) Weathering

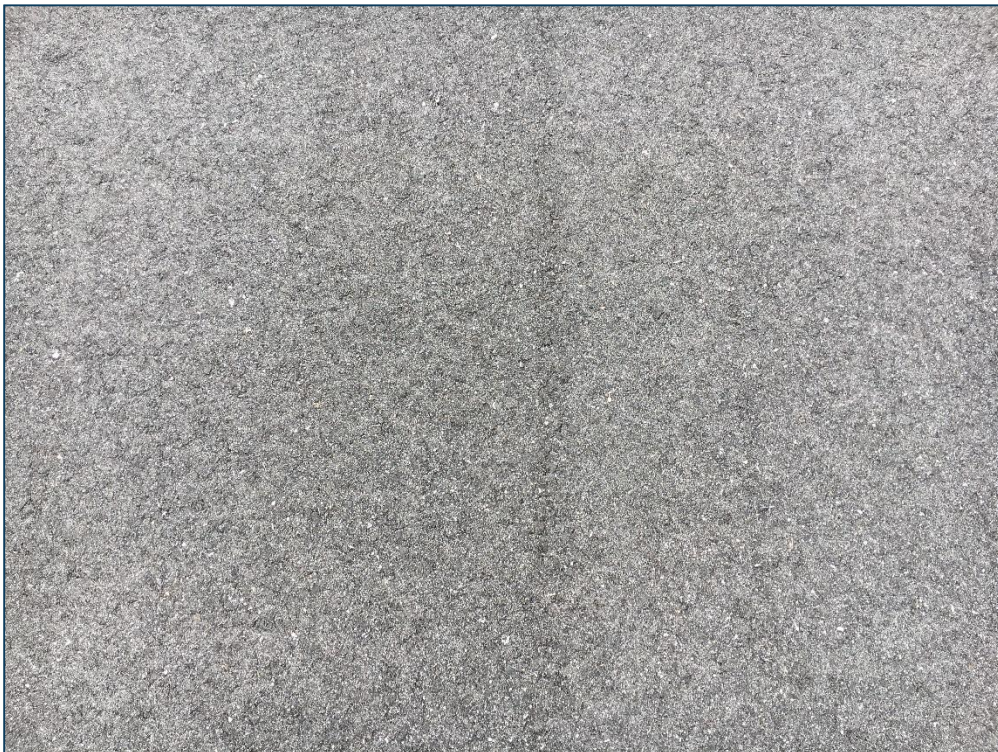
Runway 1-19, Section 6115, Sample Unit 194 – Low Severity (57) Weathering

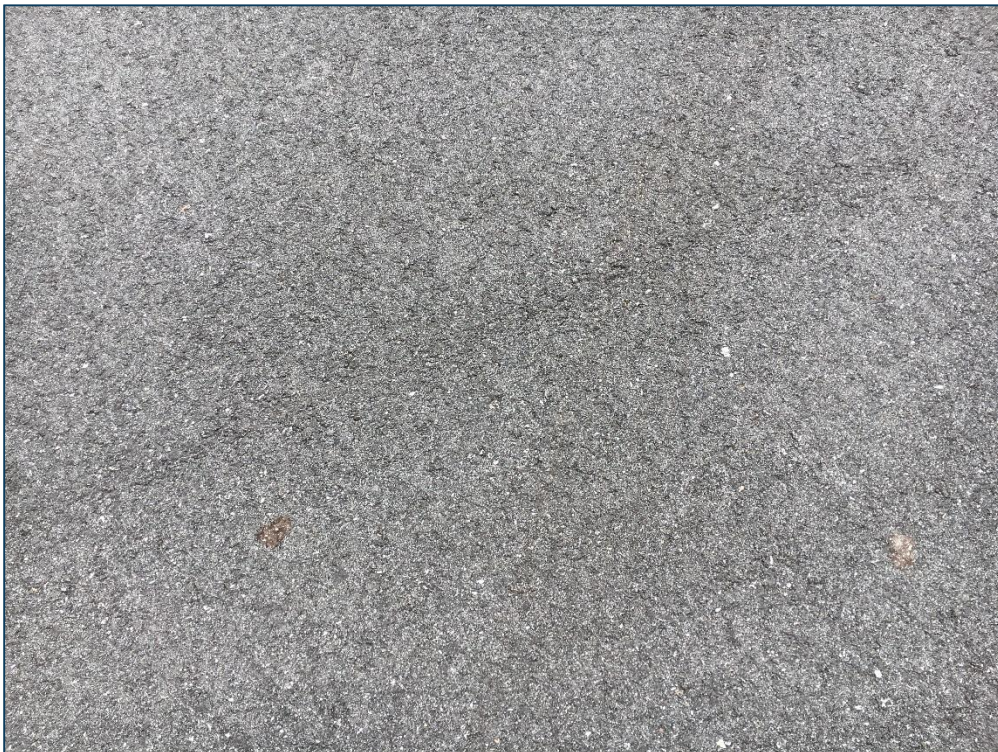
Taxiway A, Section 120, Sample Unit 106 – Low Severity (57) Weathering

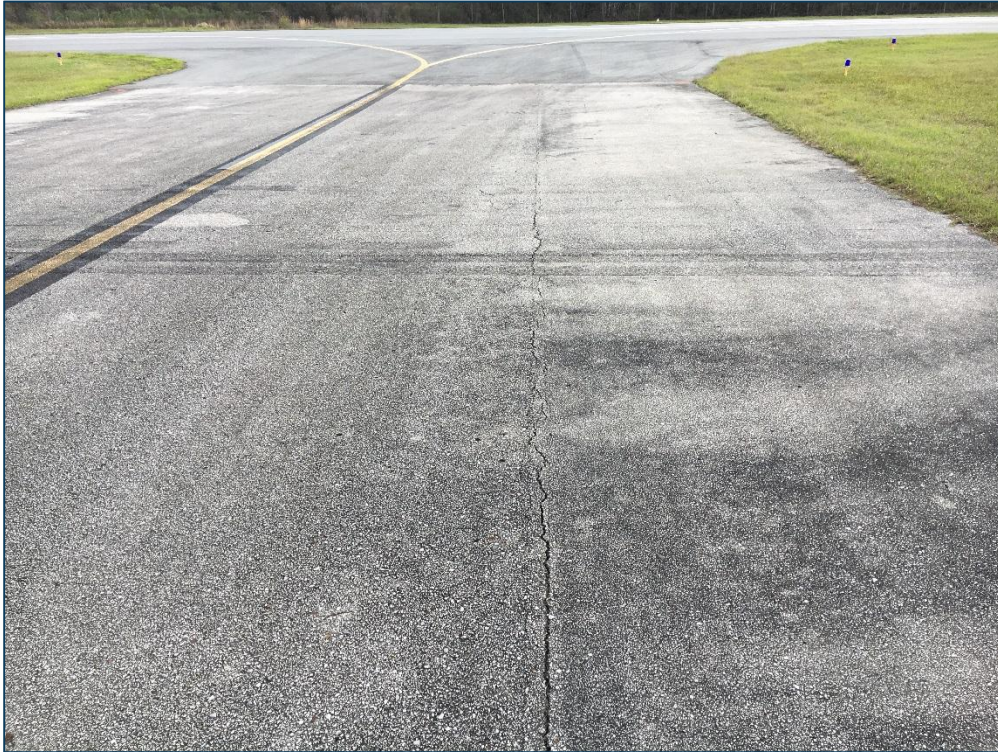
Taxiway A1, Section 105, Sample Unit 100 – Low Severity (48) Longitudinal and Transverse Cracking, Low Severity (52) Raveling, Low Severity (57) Weathering

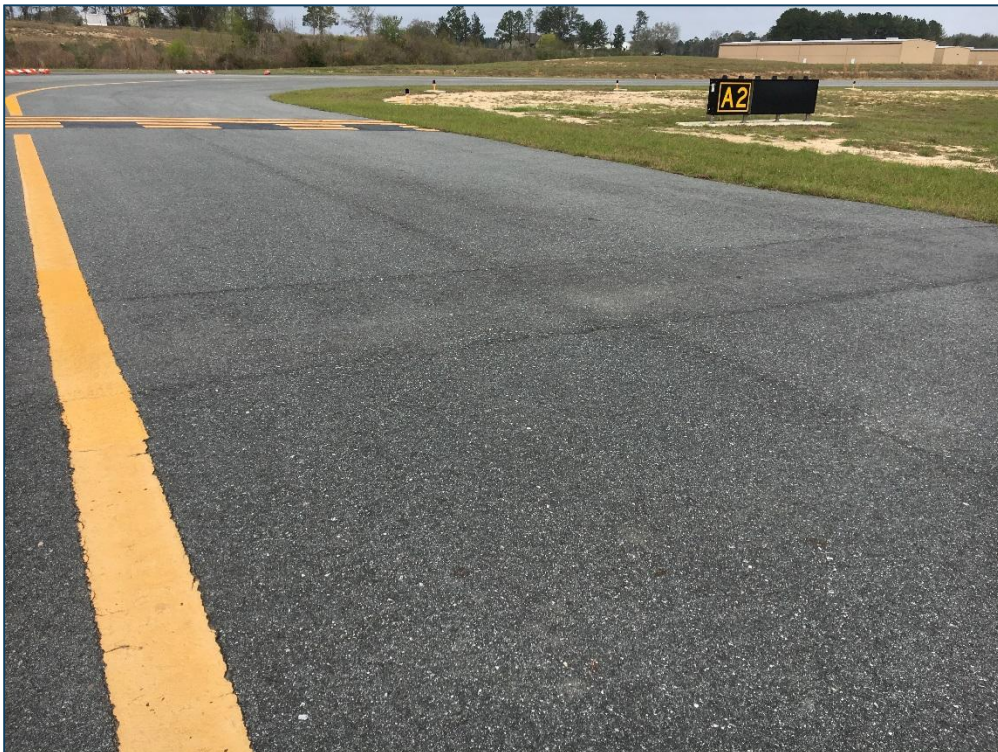
Taxiway A2, Section 205, Sample Unit 100 – Low Severity (50) Patching, Low Severity (57) Weathering

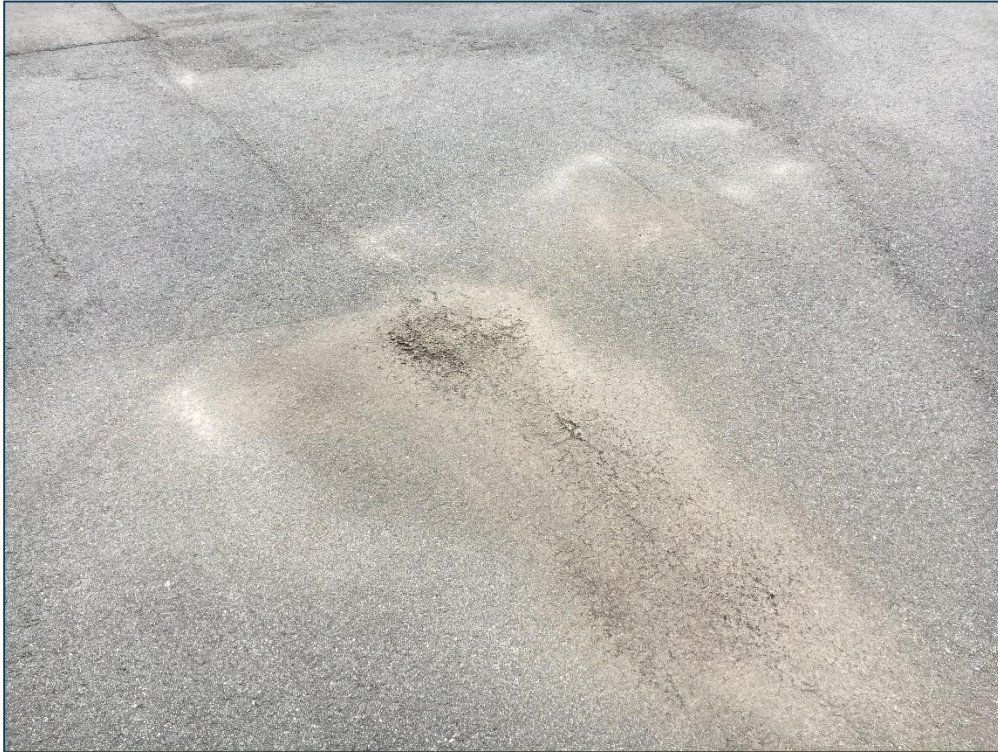
Taxiway A3, Section 305, Sample Unit 100 – Low Severity (45) Depression, Low Severity (57) Weathering,

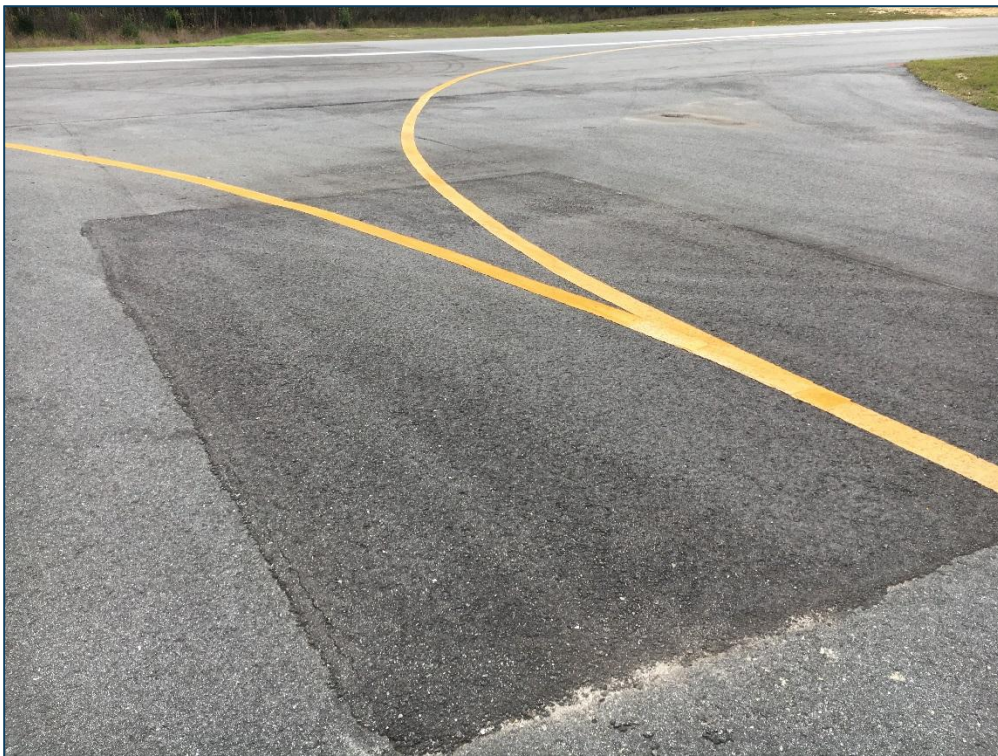
Taxiway A3, Section 305, Sample Unit 100 – Low Severity (50) Patching, Low Severity (57) Weathering

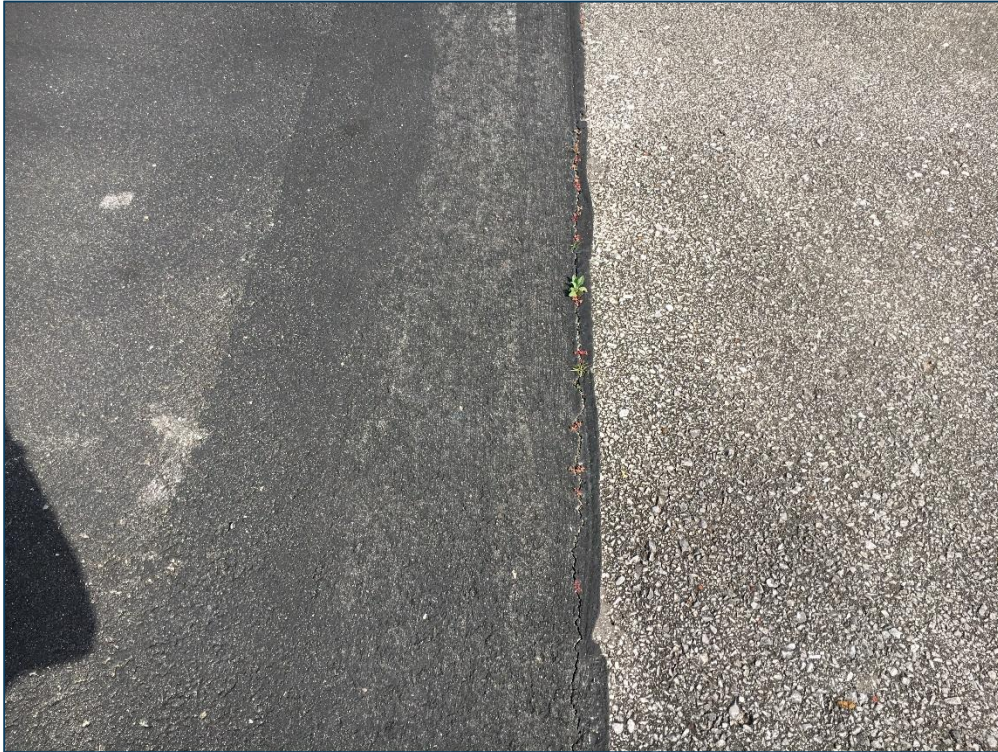
Apron, Section 4105, Sample Unit 100 - Low Severity (48) Longitudinal and Transverse Cracking, Low Severity (57) Weathering

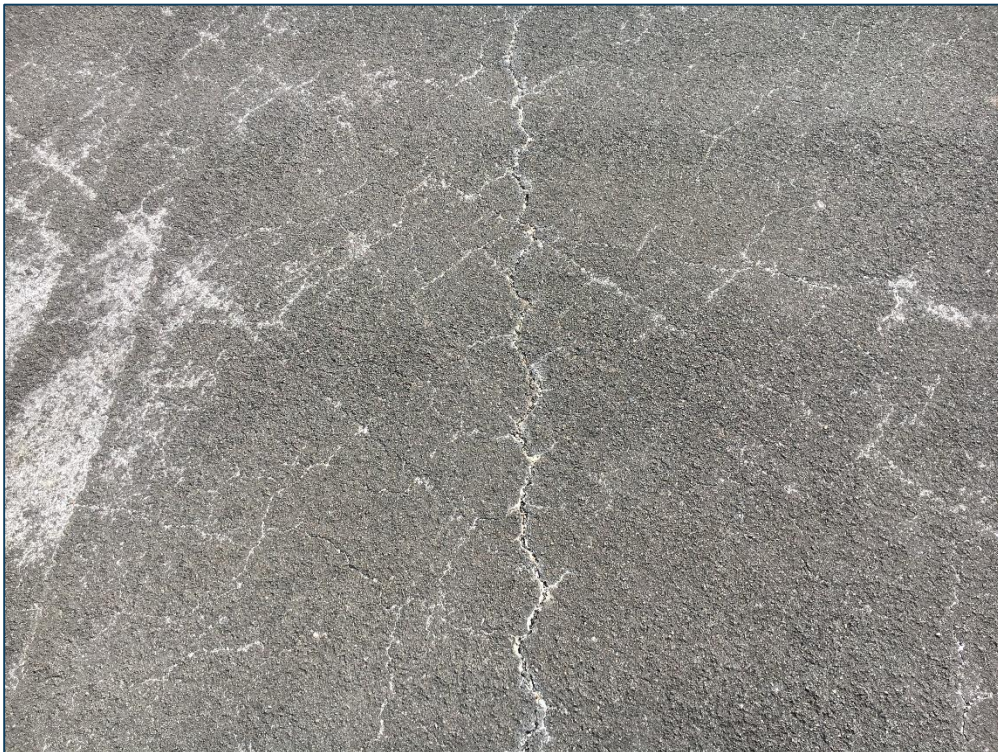
Apron, Section 4115, Sample Unit 303 - Low Severity (48) Longitudinal and Transverse Cracking, Low Severity (52) Raveling, Low Severity (57) Weathering

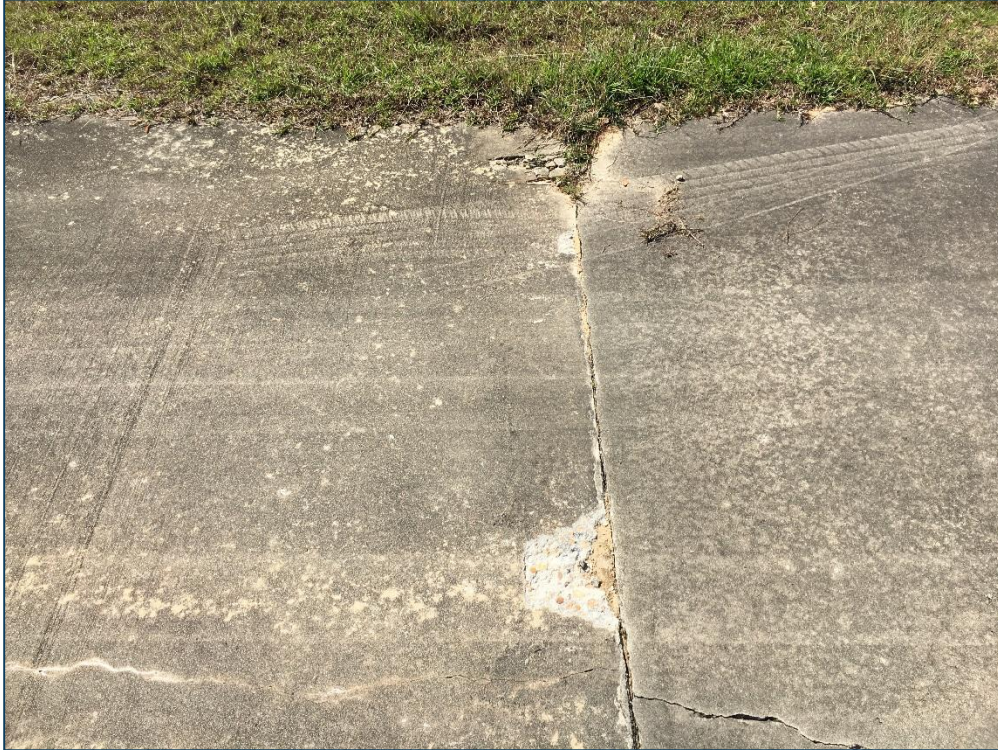
T-Hangar Taxilane, Section 4110, Sample Unit 300 – Low Severity (63) Longitudinal, Transverse, and Diagonal Cracking, Low Severity (74) Joint Spalling, High Severity (65) Joint Seal Damage.

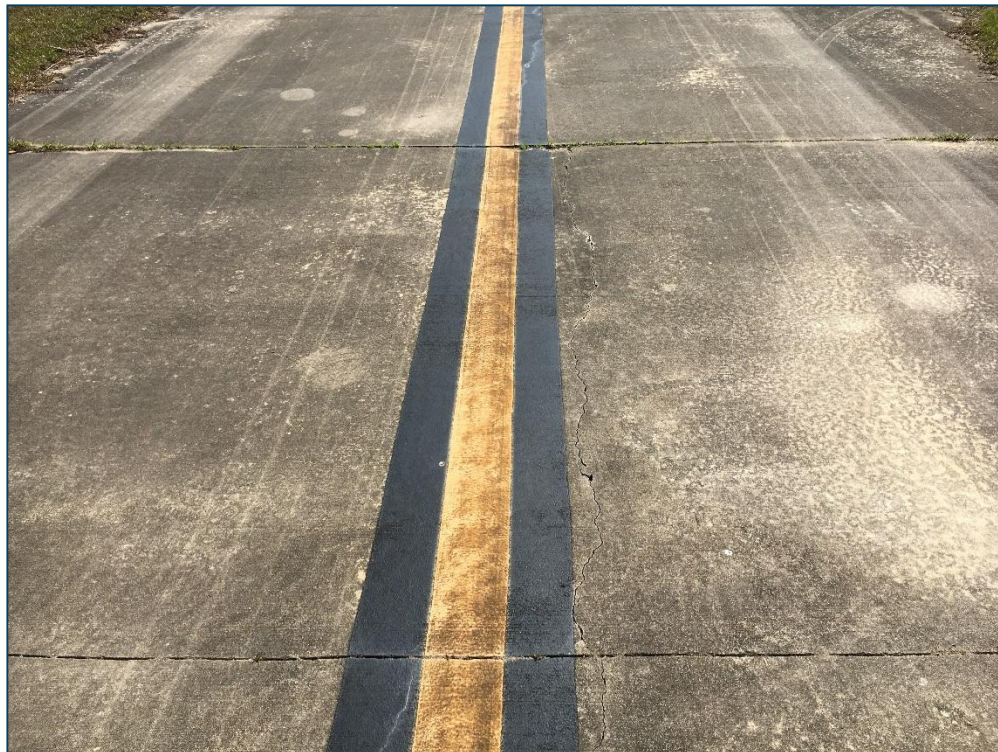
T-Hangar Taxilane, Section 4110, Sample Unit 300 – Low Severity (63) Longitudinal, Transverse, and Diagonal Cracking, High Severity (65) Joint Seal Damage.

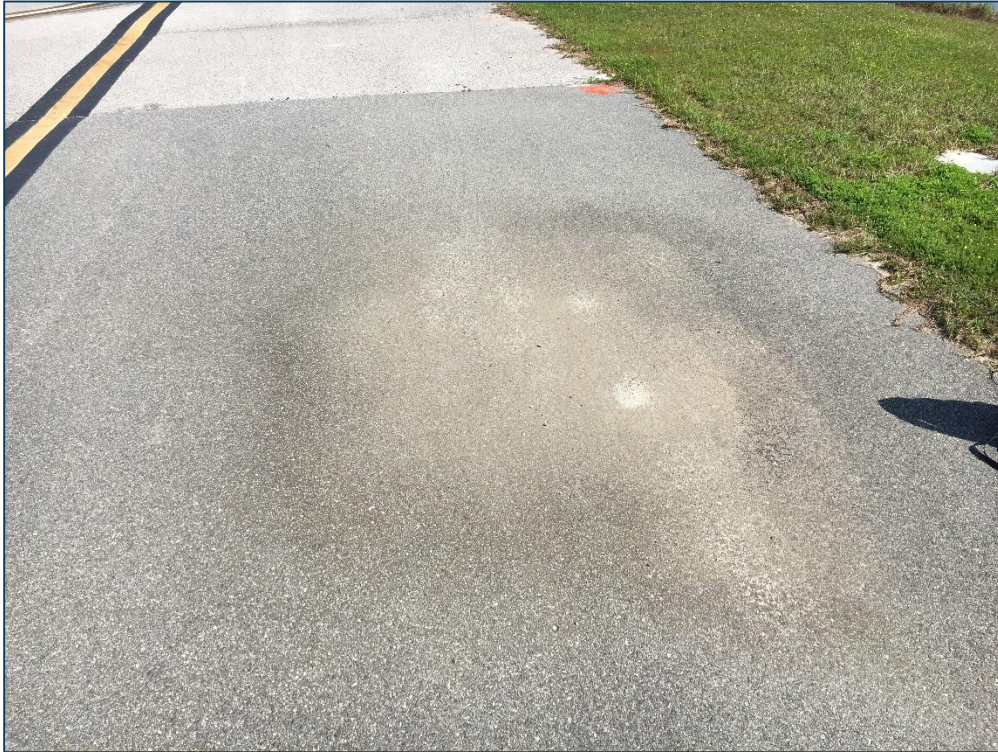
T-Hangar Taxilane, Section 4125, Sample Unit 106 – Low Severity (45) Depression, Low Severity (57) Weathering
