Statewide Airfield Pavement Management Program

Airport Pavement Evaluation Report November 2019

**Venice Municipal
Airport (VNC)**
Reliever Airport
District 1

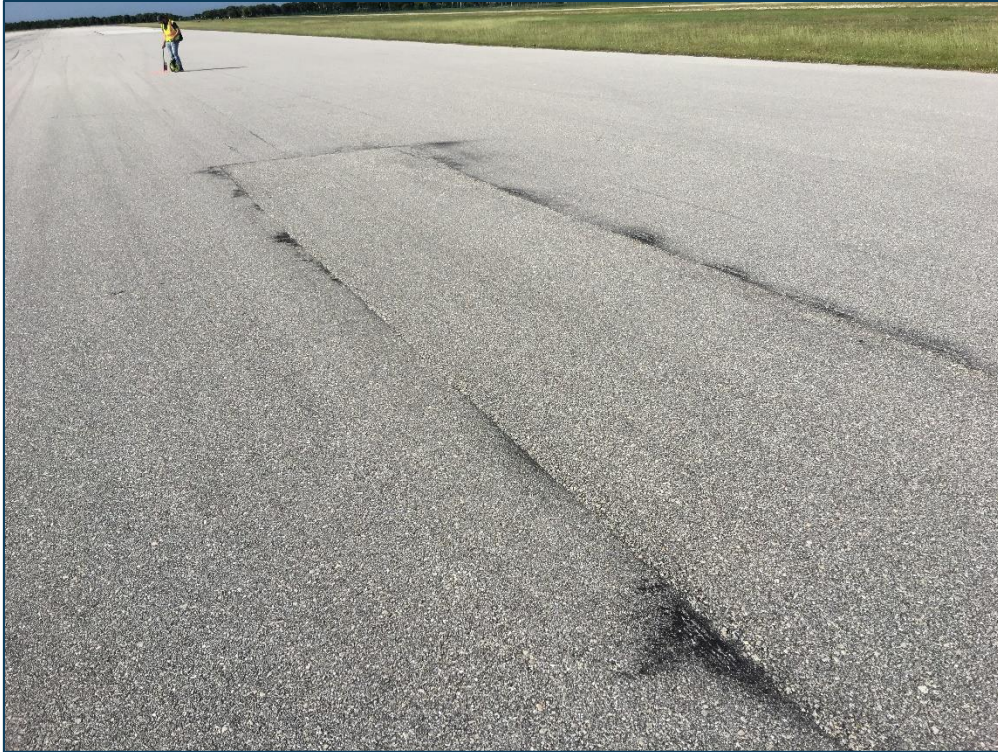
RW 5-23, Section 6205, Sample Unit 115 - Low Severity (50) Patching, Low Severity (52) Raveling, and Low Severity (57) Weathering

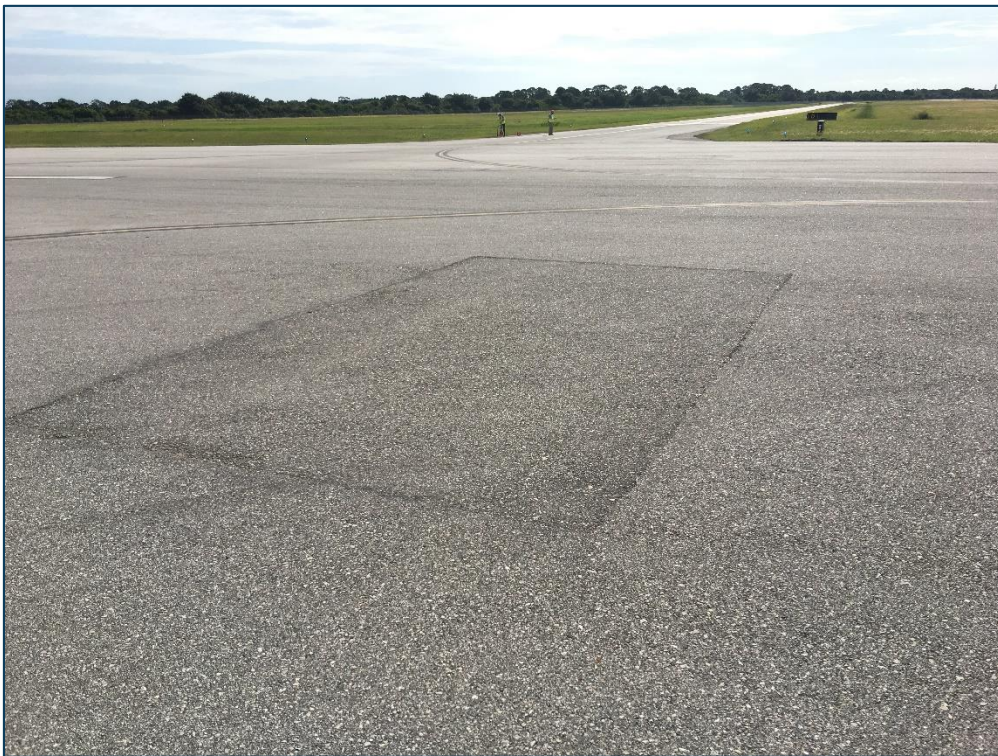
RW 5-23, Section 6240, Sample Unit 320 - Low Severity (50) Patching and Low Severity (57) Weathering

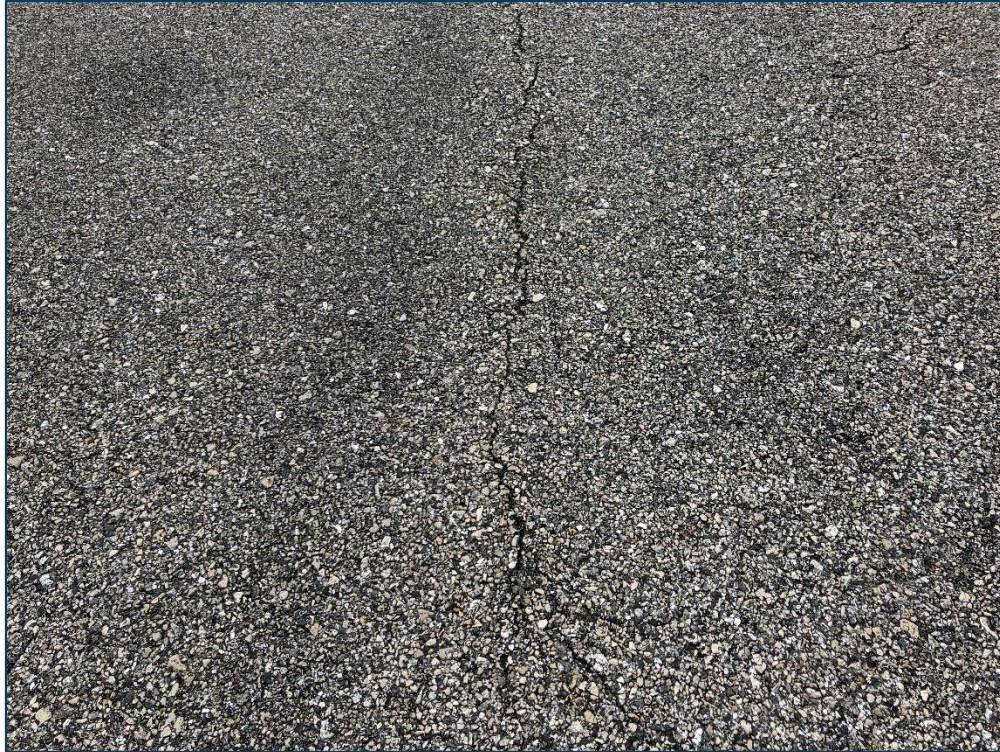
RW 13-31, Section 6110, Sample Unit 128 - Low Severity (48) Longitudinal & Transverse Cracking, Low Severity (56) Swelling, and Low Severity (57) Weathering

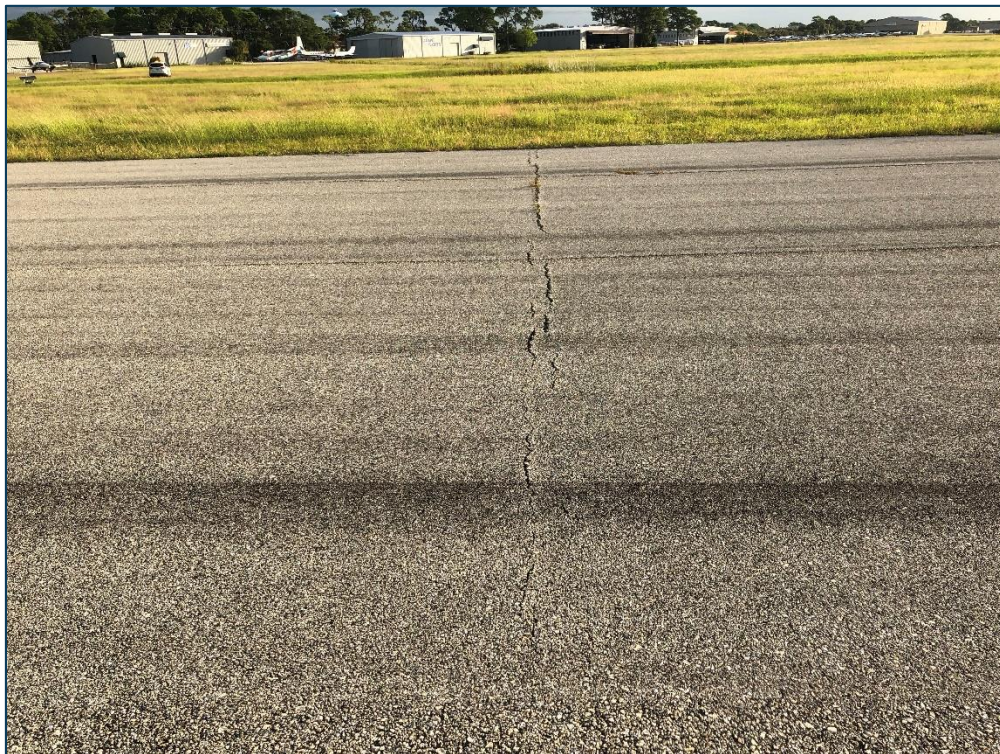
RW 13-31, Section 6125, Sample Unit 395 - Low and Medium Severity (47) Joint Reflection Cracking, Low Severity (48) Longitudinal & Transverse Cracking, Low Severity (52) Raveling, and Low Severity (57) Weathering

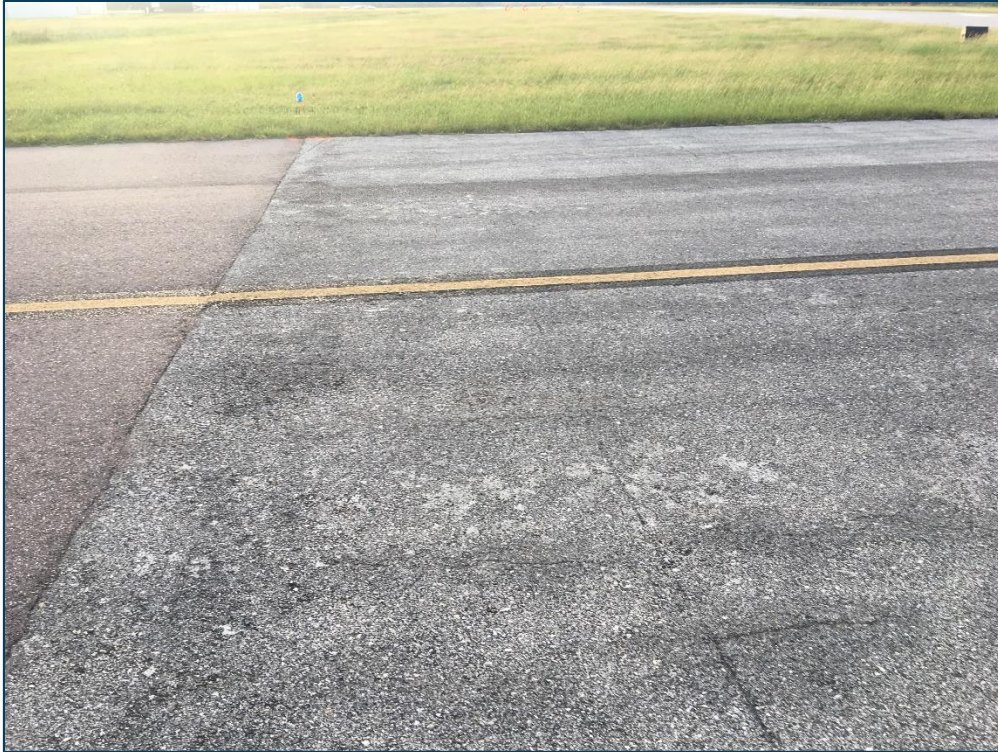
TW A, Section 125, Sample Unit 100 - Low Severity (48) Longitudinal & Transverse Cracking, Low Severity (52) Raveling, and Medium Severity (57) Weathering

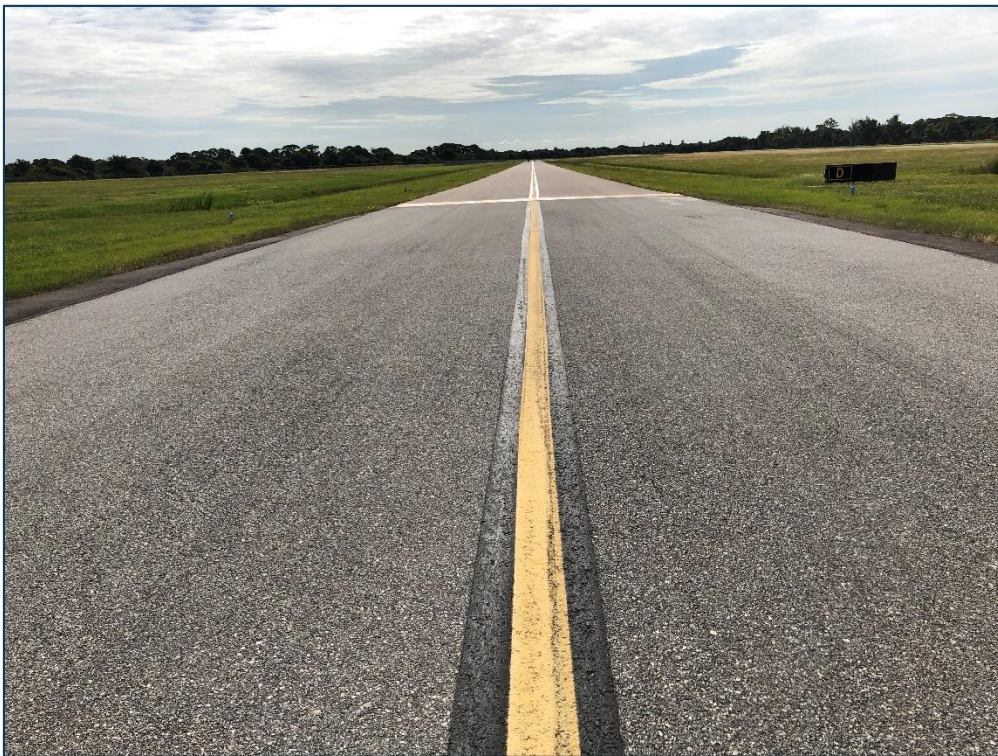
TW D, Section 410, Sample Unit 101 - Low Severity (57) Weathering

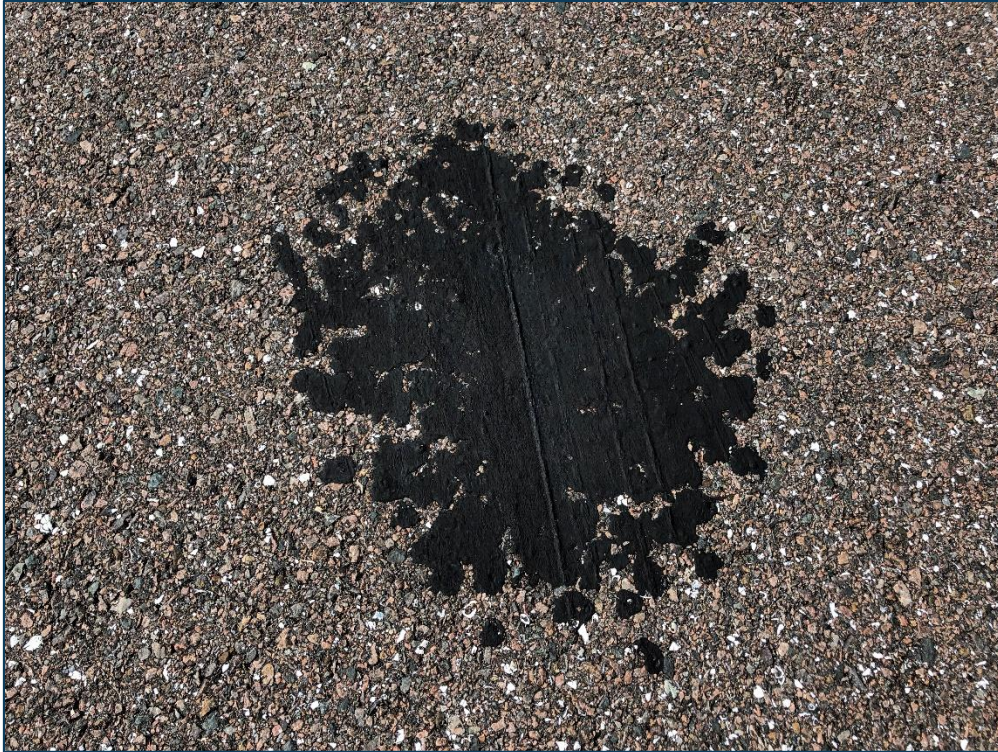
TWE, Section 515, Sample Unit 125 - (42) Bleeding and Low Severity (57) Weathering

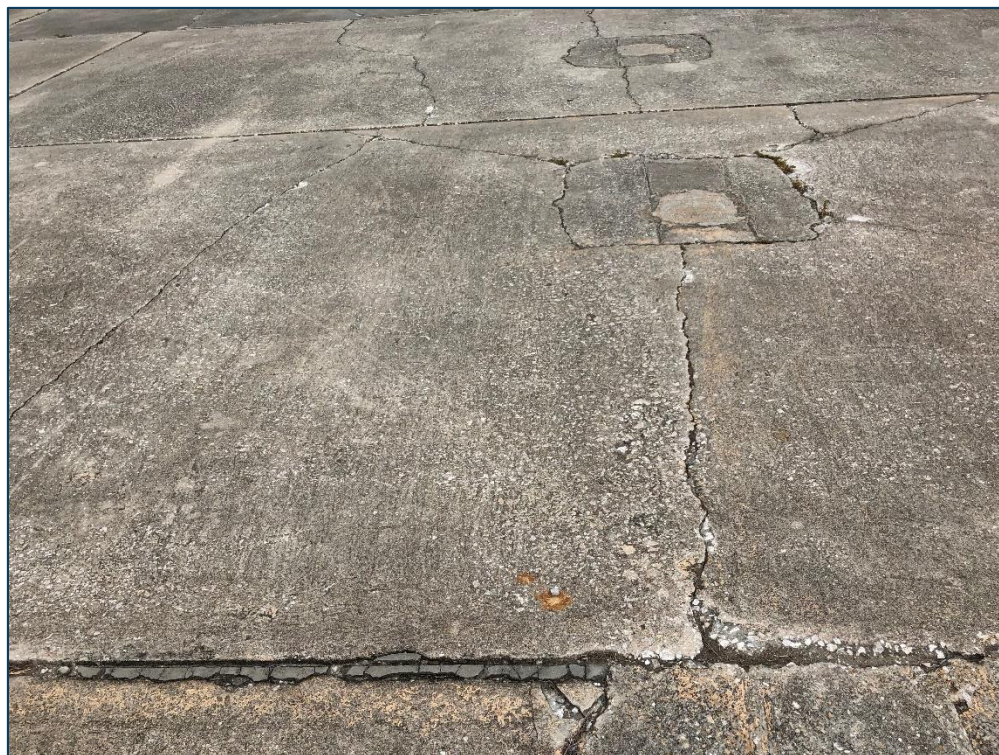
AP, Section 4115, Sample Unit300 - High Severity (65) Joint Seal Damage and Medium Severity (72) Shattered Slab
