# **Statewide Airfield Pavement Management Program**

## **Airport Pavement Evaluation Report November 2019**

**Destin-Fort Walton  
Beach Airport (VPS)**  
Commercial Airport  
District 3

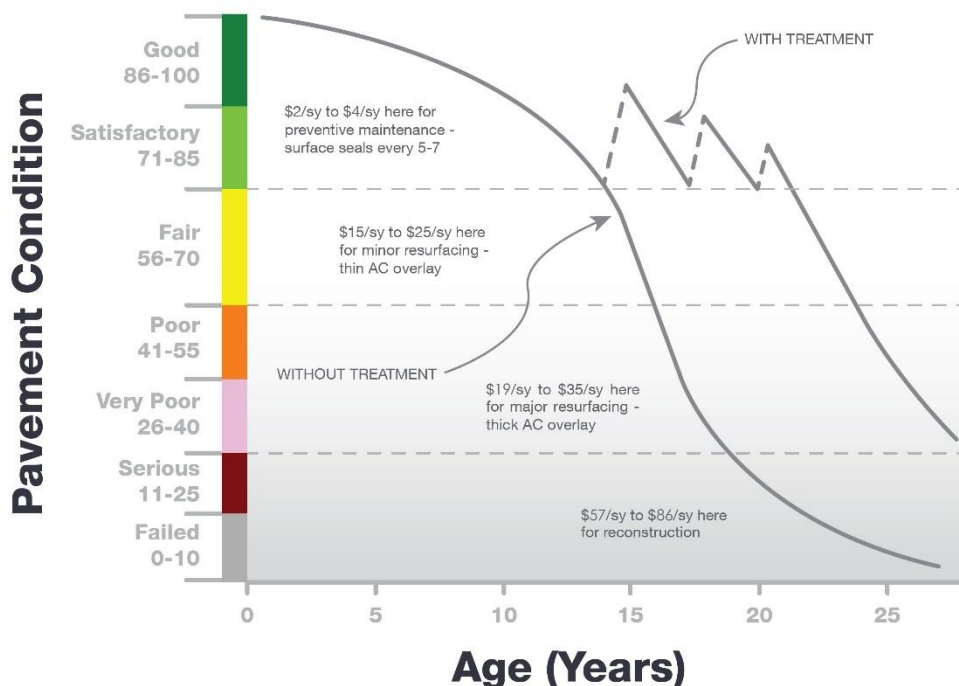
*Figure 1.7.2 (b) General Pavement Treatments by Condition Range*

**Figure 1.7.2 (b) General Pavement Treatments by Condition Range** depicts generic flexible asphalt concrete (AC) pavement treatments that are effective at specific condition ranges. This graphic is a general concept and will vary based on pavement surface type and overall

composition. The intent is to convey various treatment types that would be effective based on the condition of the pavement along the deterioration model.

Pavement maintenance, repair, and major rehabilitation would be quite anticipatory if all pavements behaved as depicted in **Figures 1.7.2 (a) and 1.7.2 (b)**, however pavement condition performance vary significantly based on several factors. Factors that contribute to a pavement section's condition and deterioration performance may include: functional design life, material type, material construction quality, climatic conditions, aircraft loading type and frequency, non-aircraft loading type and frequency, maintenance history, subgrade conditions, and other infrastructure in the vicinity. The list of factors is not all-inclusive of all factors that may contribute to a pavement's life cycle, it is intended to clarify that unique conditions certainly will affect a pavement's deterioration.

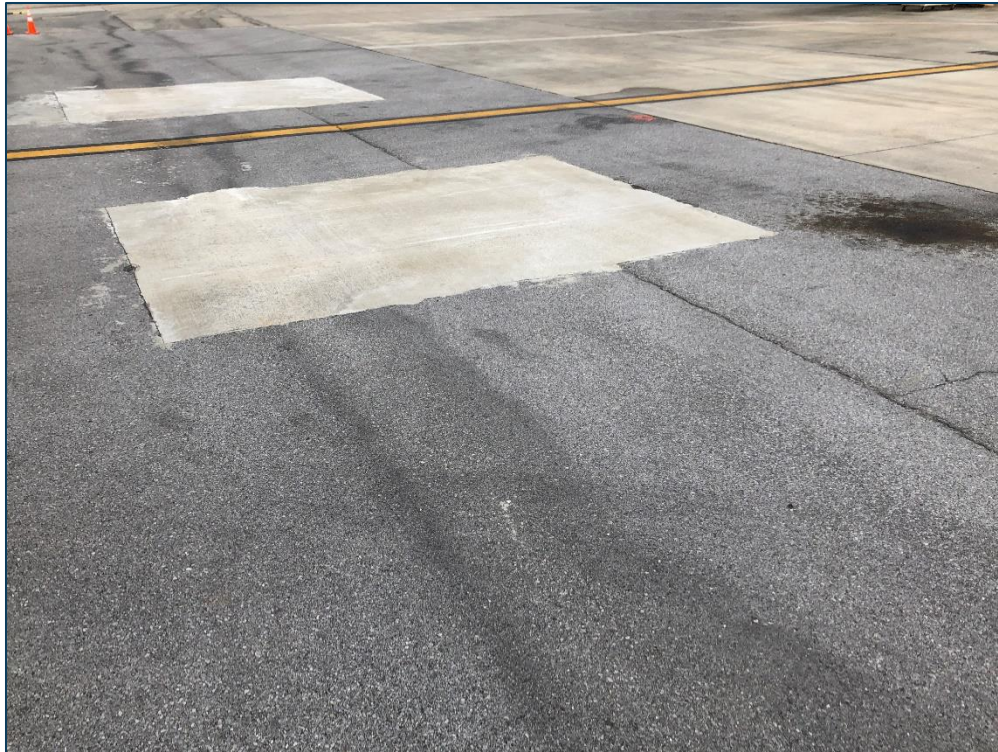
AP TERM, Section 4105, Sample Unit 301 - Low Severity (45) Depression, Low Severity (48) Longitudinal & Transverse Cracking, Medium Severity (48) Longitudinal & Transverse Cracking, Low Severity (50) Patching, Low Severity (52) Raveling, and Low Severity (57) Weathering

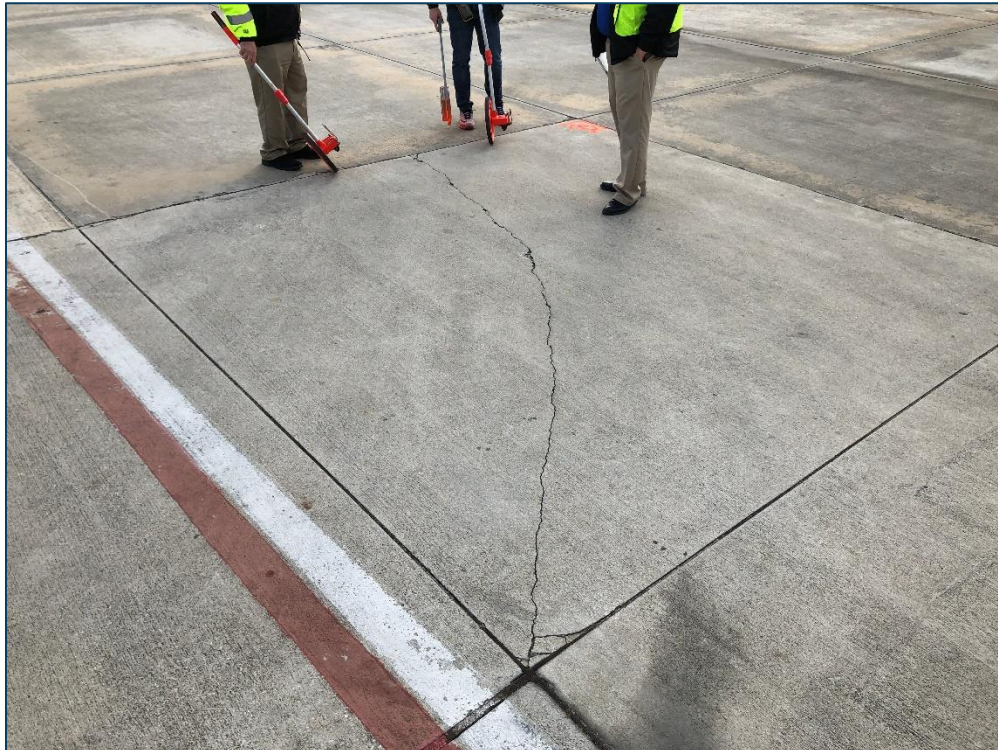
AP TERM, Section 4110, Sample Unit 153 - Medium Severity (63) Linear Cracking, Low Severity (65) Joint Seal Damage, Medium Severity (75) Corner Spall

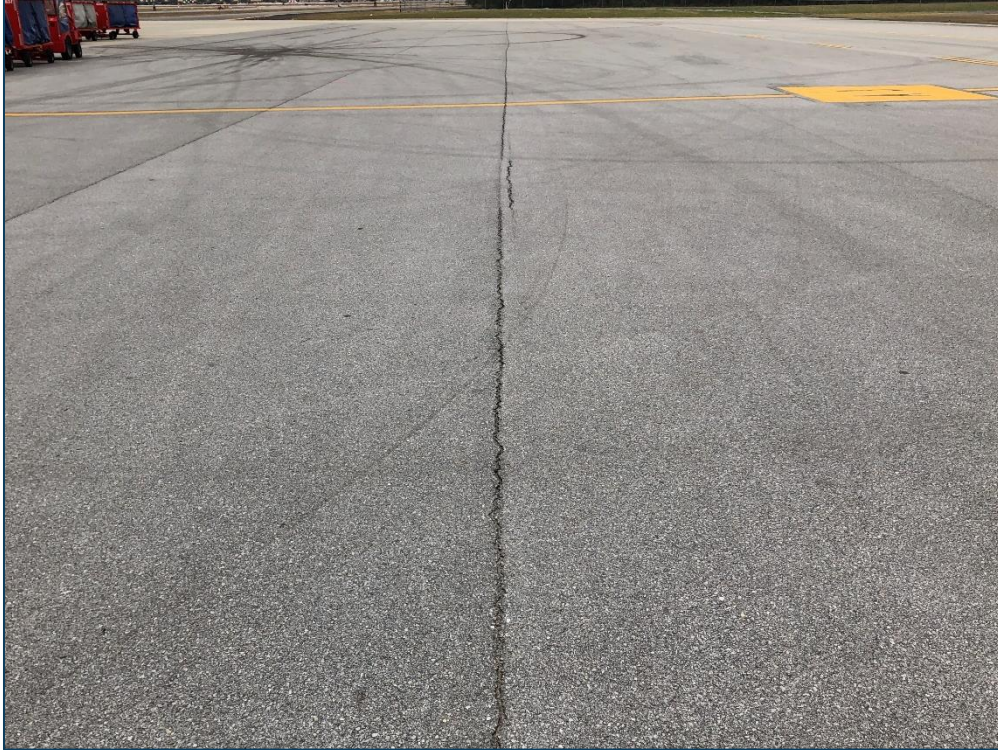
AP TERM, Section 4105, Sample Unit 203 - Medium Severity (48) Longitudinal & Transverse Cracking, Low Severity (52) Raveling, and Low Severity (57) Weathering

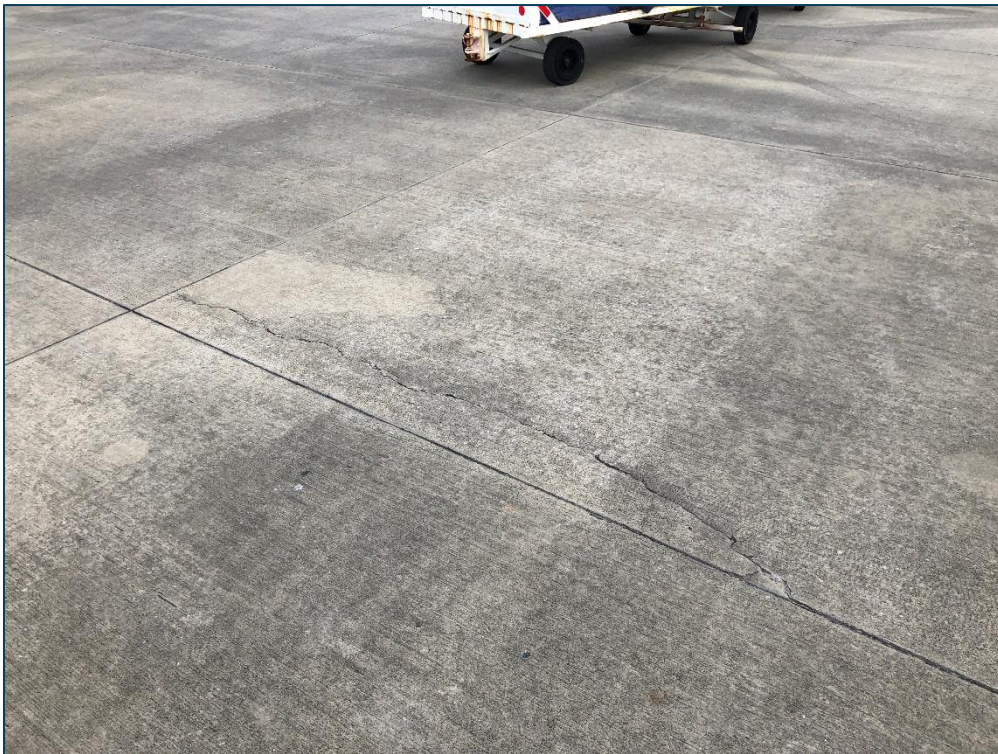
AP TERM, Section 4120, Sample Unit 304 - Low Severity (63) Linear Cracking
